Re: **Applicability of NCI (2016) Hydrology Report to
Corte Madera 4-Acre Tidal Marsh Restoration Project**

Hydrology Report

WETLAND RESTORATION DESIGN AND PERMITTING SUPPORT SERVICES AT CORTE MADERA ECOLOGICAL RESERVE

CORTE MADERA, MARIN COUNTY, CALIFORNIA

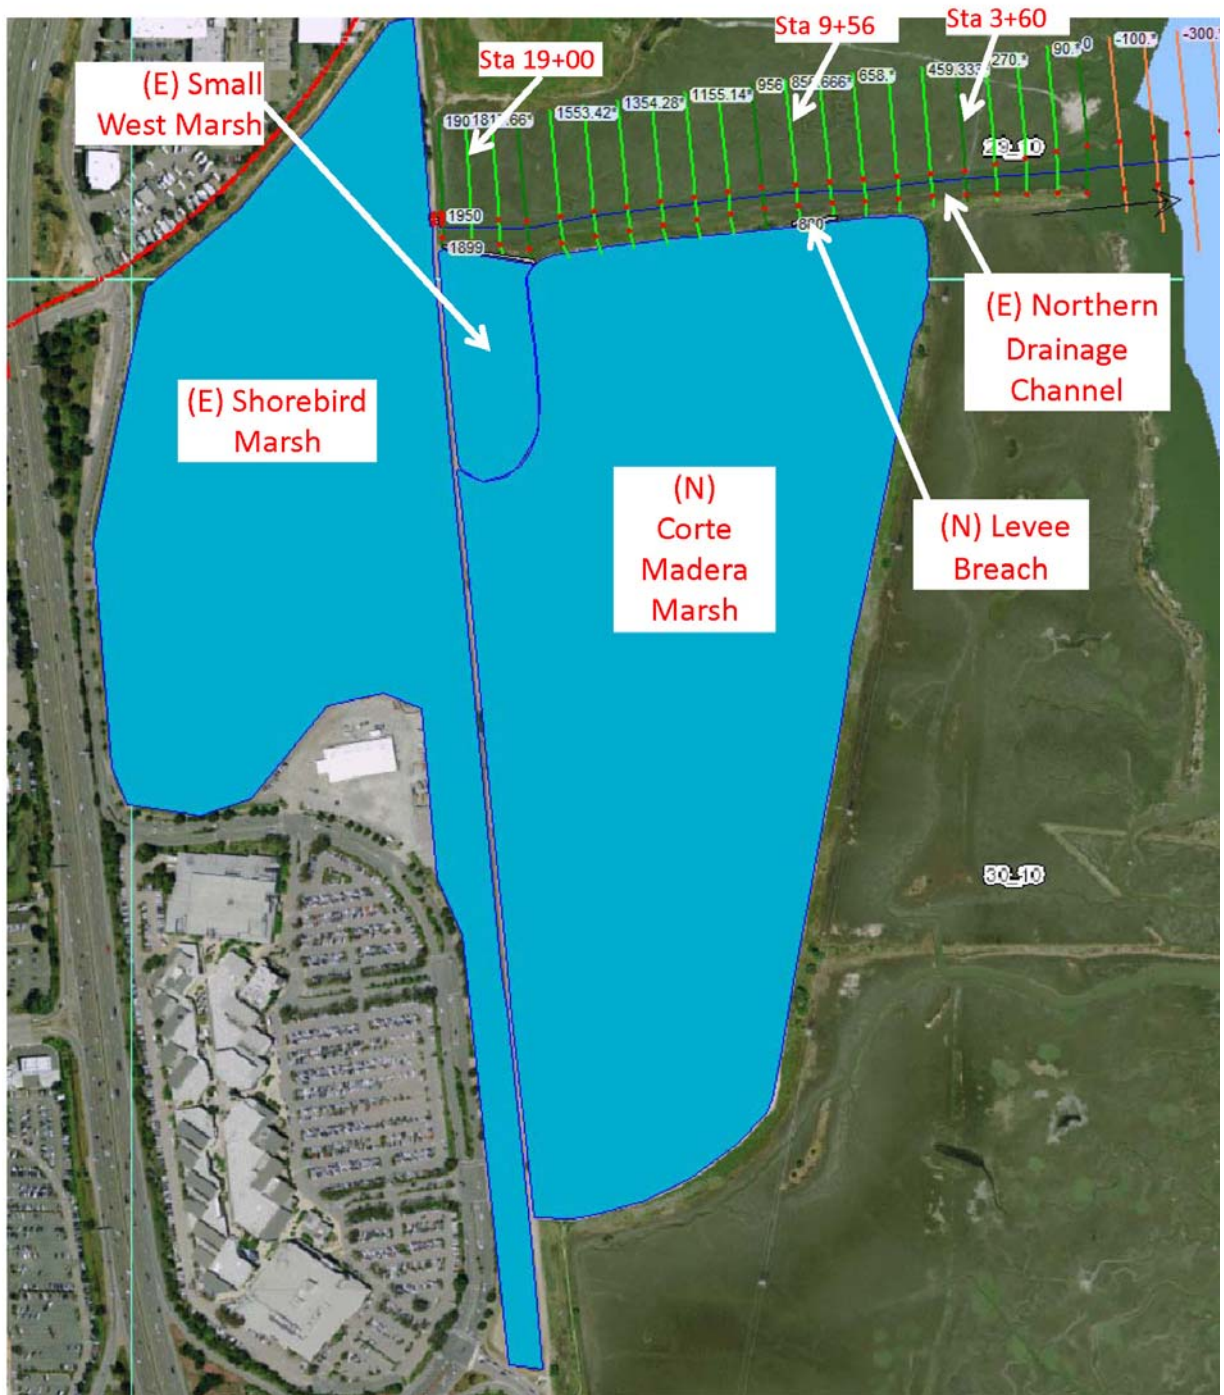
Figure 2. Geometry Schematic and Stations of the Existing Northern Drainage Channel

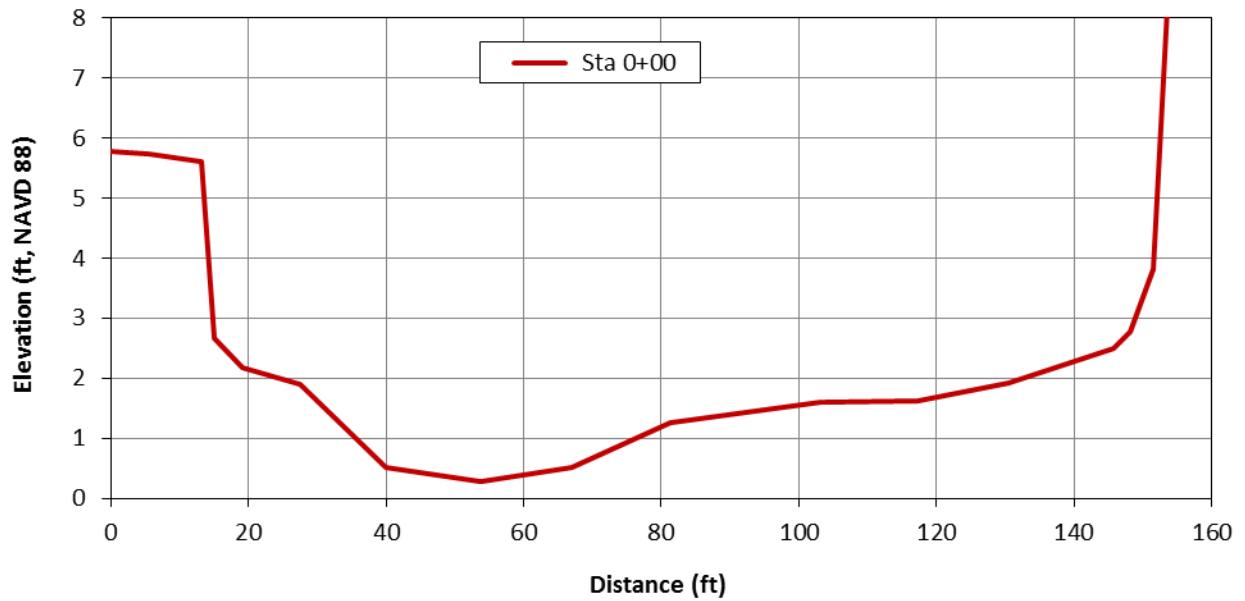
Note: north bank on the left and south bank on the right.

Figure 3. Surveyed Northern Drainage Channel Cross Section at Station 0+00

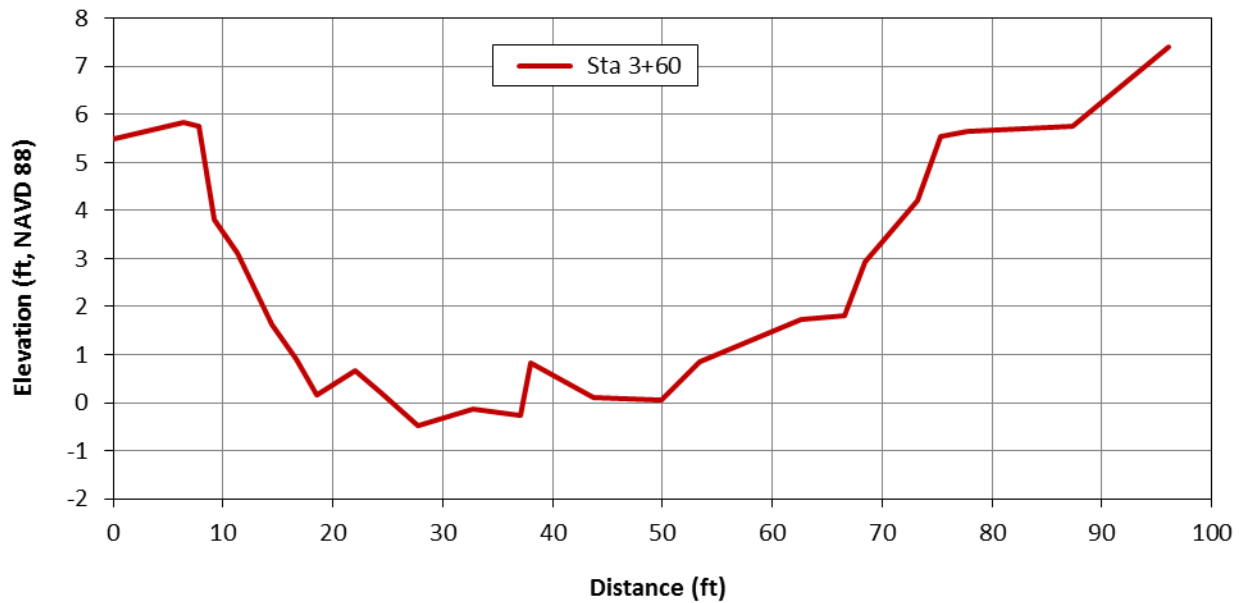
Note: north bank on the left and south bank on the right.

Figure 4. Surveyed Northern Drainage Channel Cross Section at Station 3+60

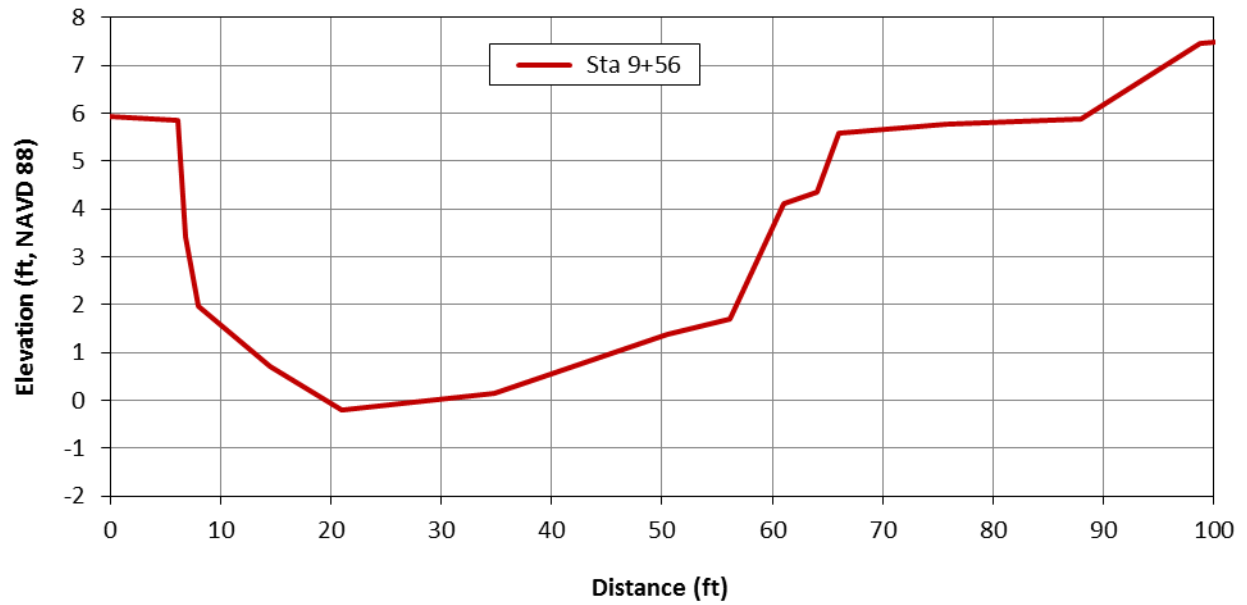
Note: north bank on the left and south bank on the right.

Figure 5. Surveyed Northern Drainage Channel Cross Section at Station 9+56

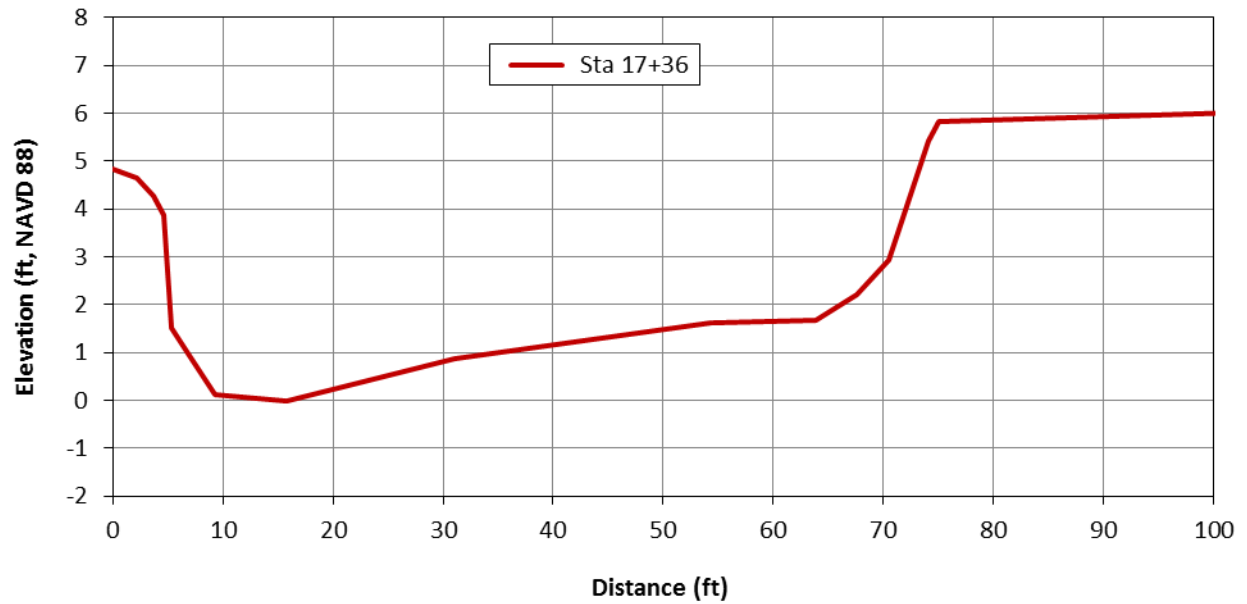
Note: north bank on the left and south bank on the right.

Figure 6. Surveyed Northern Drainage Channel Cross Section at Station 17+36

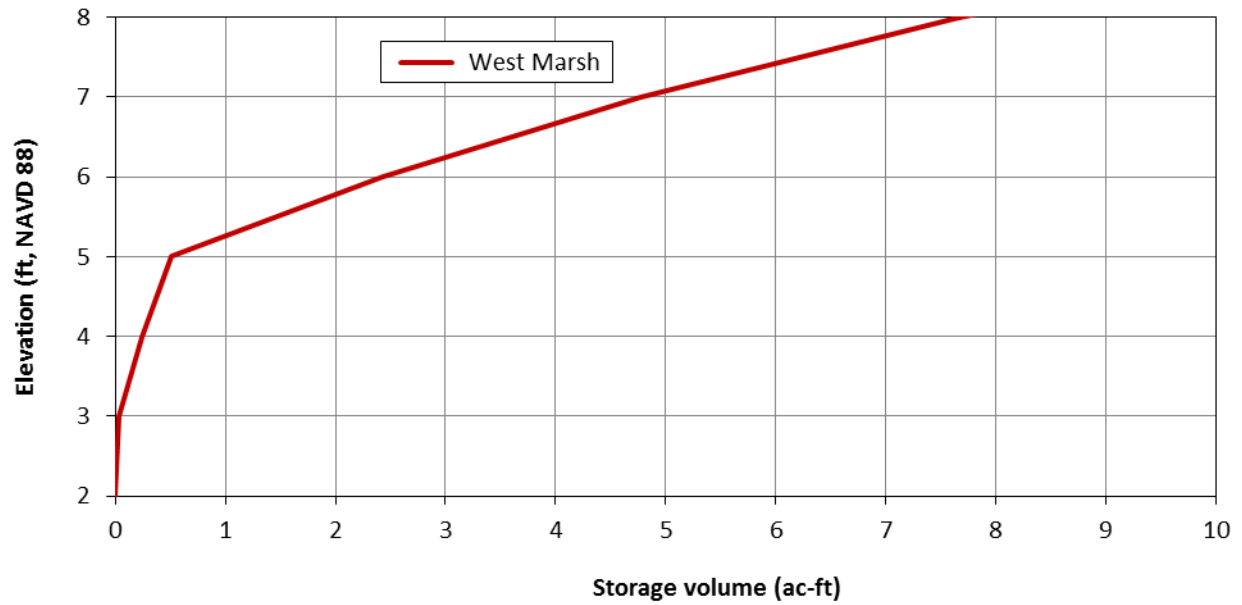
Figure 7. Elevation versus Storage Volume Curve for the Small Marsh Northwest of the Project Site

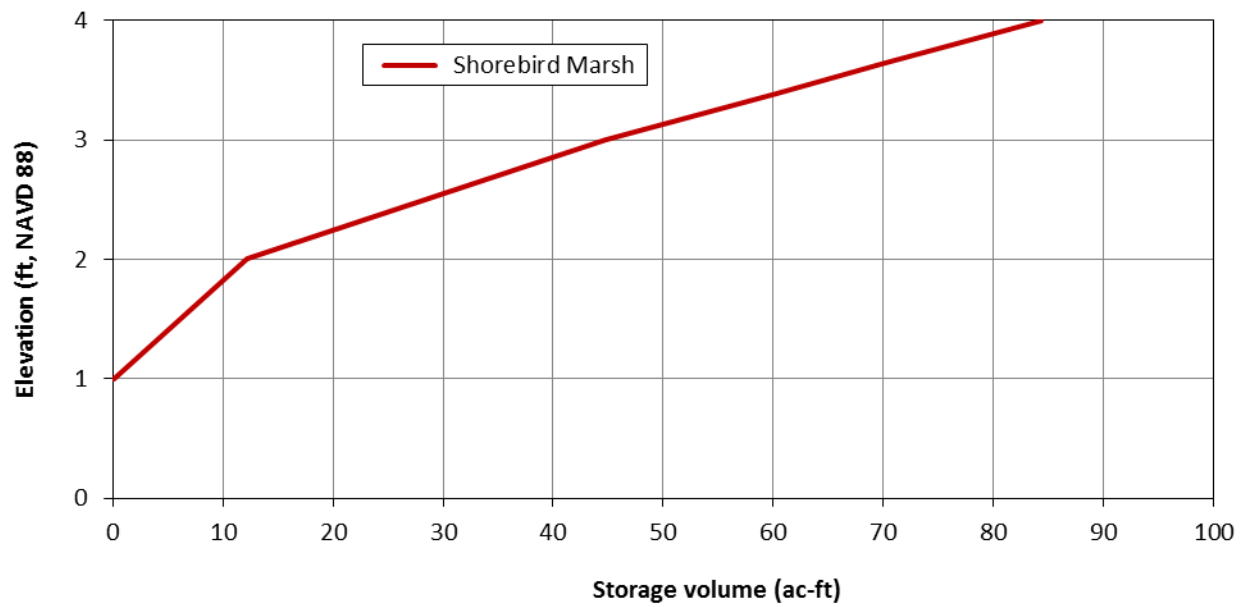
Figure 8. Elevation versus Estimated Storage Volume Curve for Shorebird Marsh

No comprehensive topographic survey was found for Shorebird Marsh. The September 2014 topographic survey by Hogan Land Services covered the channel located along the east side within Shorebird Marsh. The storage curve of Shorebird Marsh was estimated based on this limit survey data and google images (estimating water edges/contours, and elevations of high grounds). The estimated storage curve is shown in Figure 8. It is noted that the maximum water level in Shorebird Marsh is controlled at +3.64' NAVD88 (or 1.0' NGVD29) in the summer post-fledging season. Thus the storage capacity above this elevation does not impact water exchange between the marsh and the channel.

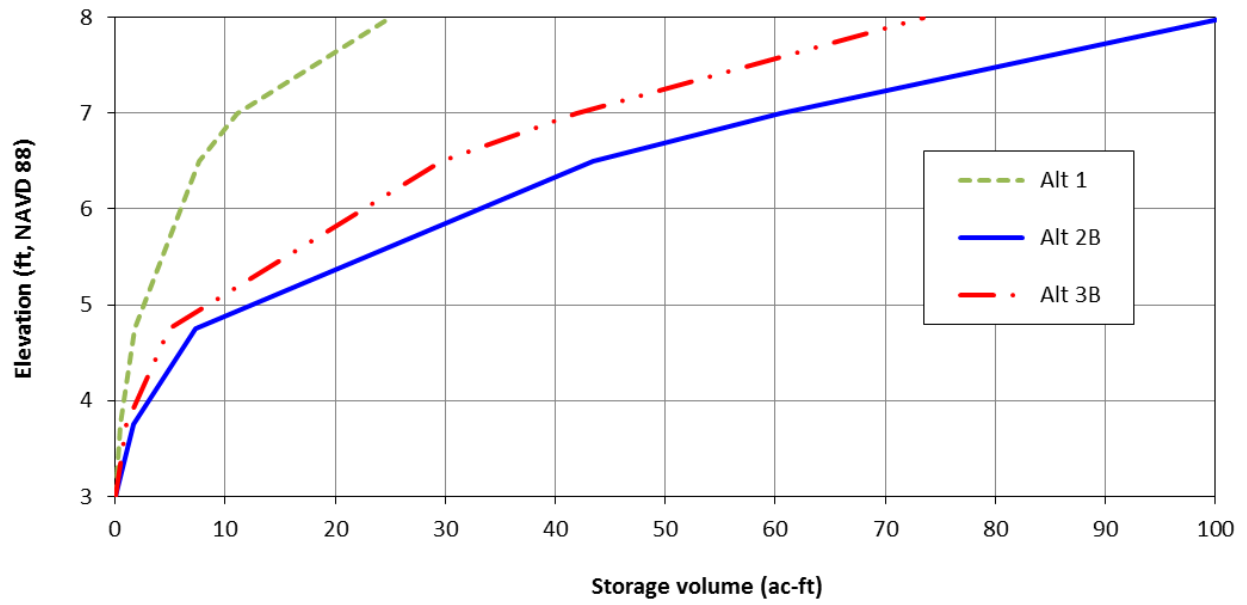
Figure 9. Elevation versus Storage Volume Curves for the Proposed Restored Corte Madera Marsh

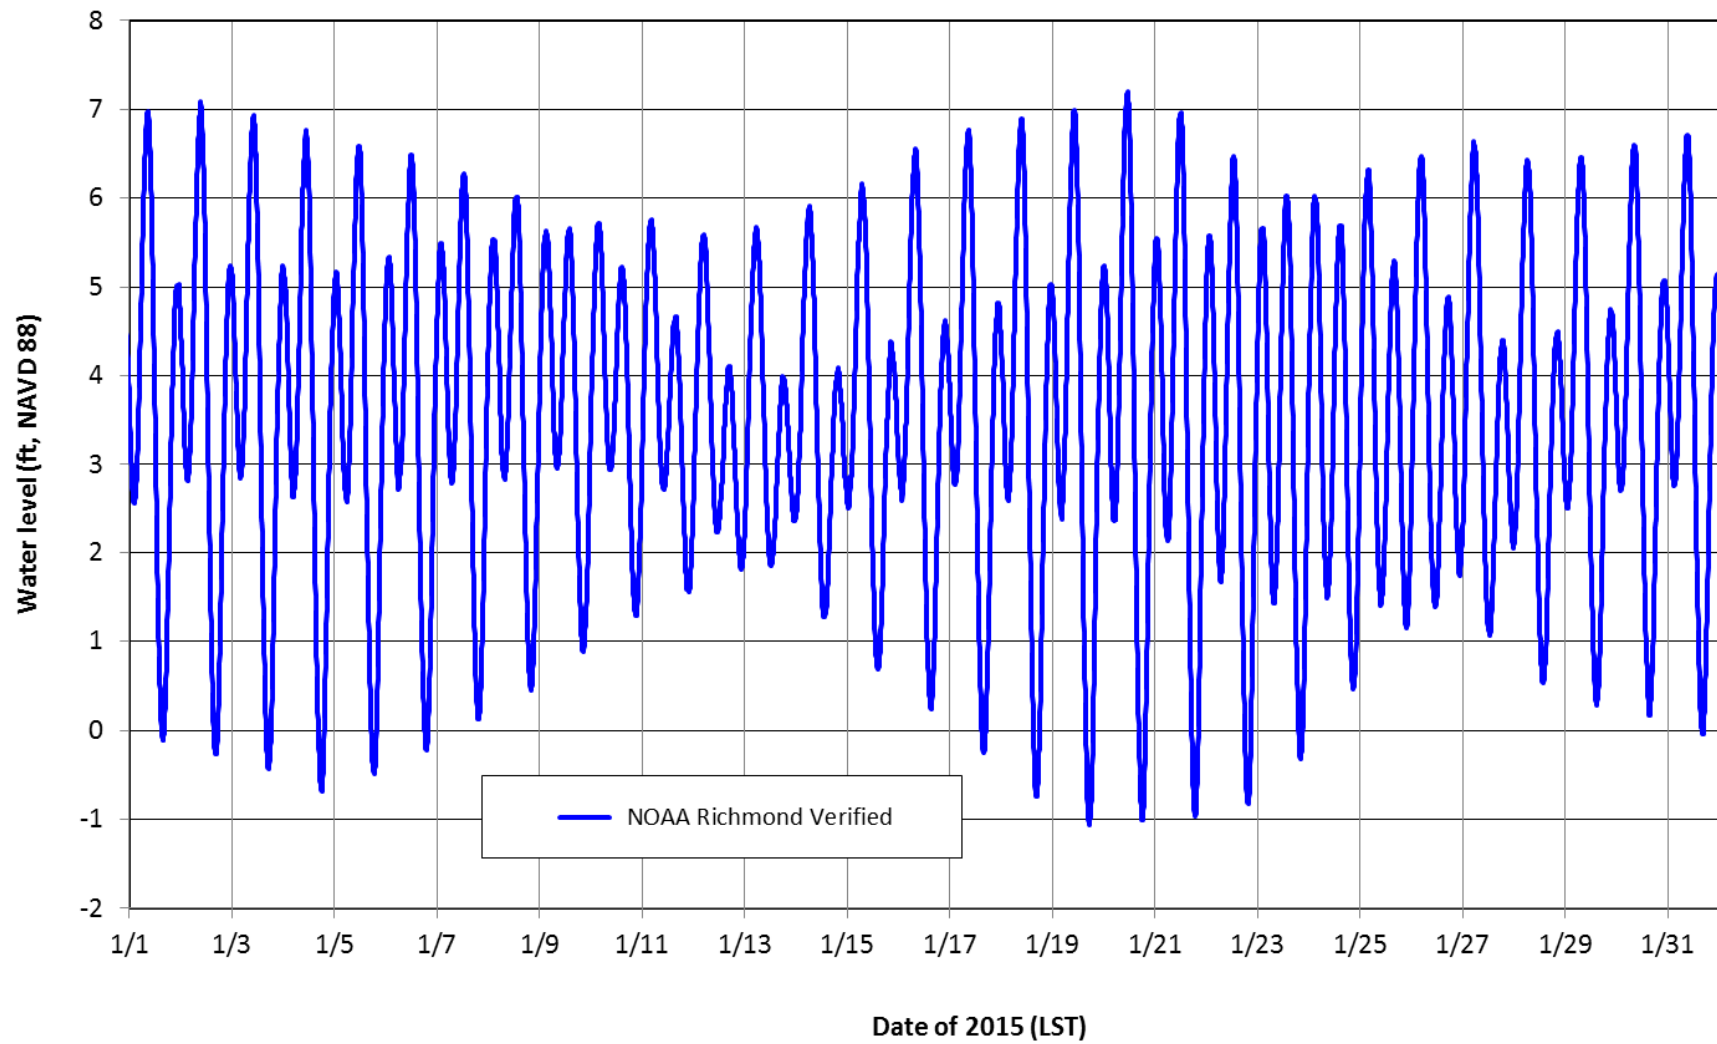
Figure 10. Measured Water Surface Elevation Data at NOAA Station at Richmond

In order to minimize the undue influence of the downstream boundary condition on the reach of interest, the modeled reach was artificially extended from the channel mouth into the Bay by approximately 2,000 feet. The water surface elevations measured at Richmond (NOAA Station ID: 9414863) were assigned at this downstream boundary. One month of data measured for January 2015, as shown in Figure 10, was used as the representative downstream water surface elevations in our model analysis.

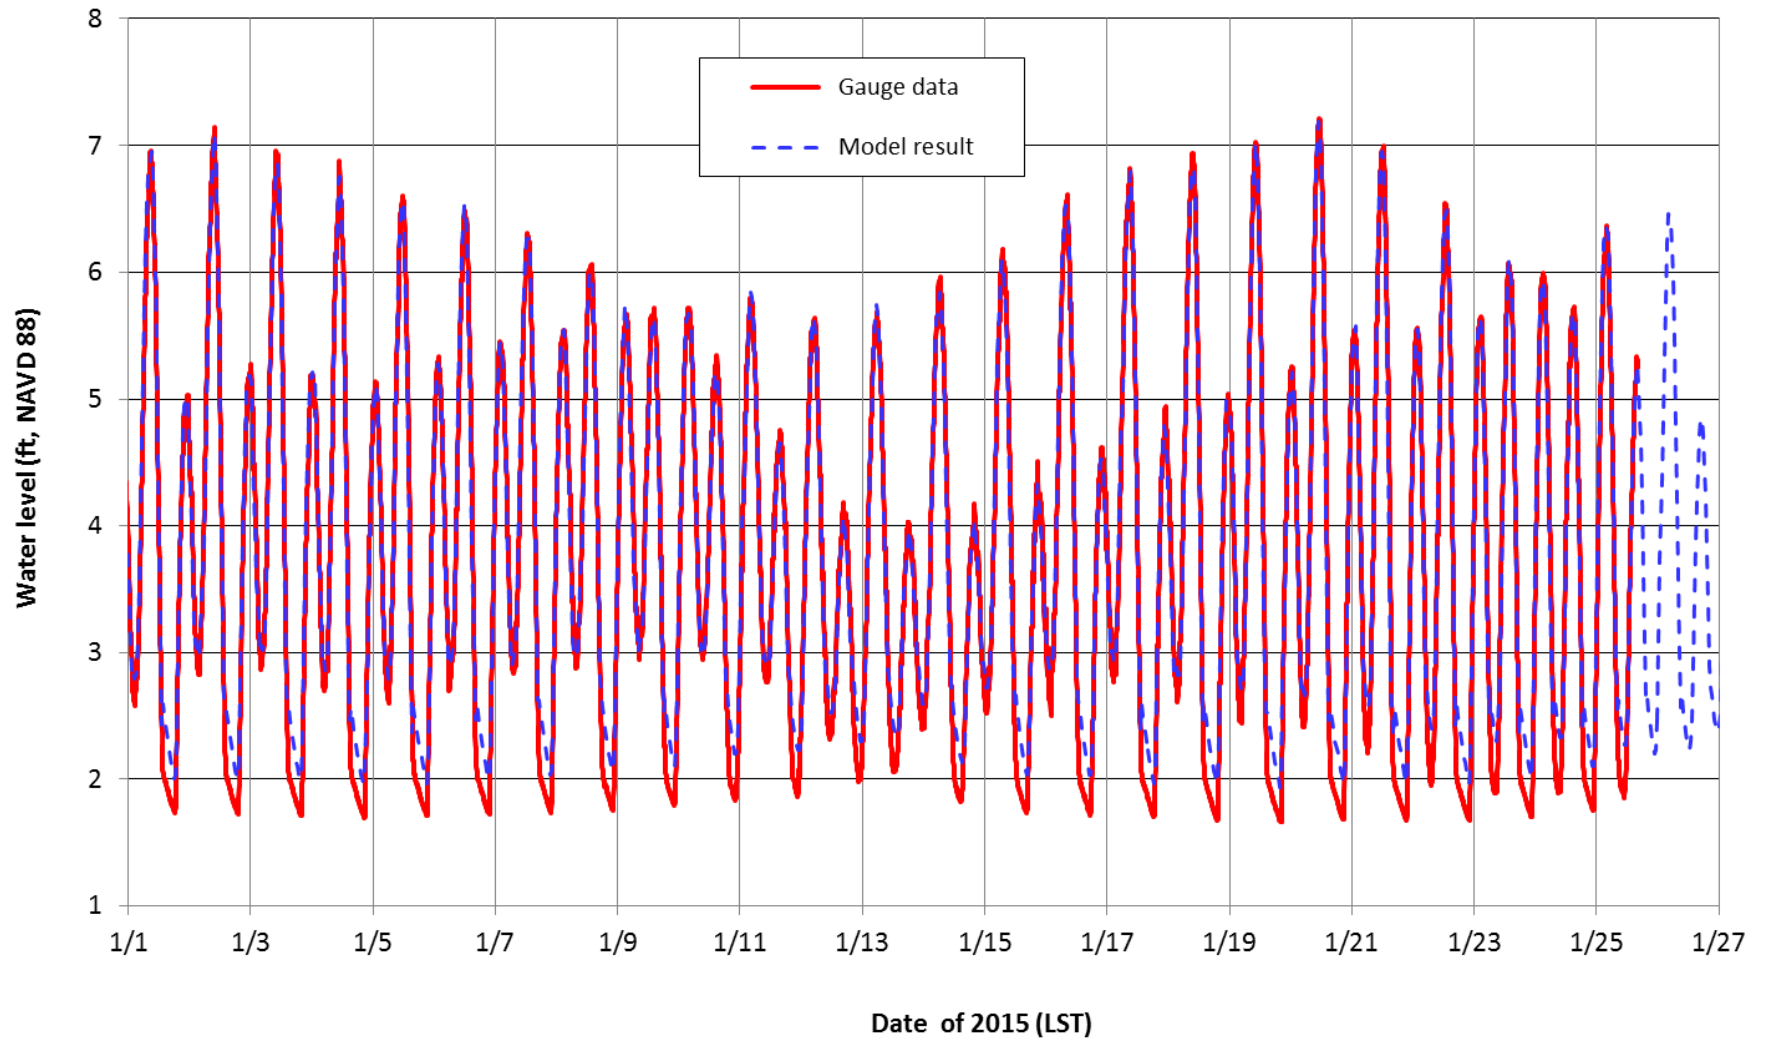
Figure 11. Comparison of Water Levels between Model Results and Data at Sta 3+30

Due to the large size of Shorebird Marsh, the flow condition in the drainage channel is controlled by the water exchange between Shorebird Marsh and the channel. Therefore, a good agreement between the model results and the measured data also indicates that the configuration of Shorebird Marsh, including the storage capacity of the marsh and the connection (culverts with gates) between the marsh and the channel, was reasonably represented in the HEC-RAS model.

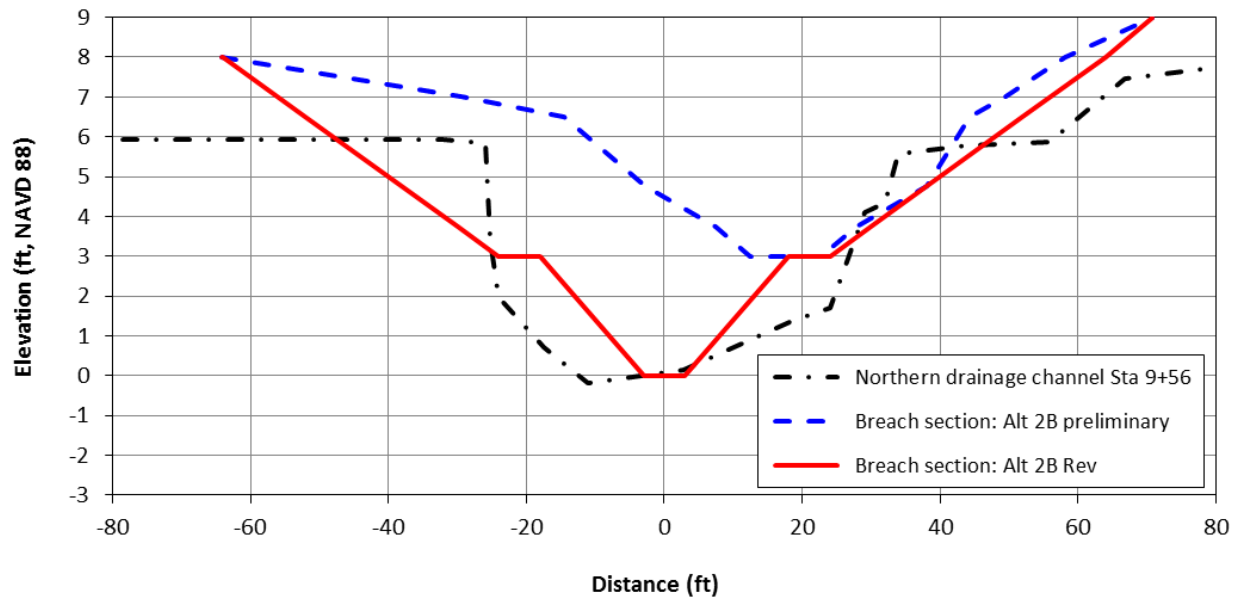
Figure 12. Optimized Breach Channel Section for Alternative 2B

As discussed later in this memorandum, scour is expected in the breach channel and in the internal tidal channel near the breach for WRA's preliminary alternatives. Therefore, a channel size optimization analysis was conducted to determine the optimal channel size that would result in a stable channel condition in these channels. For simplicity, only Alternative 2B was included in this size optimization analysis. A series of revisions were made to the breach and internal tidal channels, followed by additional hydraulic analyses for these revised configurations until an optimal channel size, which will result in a stable channel condition, was determined.

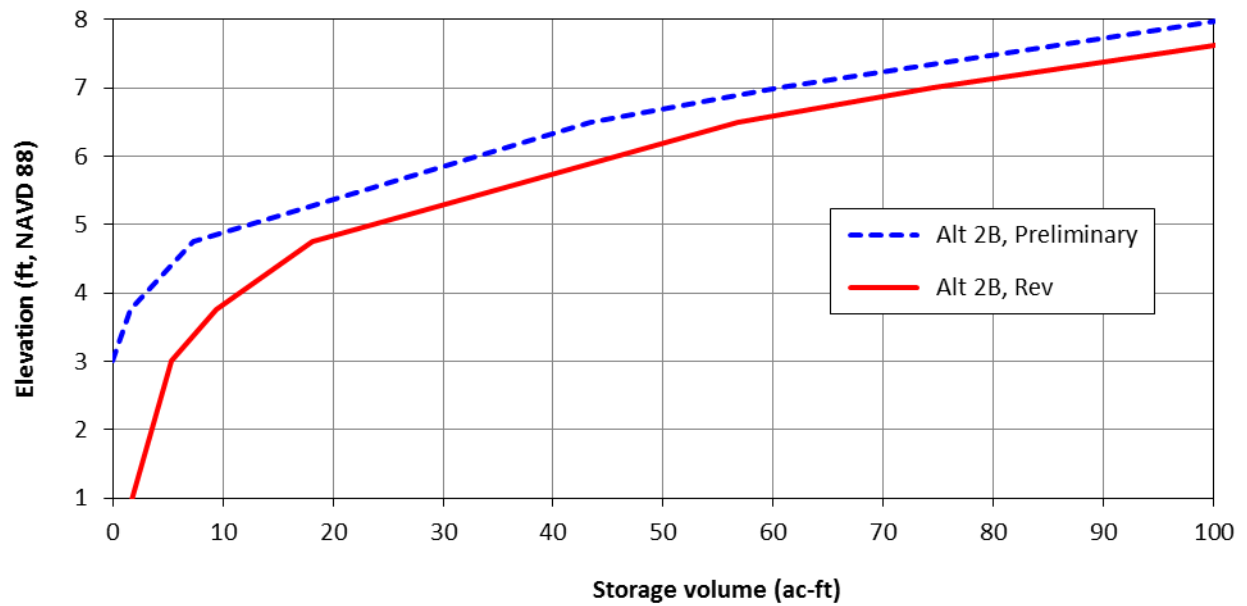
Figure 13. Revised Corte Madera Marsh Storage Volume Curves for Alternative 2B

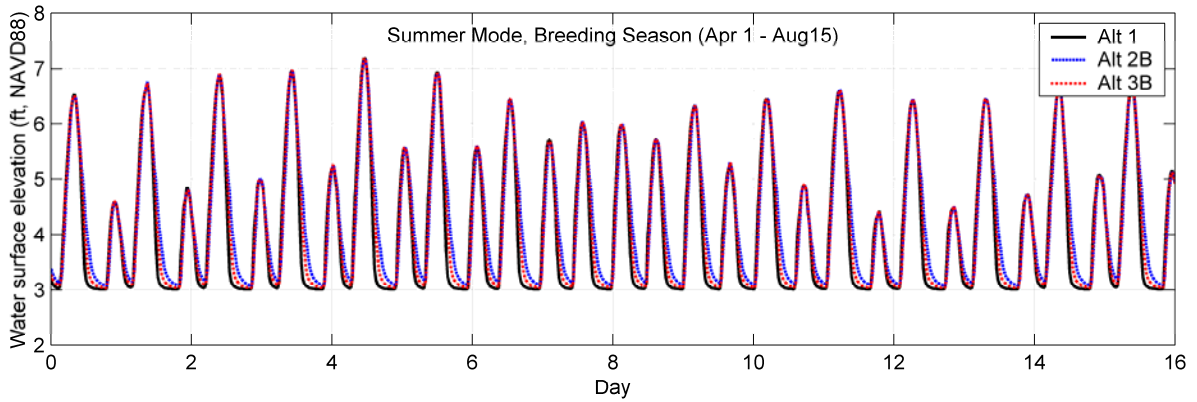
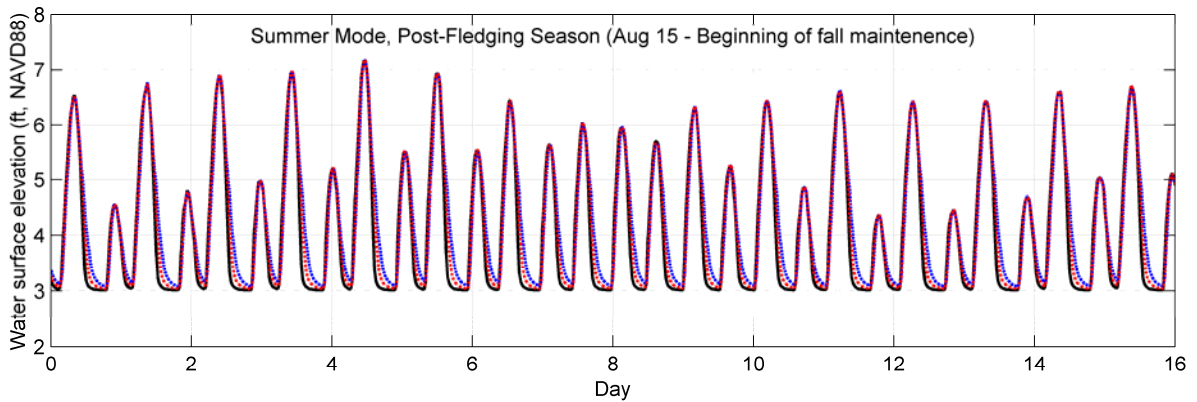
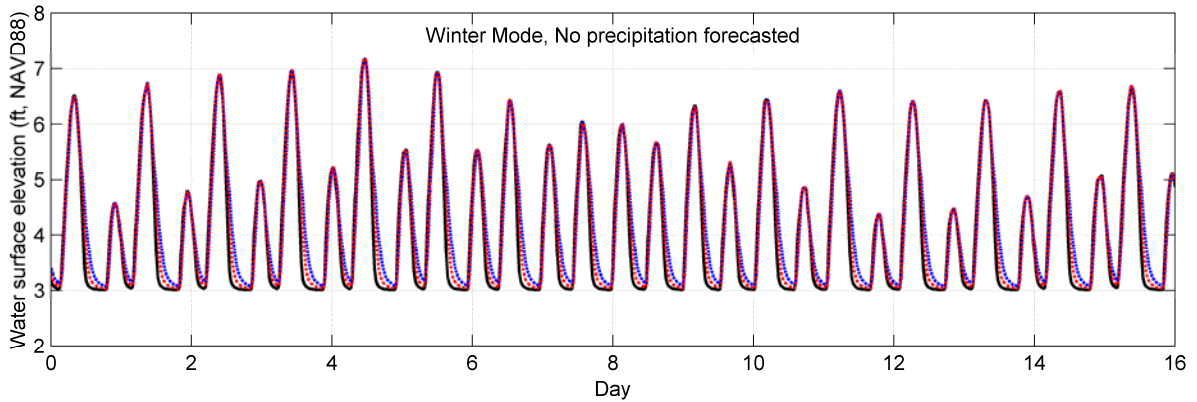
Figure 14. Water Levels in Proposed Restored Corte Madera Marsh for WRA's Preliminary Alternatives 1, 2B, and 3B

The predicted water levels at the proposed restored Corte Madera Marsh for WRA's three preliminary project alternatives are shown in Figure 14 for the three seasons (or three Shorebird Marsh operations), respectively. While the model simulations were conducted for one month period (using January 2015 tides), these figures only show the results for 16 days in order to have a better resolution. As discussed before, these three seasons cover most time of each year except for the winter days with precipitation. Therefore, the results for these three seasons shall represent the typical condition at the project site. The results for Alternative 2B with the optimized size for the breach and internal tidal channels are shown in Figure 15.

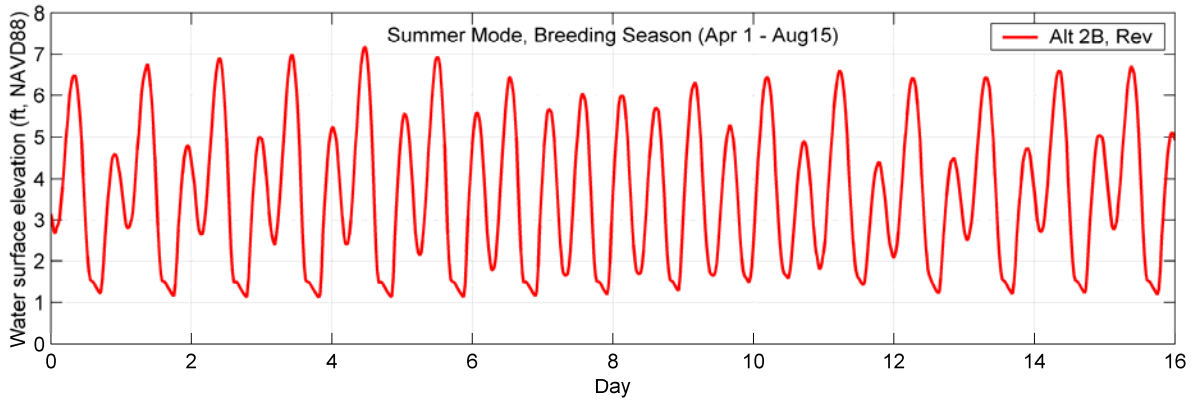
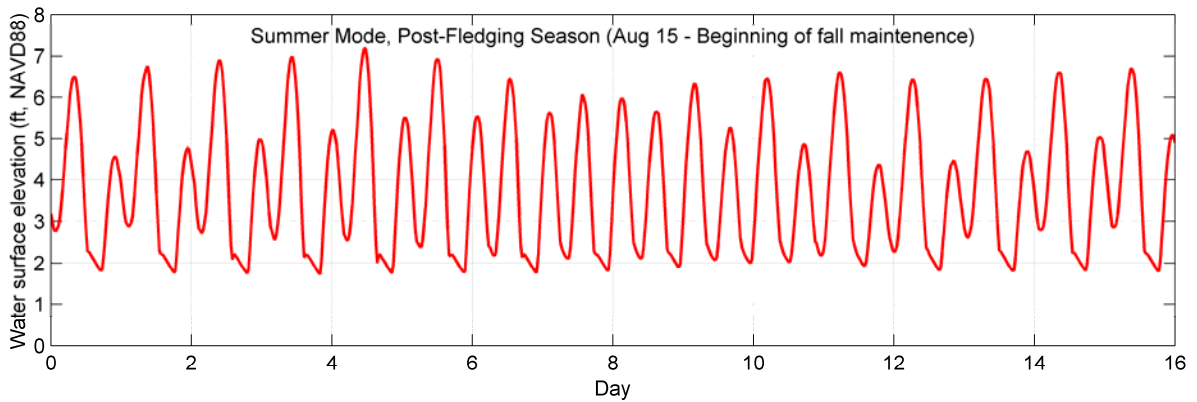
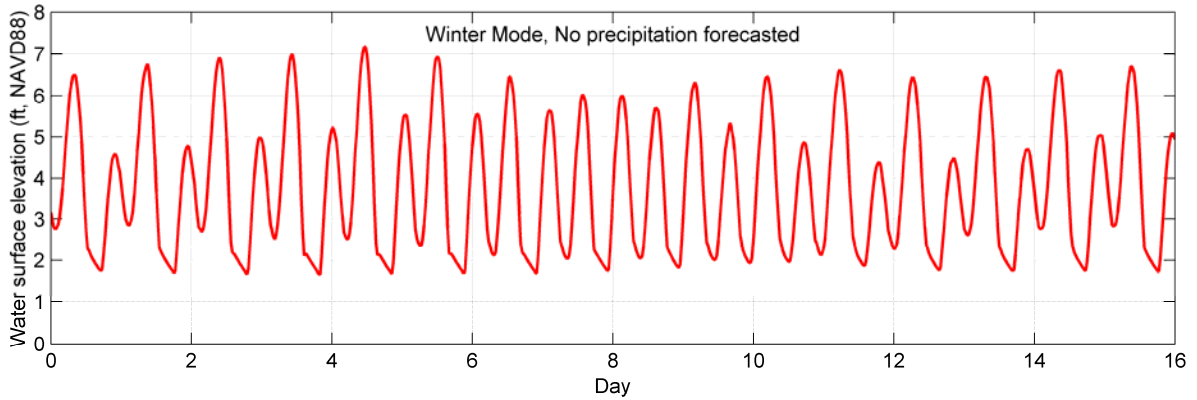
Figure 15. Water Levels in Proposed Restored Corte Madera Marsh for WRA's Alternative 2B with Optimized Size for Breach and Internal Tidal Channels

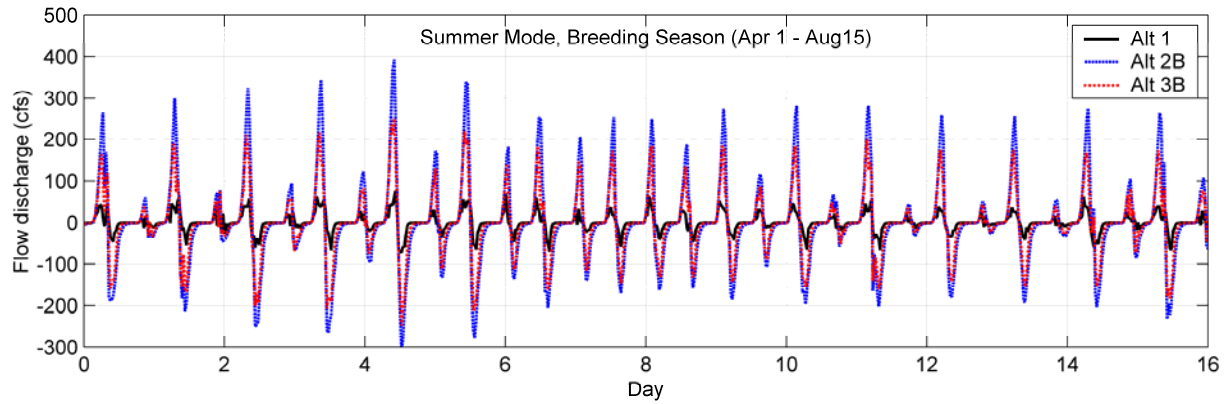
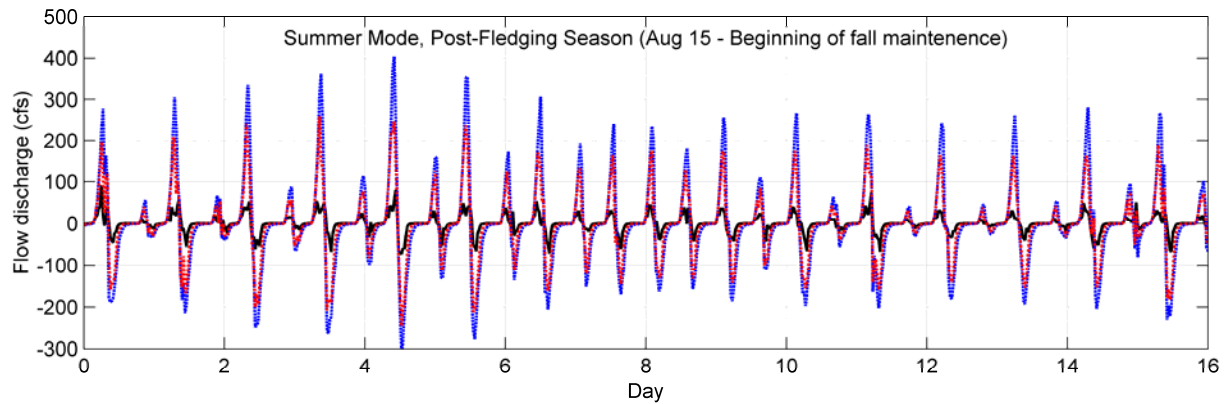
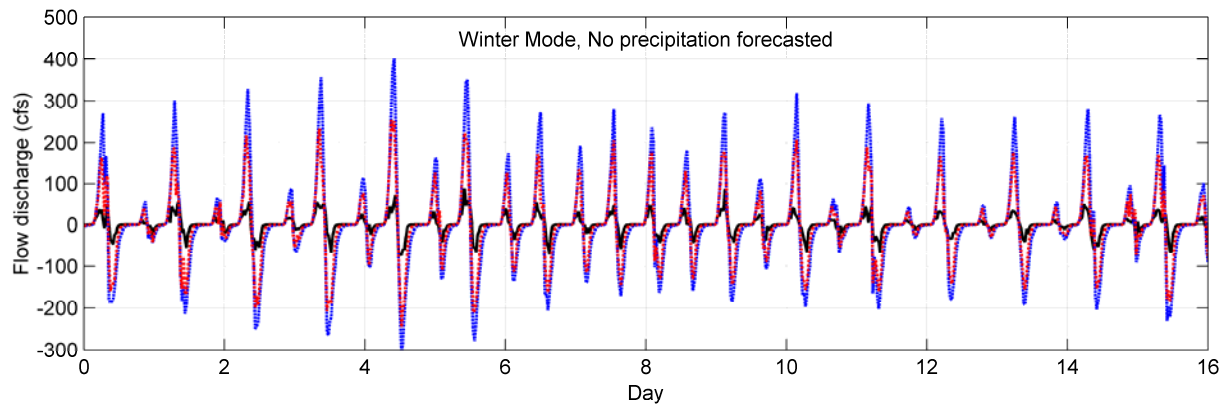
Figure 16. Flow Discharges in the Proposed Breach Channel for WRA’s Preliminary Alternatives 1, 2B, and 3B

As shown in Figure 16 and in Table 4, the peak flow velocities at the breach channel for WRA's three preliminary alternatives will be much higher than the existing condition in the northern drainage channel. Particularly, the maximum flow velocity at the breach channel can be as high as 5.6 feet per second (fps) for preliminary Alternative 2B, compared to the maximum flow velocity of 1.7 fps in the existing northern drainage channel.

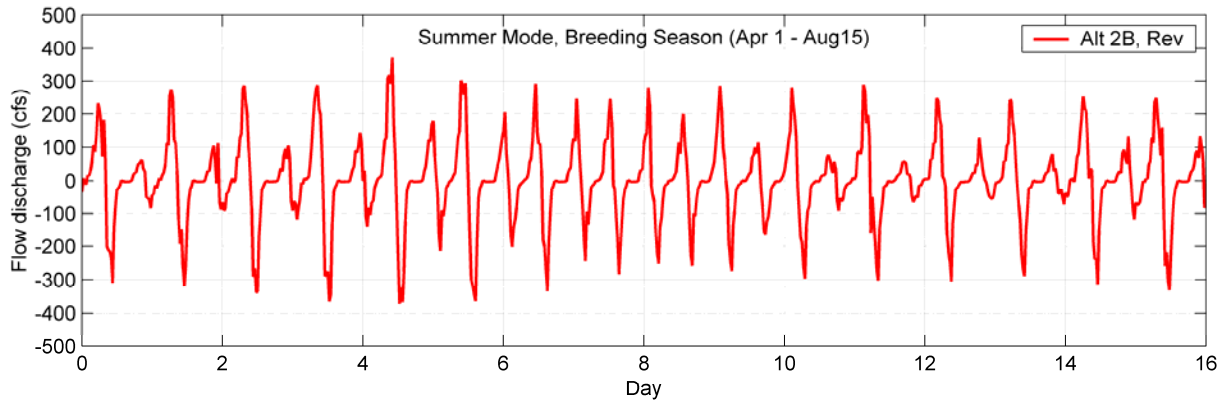
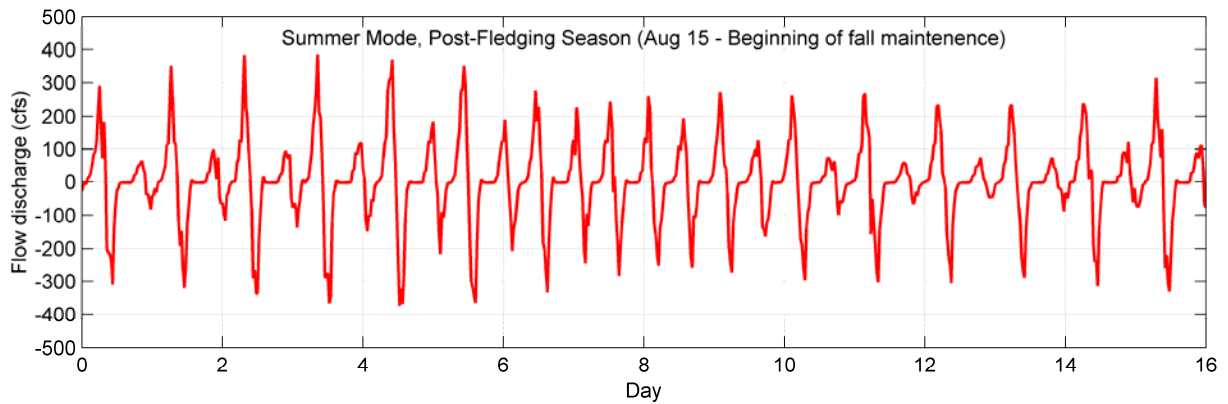
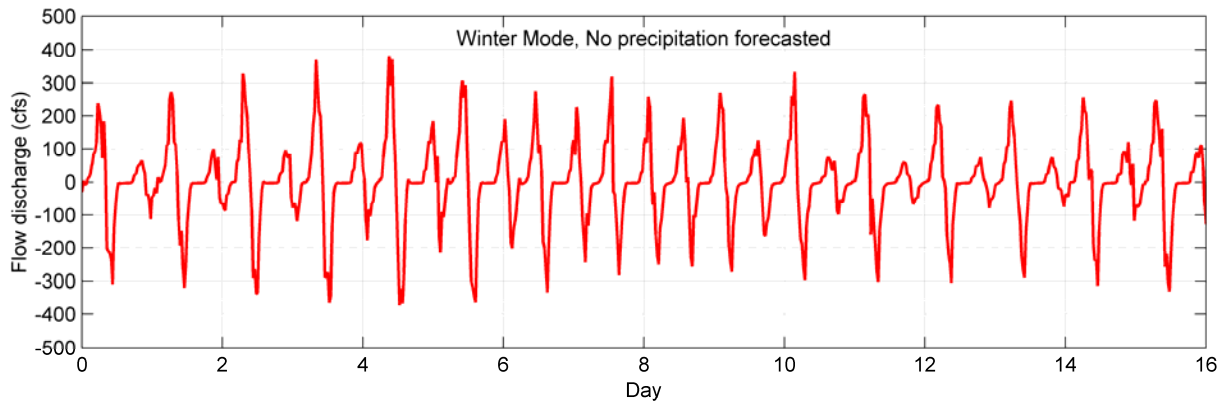
Figure 17. Flow Discharges in the Proposed Breach Channel for WRA's Alternative 2B with Optimized Size for Breach and Internal Tidal Channels

The flow discharges for the water exchange between the marsh and the northern drainage channel are shown in Figure 16 for WRA's three preliminary alternatives, and in Figure 17 for Alternative 2B with optimized size for the breach and internal tidal channels. The maximum flow discharges passing through the breach channel compared to the peak flow discharges in the exiting northern drainage channel (at Station 3+60) are summarized in Table 3.

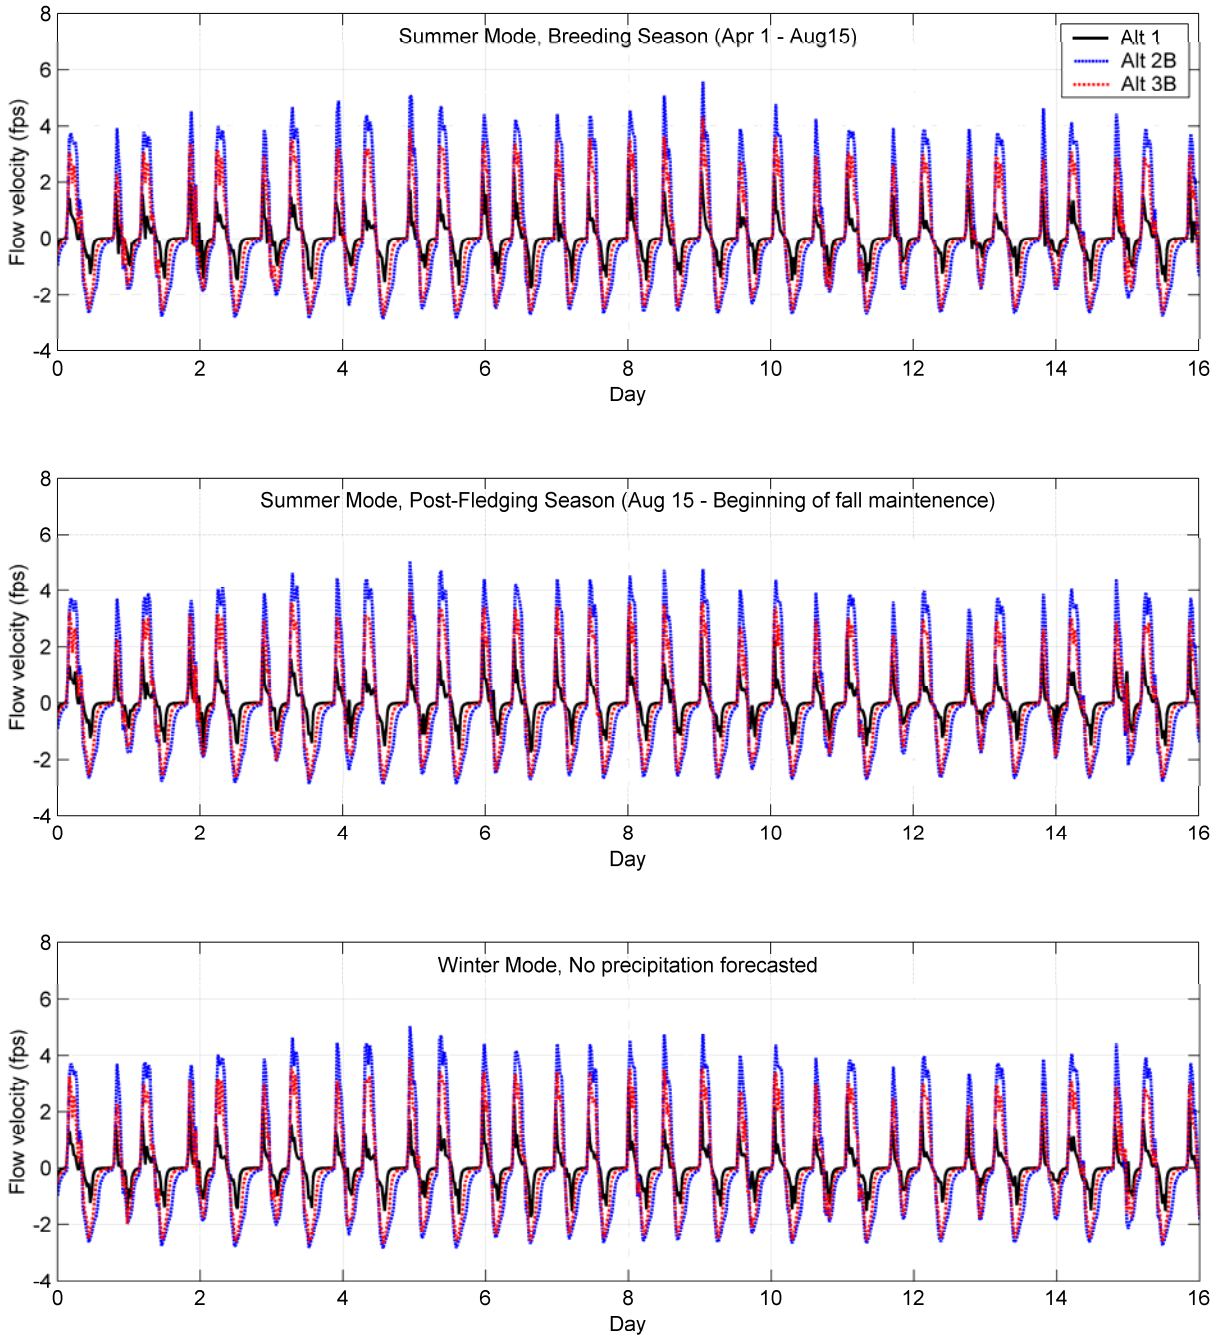
Figure 18. Channel Flow Velocities in the Proposed Breach Channel for WRA's Preliminary Alternatives 1, 2B, and 3B

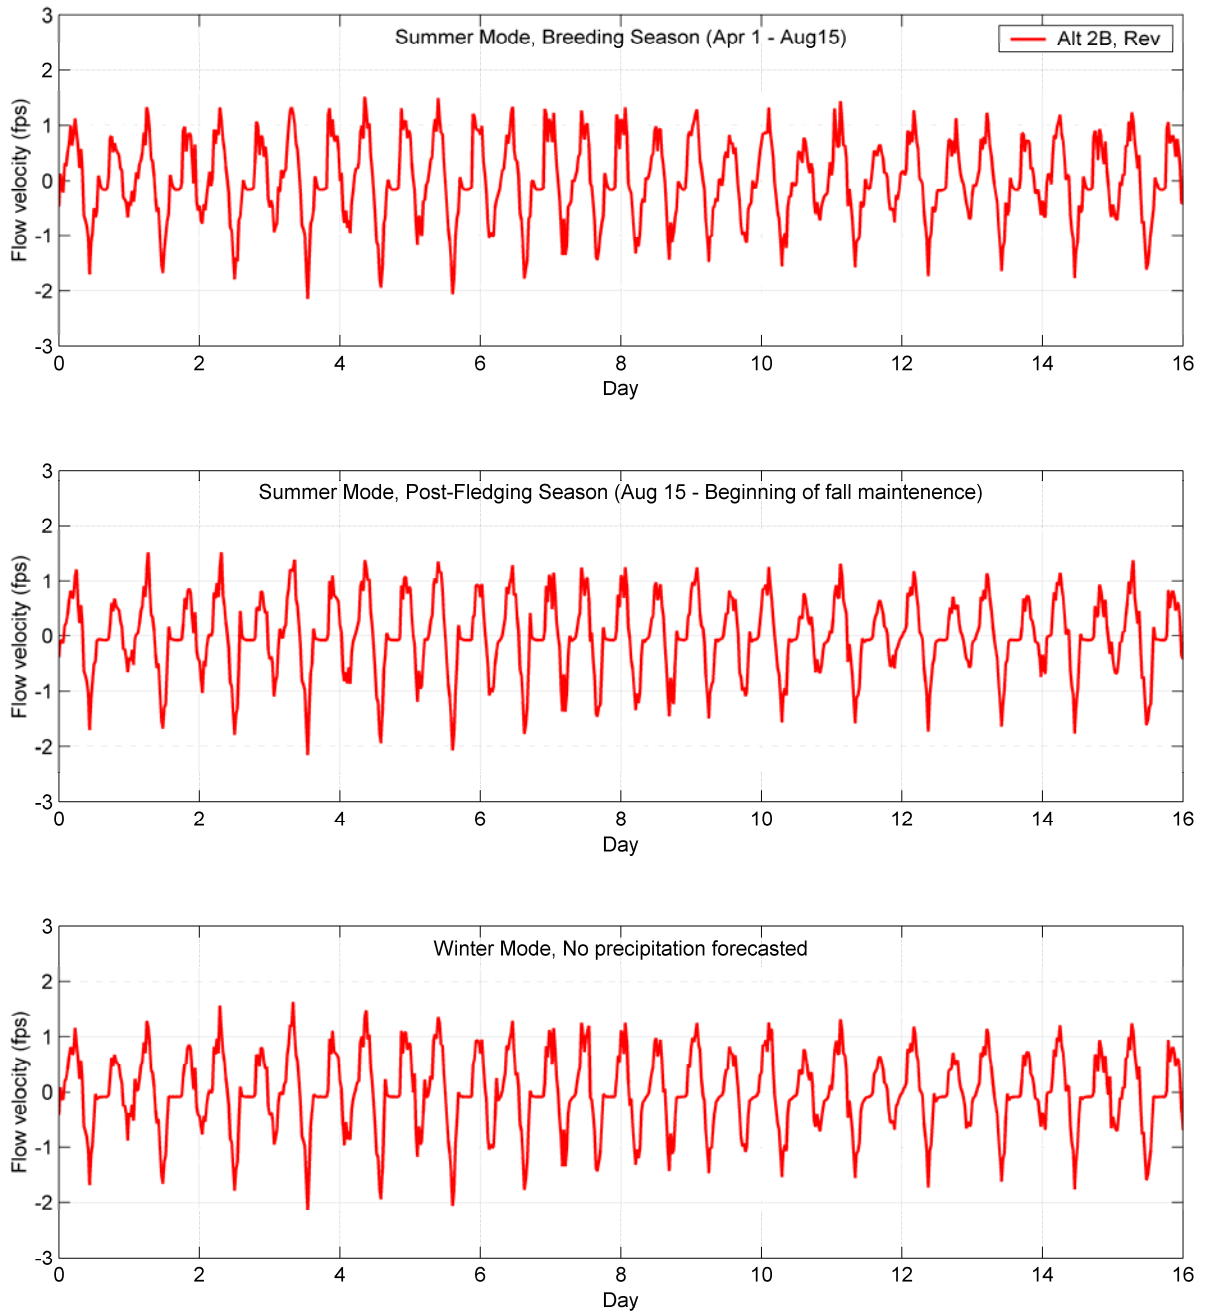
Figure 19. Channel Flow Velocities in the Proposed Breach Channel for WRA's Alternative 2B with Optimized Size for Breach and Internal Tidal Channels

As shown in Figure 19, Figure 21, and Table 4, the peak flow velocities and the peak bottom shear stresses in the breach channel will significantly drop after optimizing (increasing) the size of the breach and internal tidal channels. The optimized channel section is shown in Figure 12. The maximum flow velocity in the breach channel will drop to 2.1 fps and the maximum bottom shear stress will drop to 2.4 Pa, which are similar to the condition in the existing northern drainage channel. The existing northern drainage channel seems to be in a dynamical equilibrium condition in long term. If using the existing bottom shear stress in the northern

drainage channel as a baseline measure, the breach channel and the internal drainage channel with the optimized cross section are expected to be in a stable condition, without significant scour or sedimentation.
