Re: **Applicability of NCI (2016) Hydrology Report to
Corte Madera 4-Acre Tidal Marsh Restoration Project**

Hydrology Report

WETLAND RESTORATION DESIGN AND PERMITTING SUPPORT SERVICES AT CORTE MADERA ECOLOGICAL RESERVE

CORTE MADERA, MARIN COUNTY, CALIFORNIA

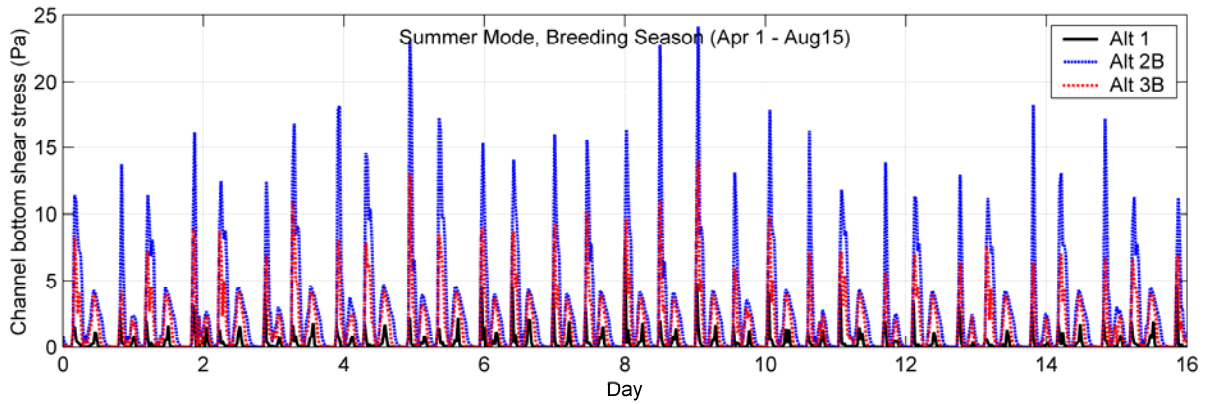
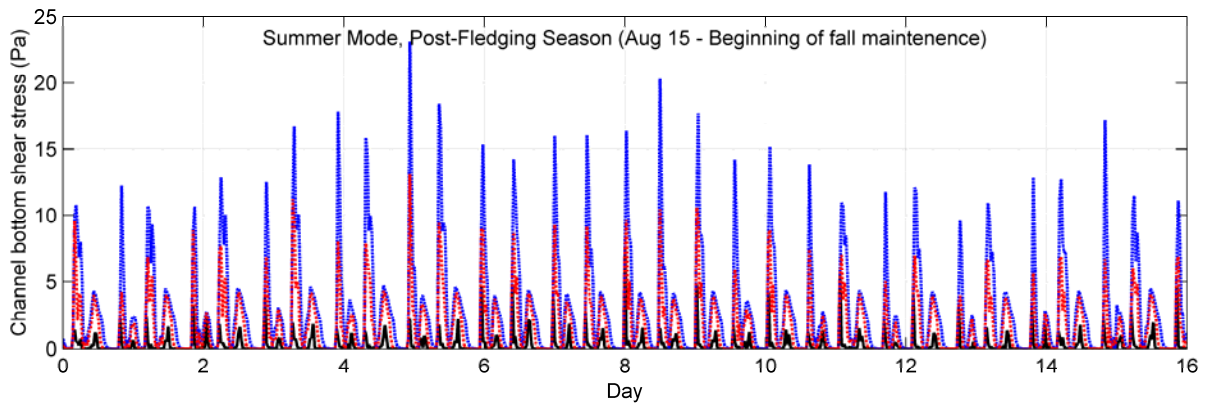
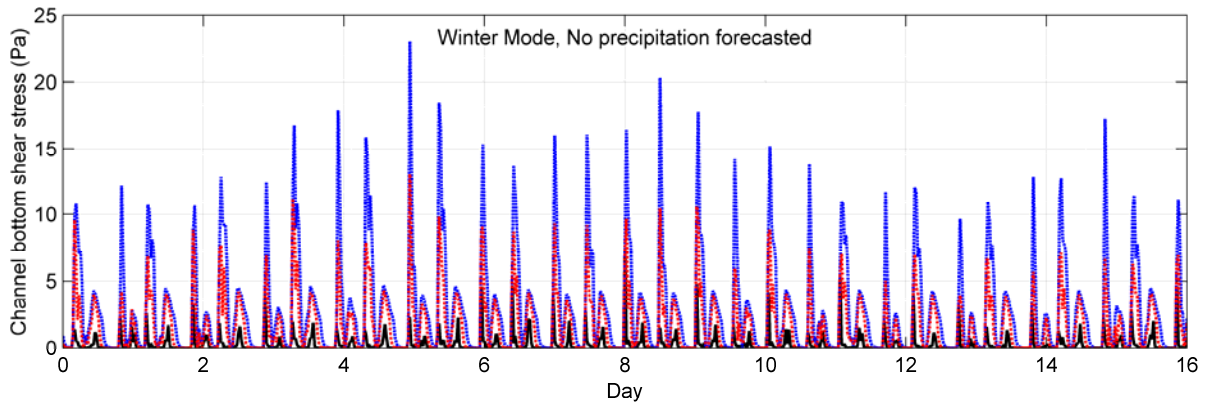
Figure 20. Channel Bottom Shear Stresses in the Proposed Breach Channel for WRA’s Preliminary Alternatives 1, 2B, and 3B

The flow velocities and the channel bottom shear stresses were computed for the breach channel. The time series of the computed flow velocities are shown in Figure 18 for WRA's three preliminary alternatives, and in Figure 19 for Alternative 2B with the optimized channel size for the breach and internal tidal channels. The time series of the channel bottom shear stresses are shown in Figure 20 for WRA's three preliminary alternatives, and in Figure 21 for Alternative 2B with optimized channel size.

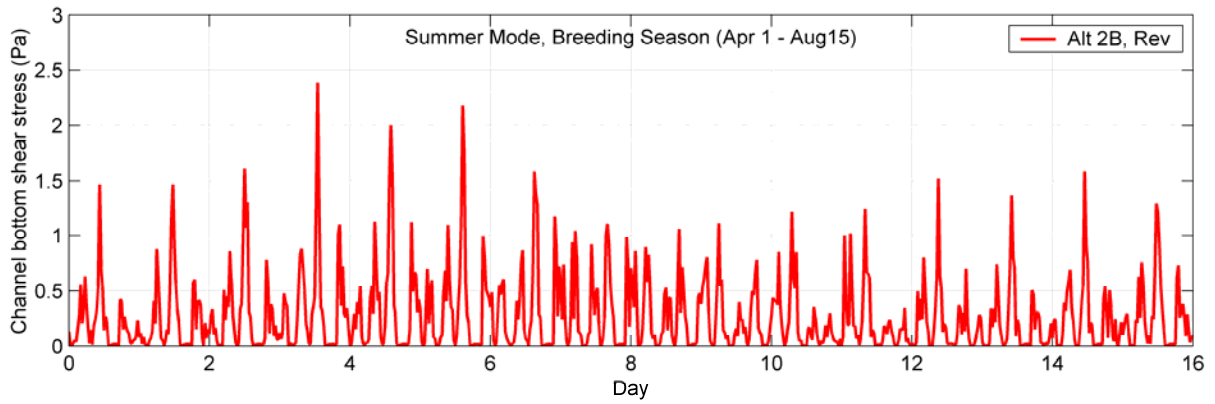
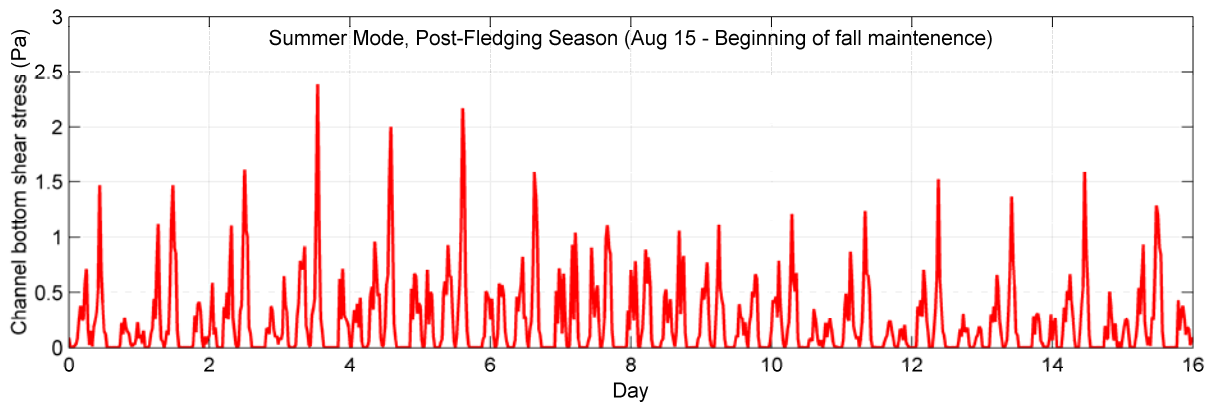
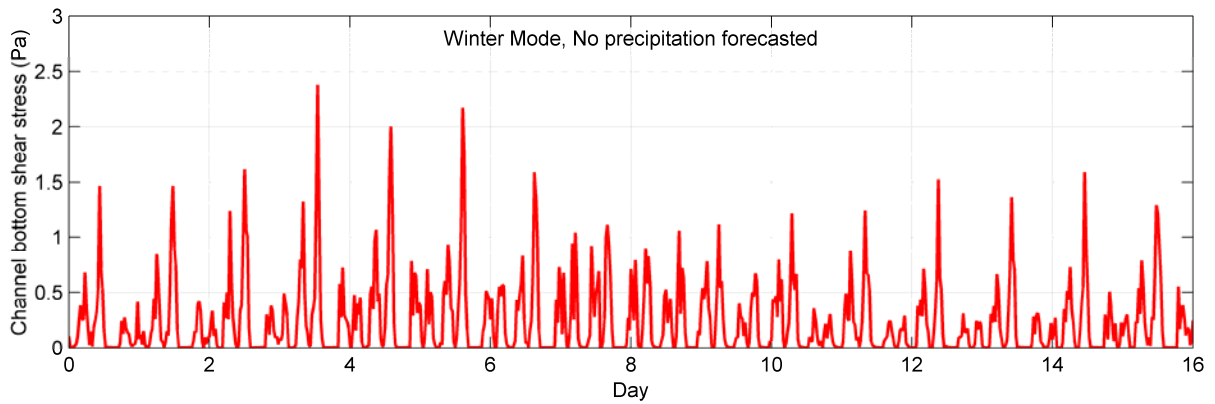
Figure 21. Channel Bottom Shear Stresses in the Proposed Breach Channel for WRA's Alternative 2B with Optimized Size for Breach and Internal Tidal Channels

As shown in Figure 19, Figure 21, and Table 4, the peak flow velocities and the peak bottom shear stresses in the breach channel will significantly drop after optimizing (increasing) the size of the breach and internal tidal channels. The optimized channel section is shown in Figure 12. The maximum flow velocity in the breach channel will drop to 2.1 fps and the maximum bottom shear stress will drop to 2.4 Pa, which are similar to the condition in the existing northern drainage channel. The existing northern drainage channel seems to be in a dynamical equilibrium condition in long term. If using the existing bottom shear stress in the northern

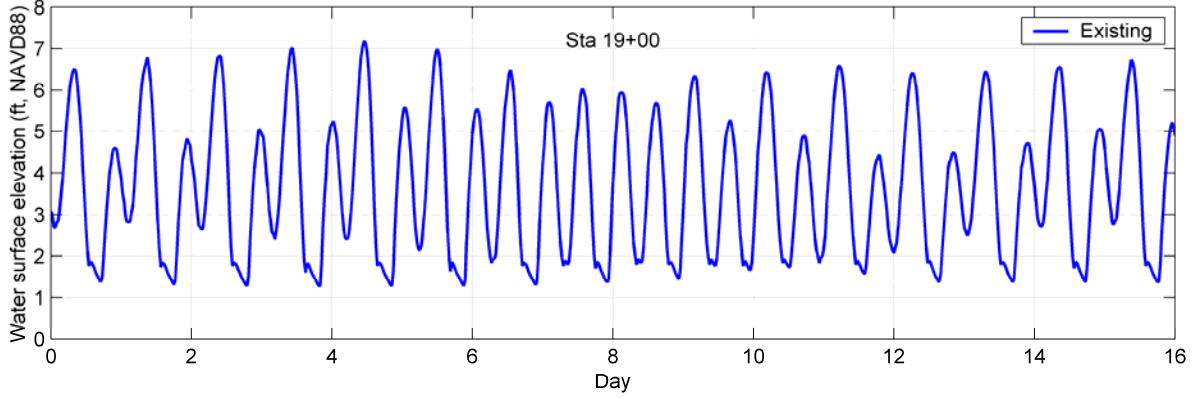
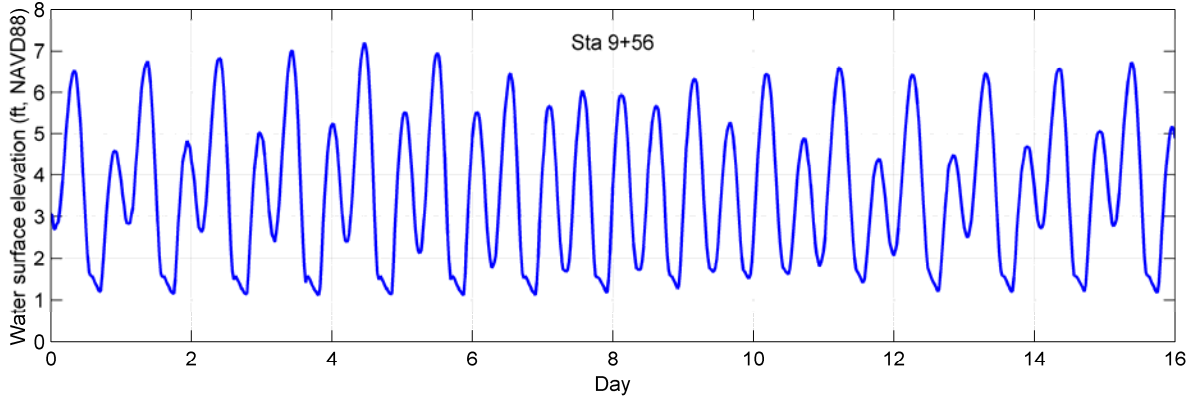
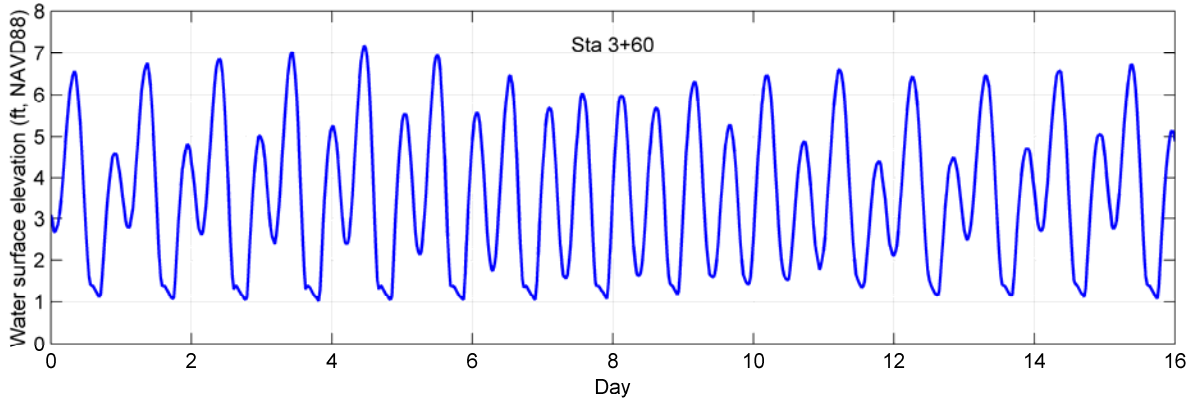
Figure 22. Water Levels in Existing Northern Drainage Channel (Apr 1 – Aug 15)

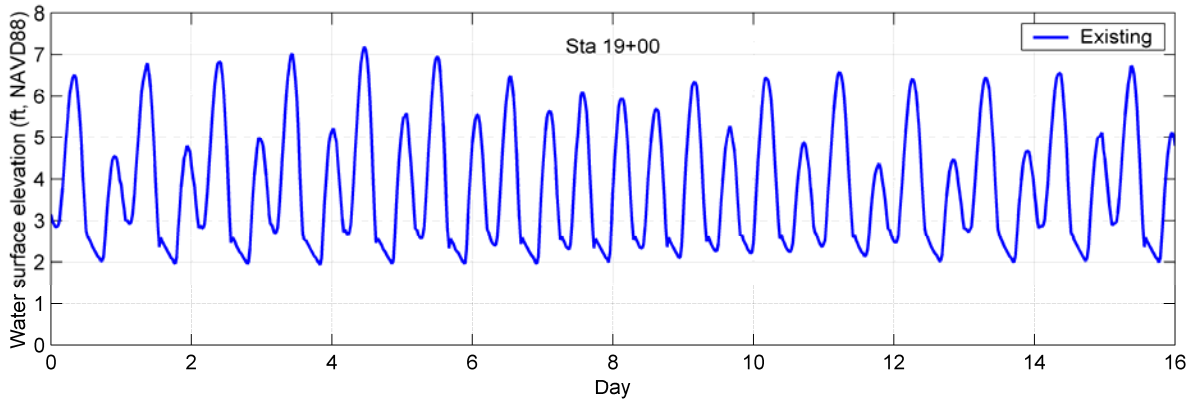
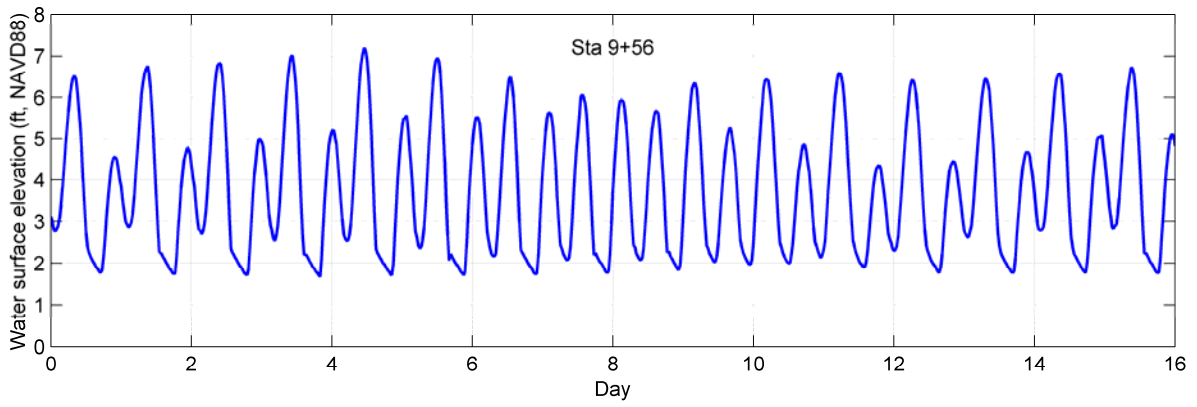
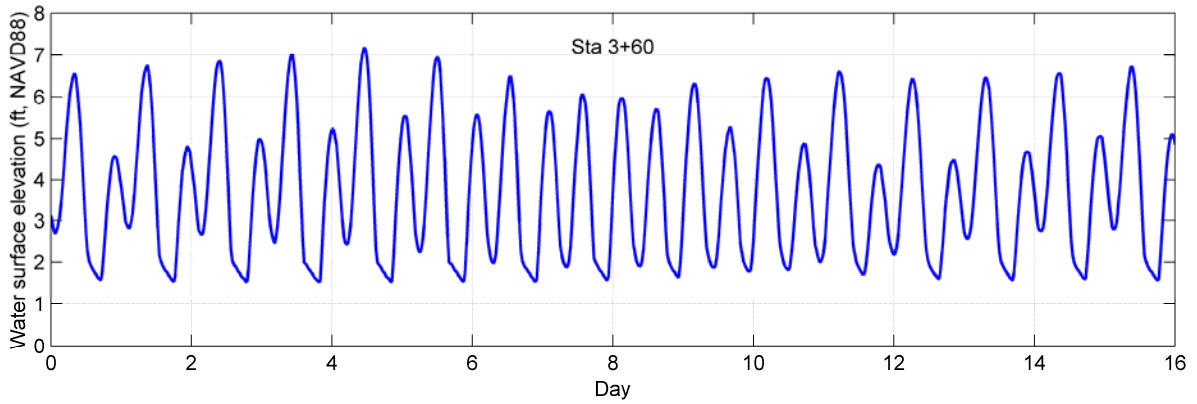
Figure 24. Water Levels in Existing Northern Drainage Channel (Winter with No Precipitation Forecasted)

The water levels computed for the three representative locations are shown in Figure 22 through Figure 24 for three seasons, respectively. Figure 25 through Figure 27 show the flow discharges, Figure 28 through Figure 30 show the flow velocities, and Figure 31 through Figure 33 show the derived channel bottom shear stresses. The annual variation ranges of these hydraulic parameters are listed in Table 5 through Table 8, respectively.

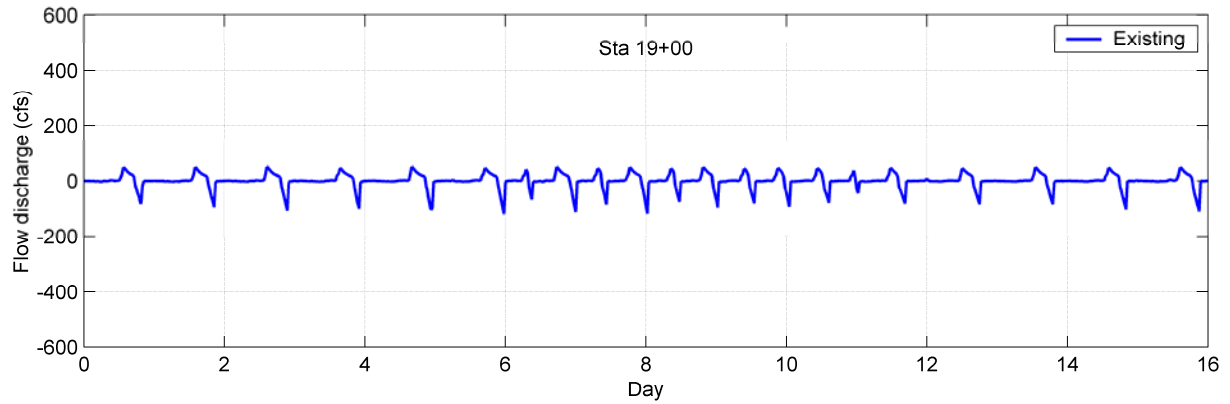
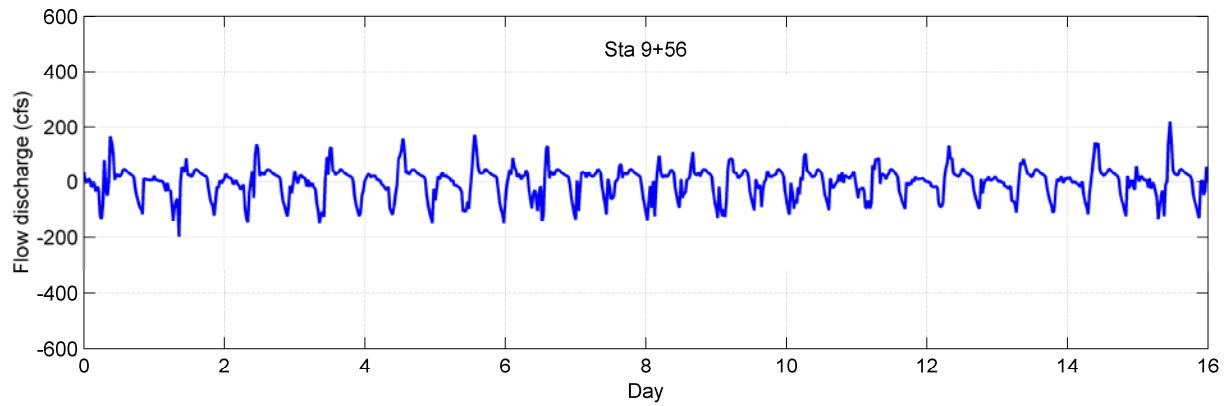
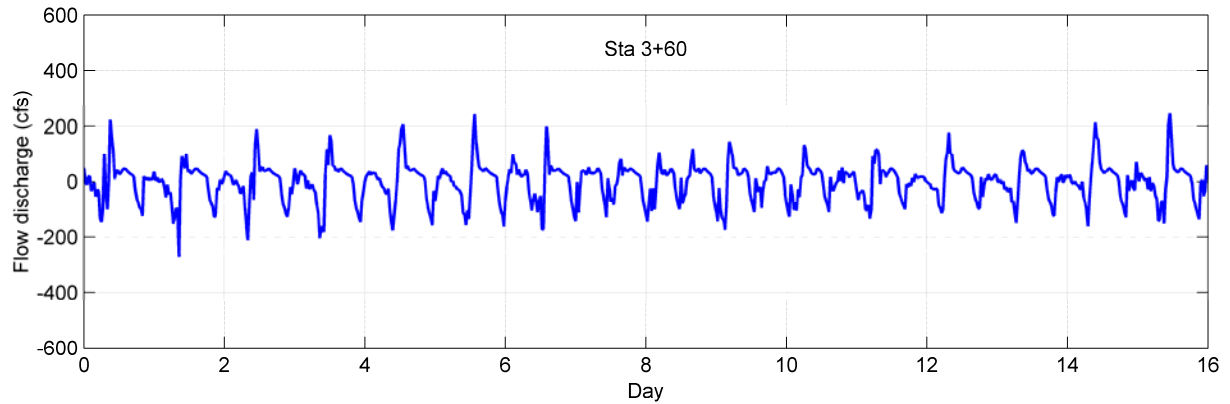
Figure 25. Flow Discharges in Existing Northern Drainage Channel (Apr 1 – Aug 15)

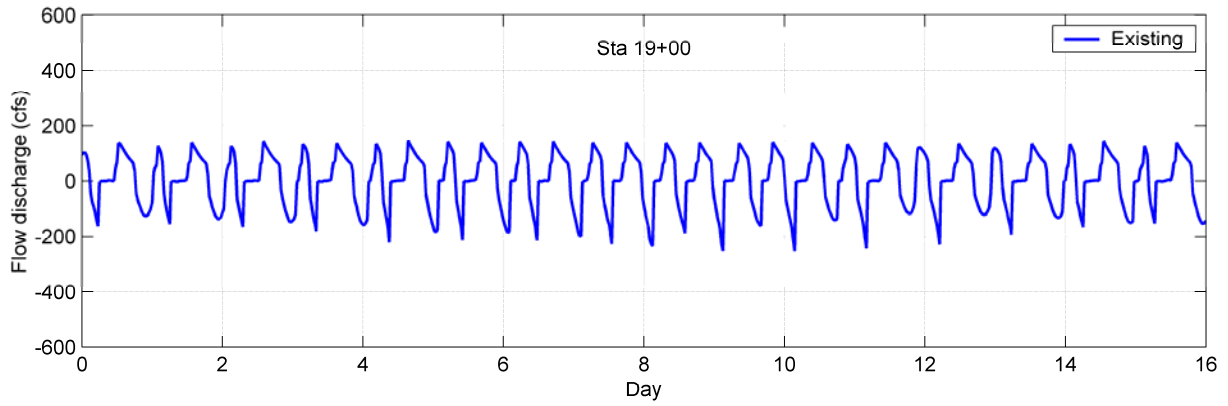
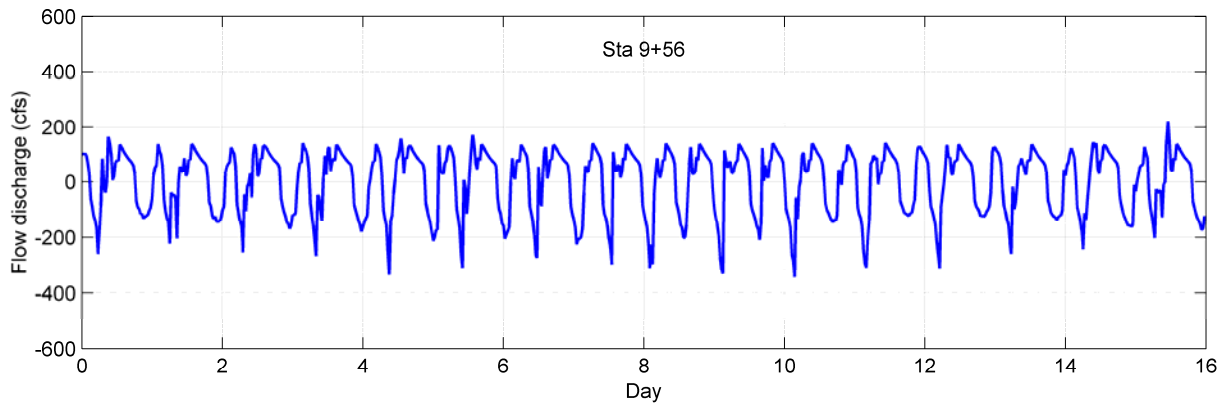
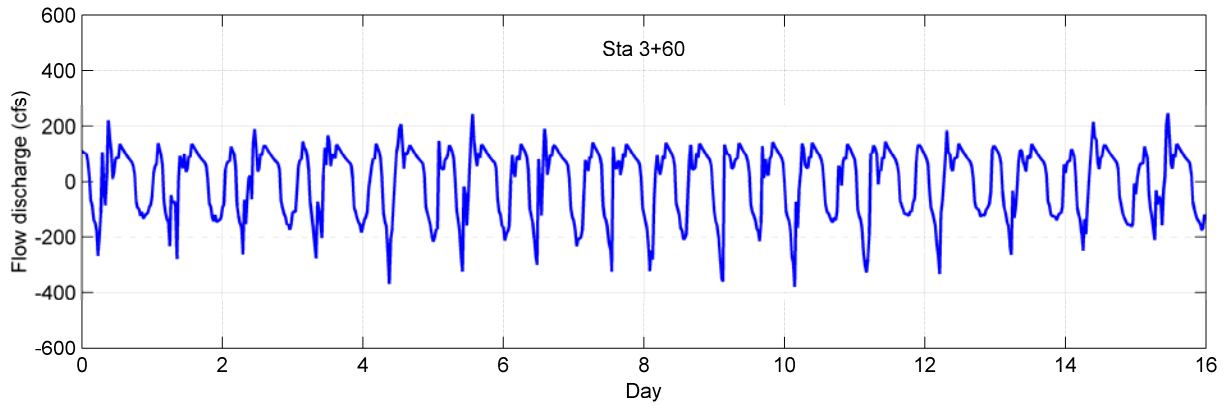
Figure 26. Flow Discharges in Existing Northern Drainage Channel (Aug 15 – Beginning of Shorebird Marsh Fall Maintenance)

It is noted that the strongest tidal currents (flow discharges, flow velocities, and channel bottom shear stresses) occur in the summer post-fledging season between August 15 and the beginning of the fall maintenance, when the Shorebird Marsh (north) gate closes at the highest control marsh water level of 3.64' MAVD88 (1.0' NGVD29). Compared to the other seasons, the close-gate elevation for this season is the highest, resulting in the maximum water exchange between Shorebird Marsh and the northern drainage channel.

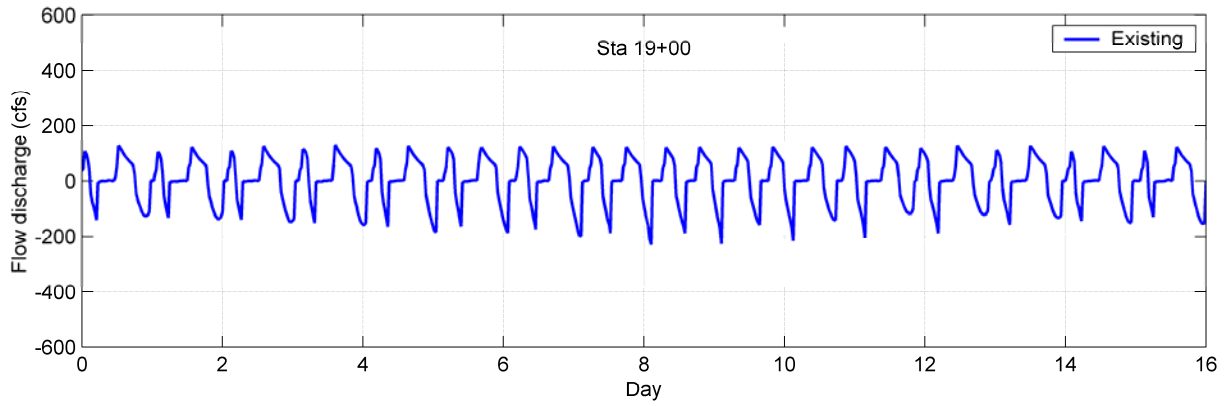
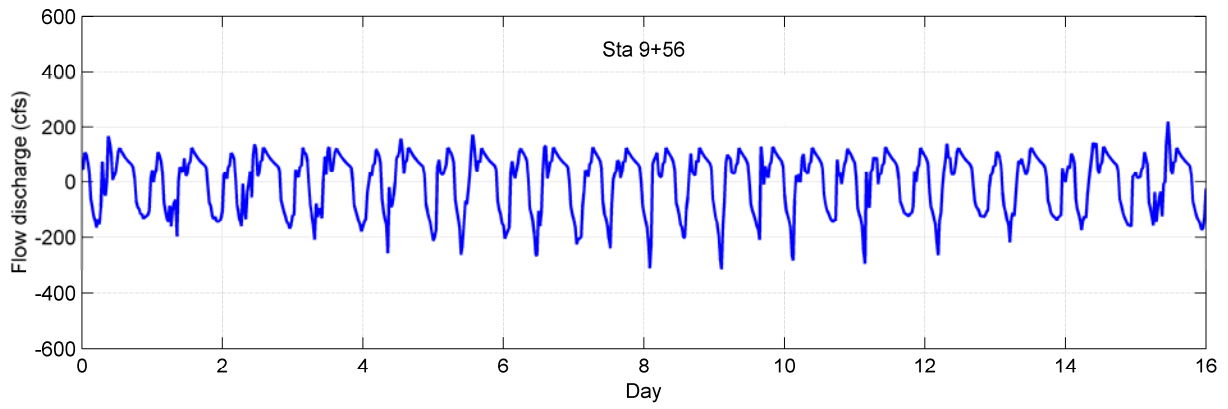
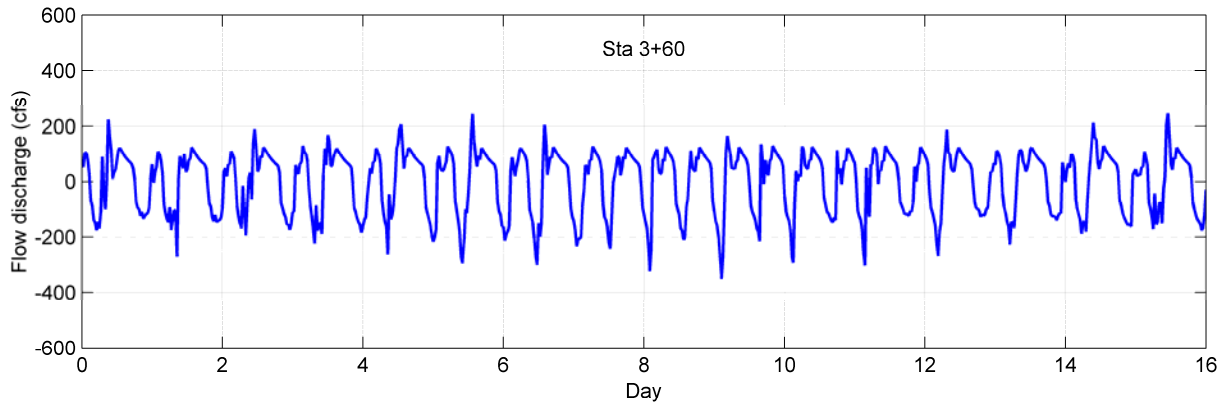
Figure 27. Flow Discharges in Existing Northern Drainage Channel (Winter with No Precipitation Forecasted)

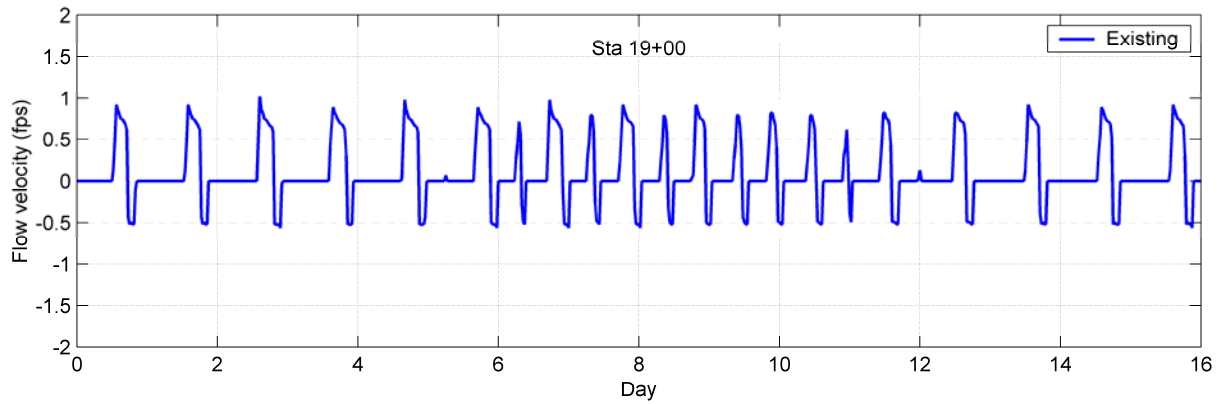
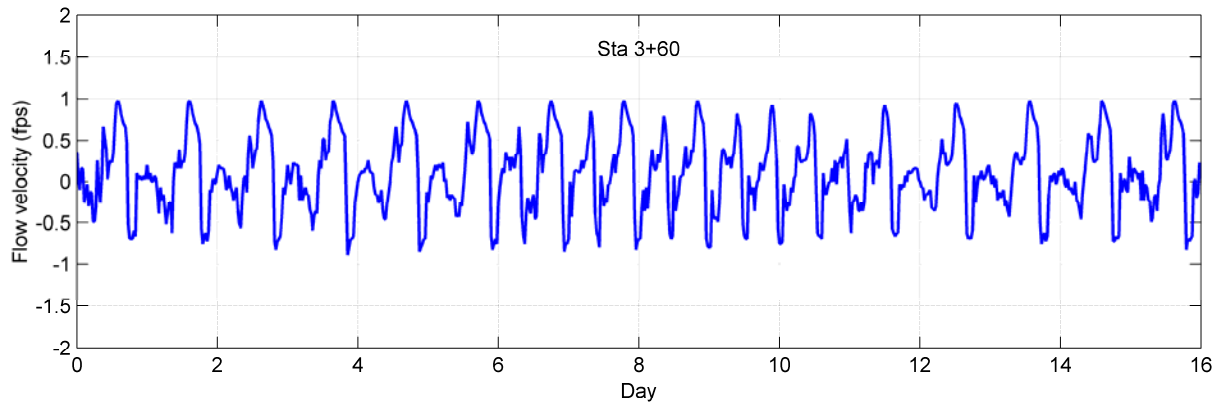
Figure 28. Flow Velocities in Existing Northern Drainage Channel (Apr 1 – Aug 15)

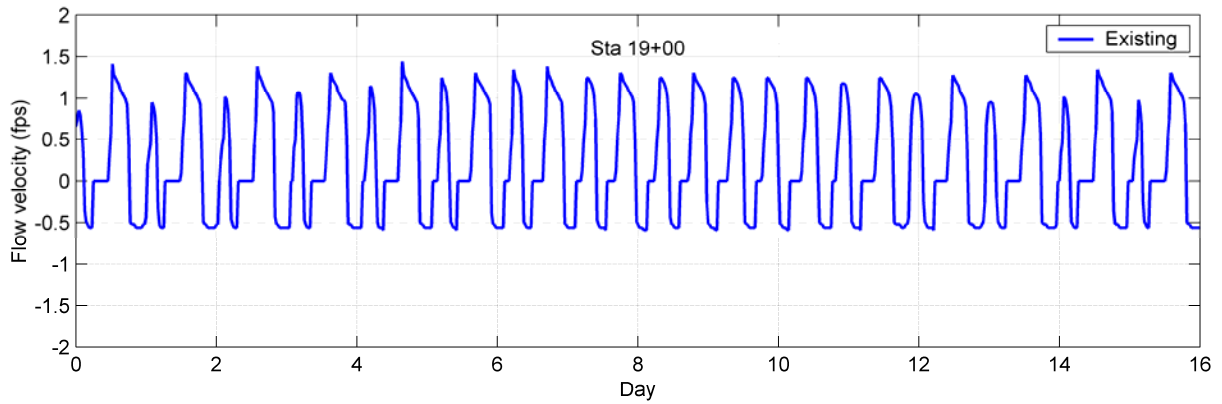
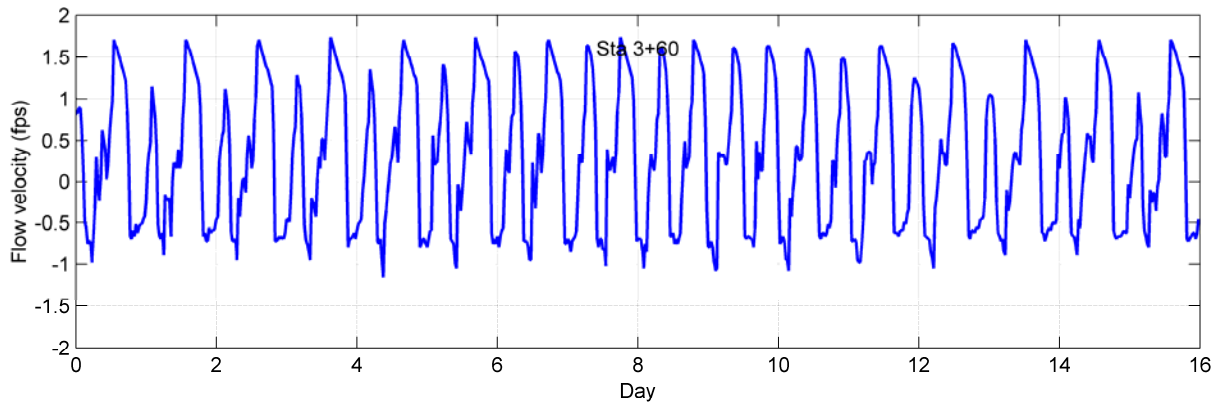
Figure 29. Flow Velocities in Existing Northern Drainage Channel (Aug 15 – Beginning of Shorebird Marsh Fall Maintenance)

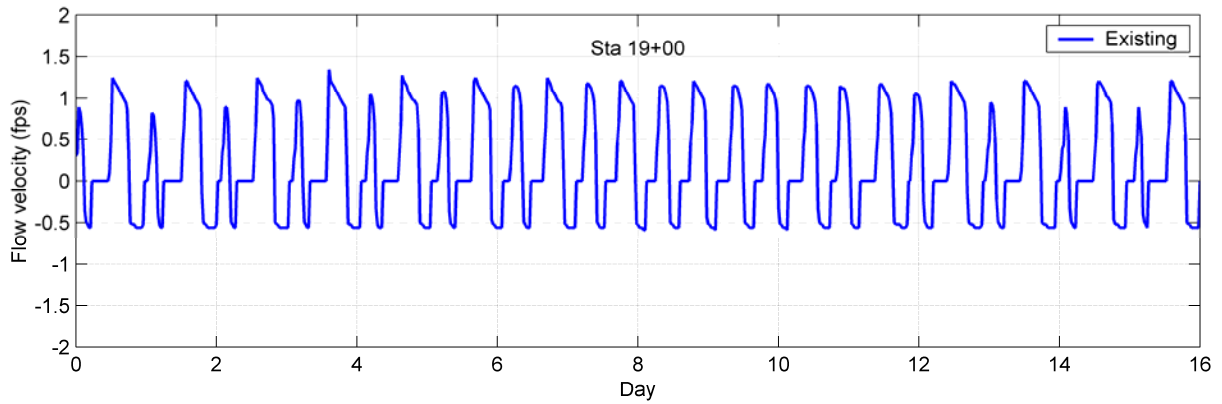
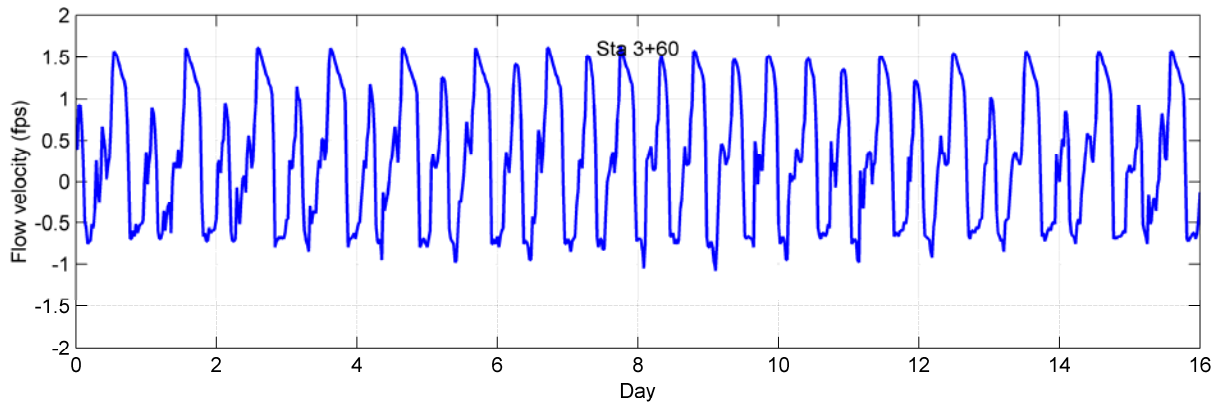
Figure 30. Flow Velocities in Existing Northern Drainage Channel (Winter with No Precipitation Forecasted)

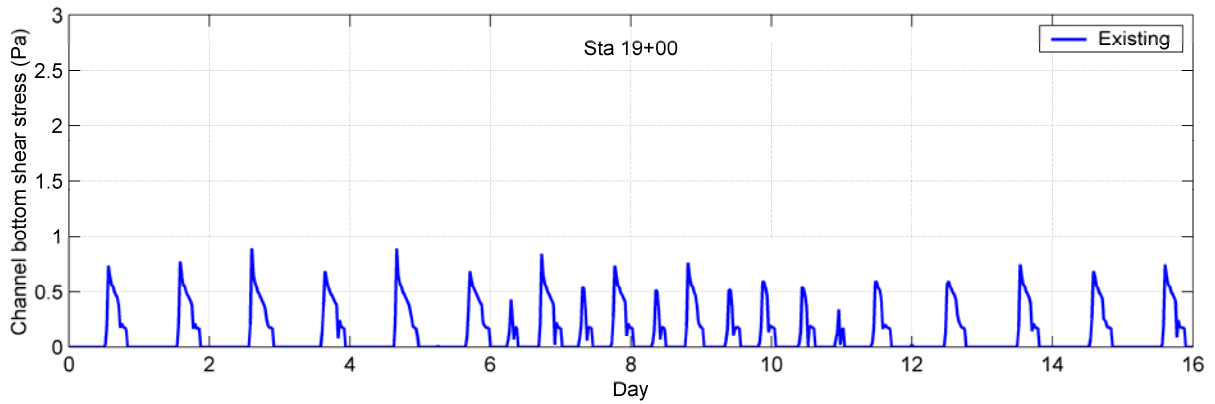
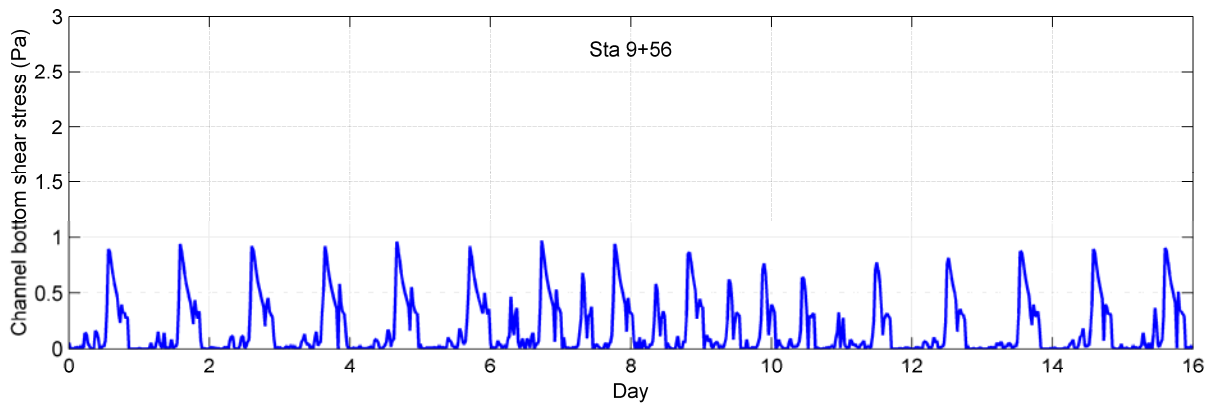
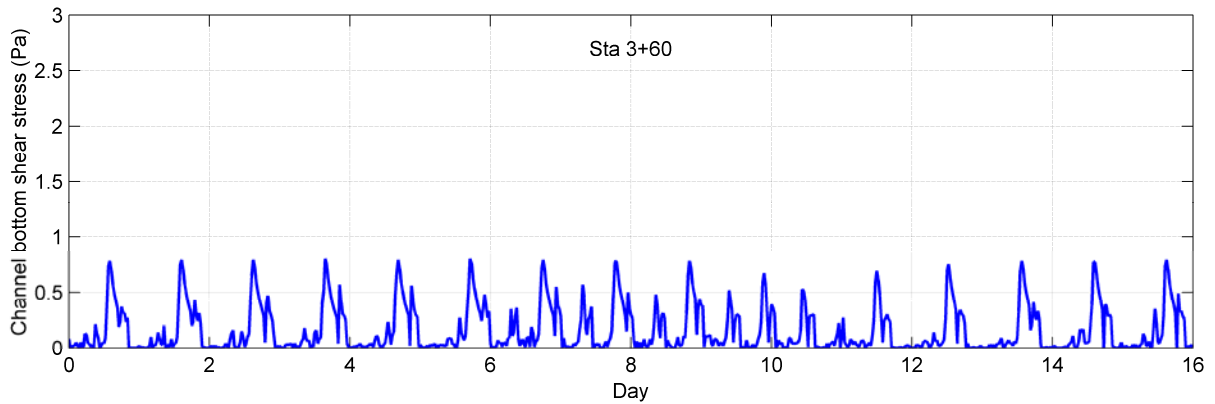
Figure 31. Channel Bottom Shear Stresses in Existing Northern Drainage Channel (Apr 1 – Aug 15)

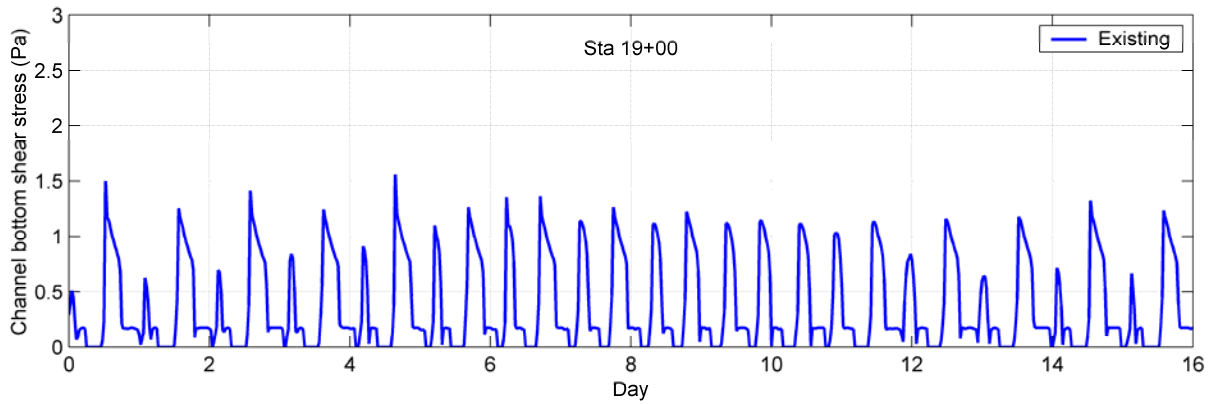
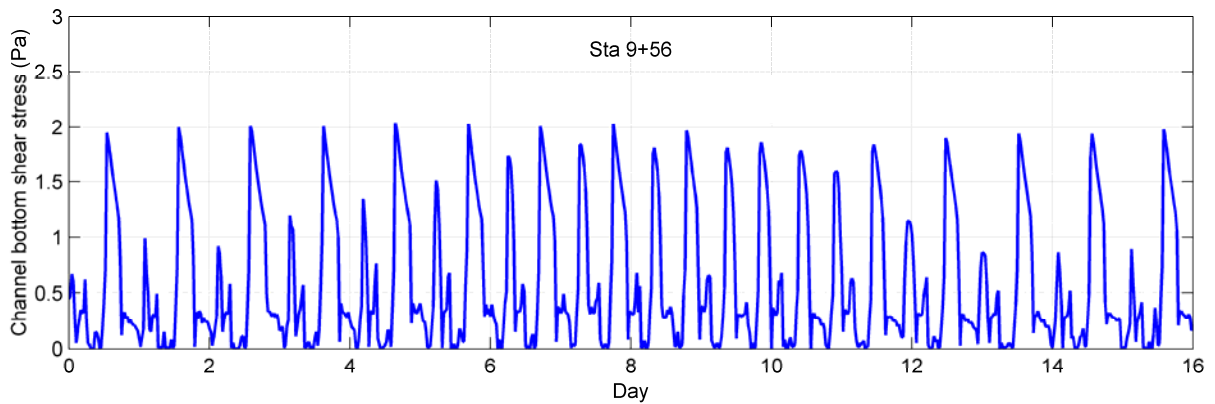
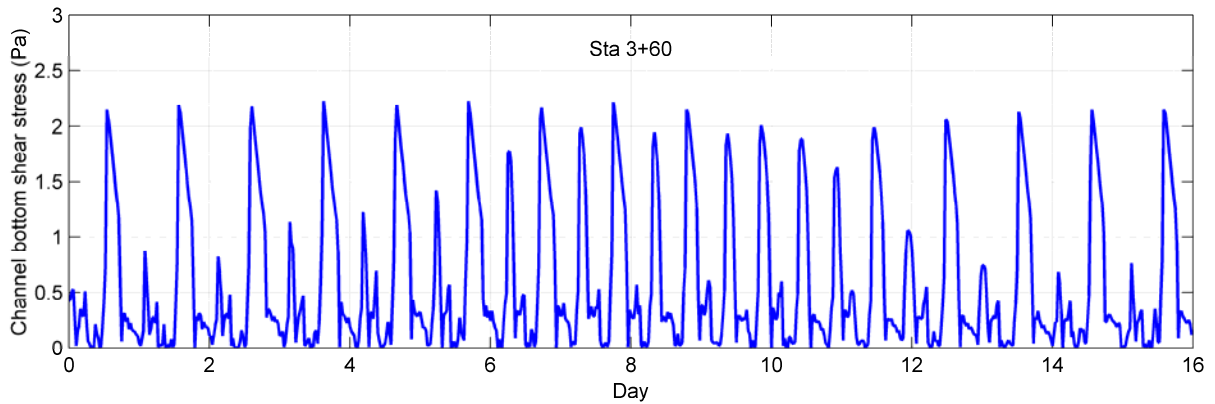
Figure 32. Channel Bottom Shear Stresses in Existing Northern Drainage Channel (Aug 15 – Beginning of Shorebird Marsh Fall Maintenance)

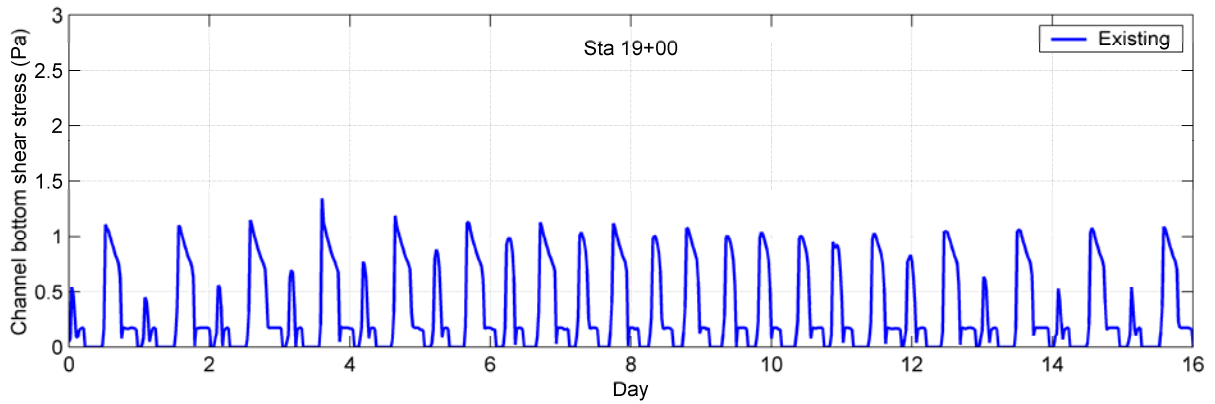
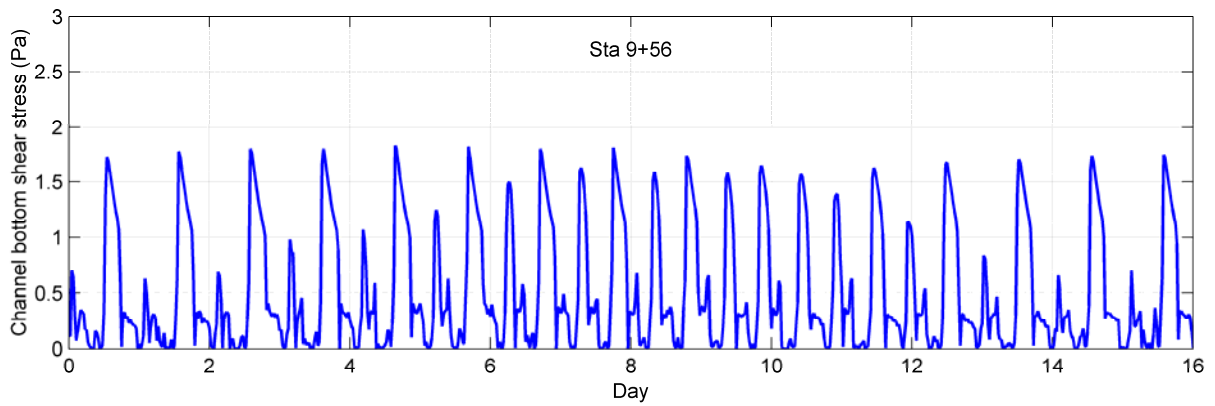
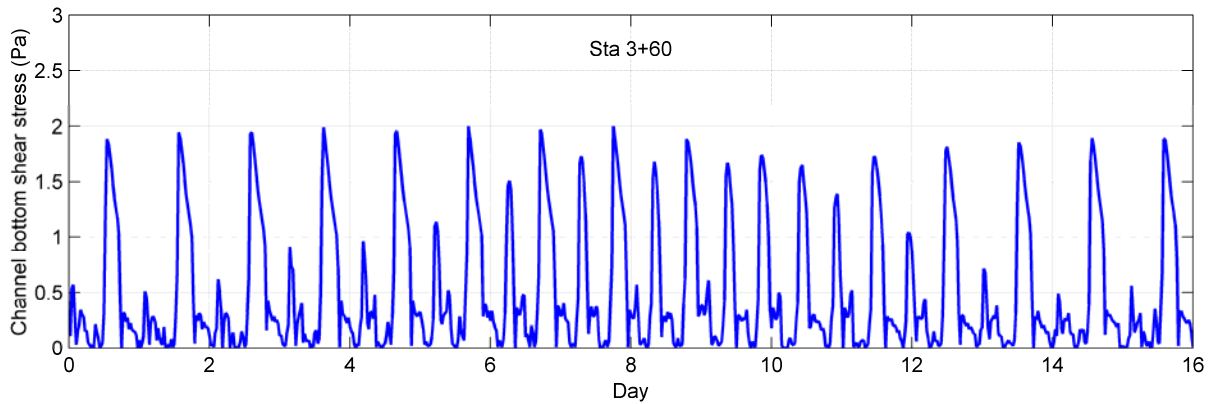
Figure 33. Channel Bottom Shear Stresses in Existing Northern Drainage Channel (Winter with No Precipitation Forecasted)

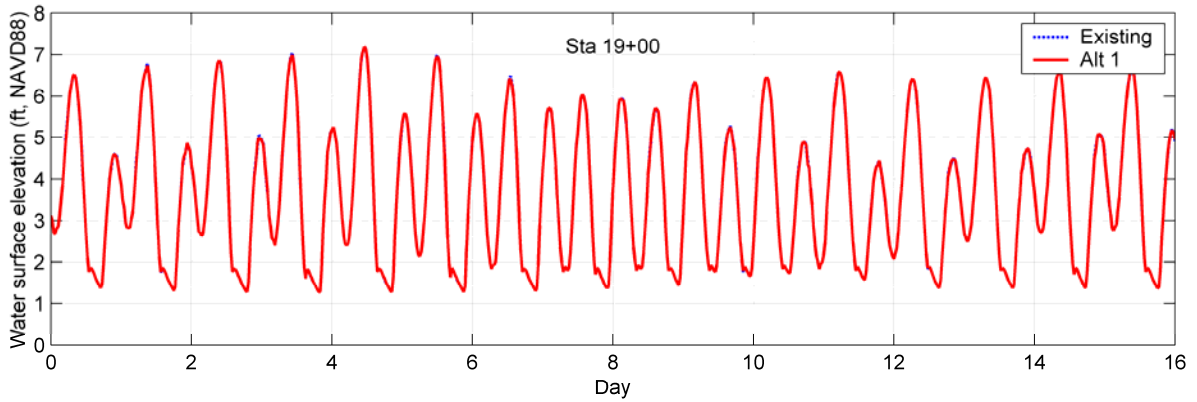
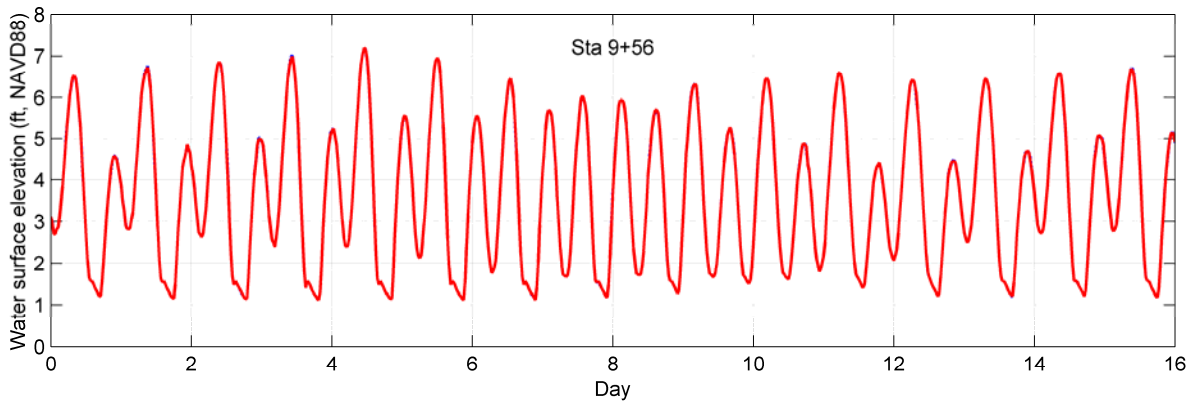
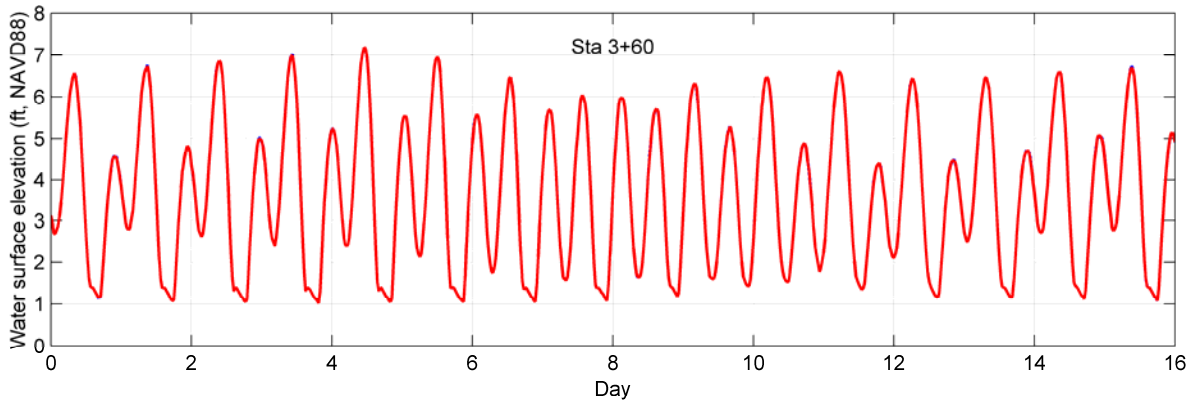
Figure 34. Water Levels in Northern Drainage Channel for WRA's Alternative 1 (Apr 1 – Aug 15)

The water levels computed for WRA's three preliminary alternatives and Alternative 2B with the optimized channel size are shown in Figure 34 through Figure 45 for the three representative locations in the northern drainage channel for various seasons, respectively. The water levels for the existing condition are also included in each of these figures for comparison. The annual variation ranges of the water levels, compared to the existing condition, are summarized in Table 5. As shown in these figures and in Table 5, the water levels along the drainage channel

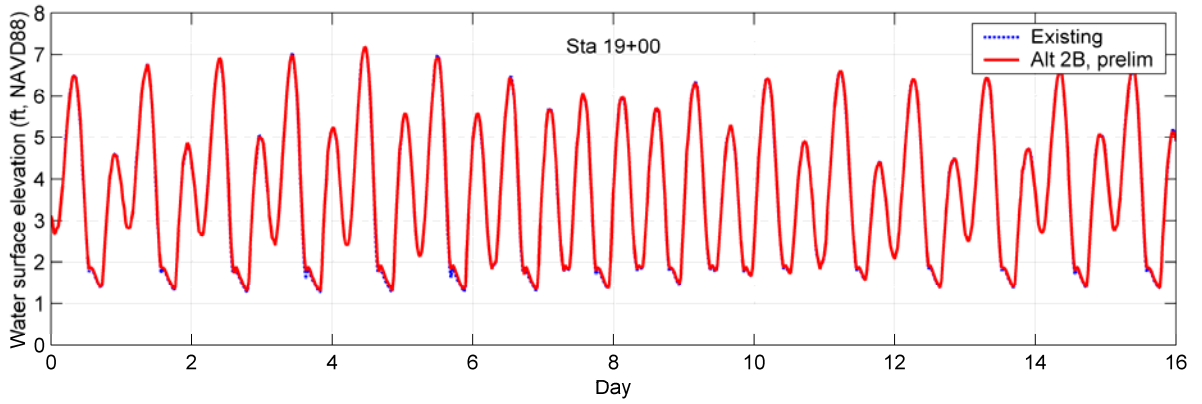
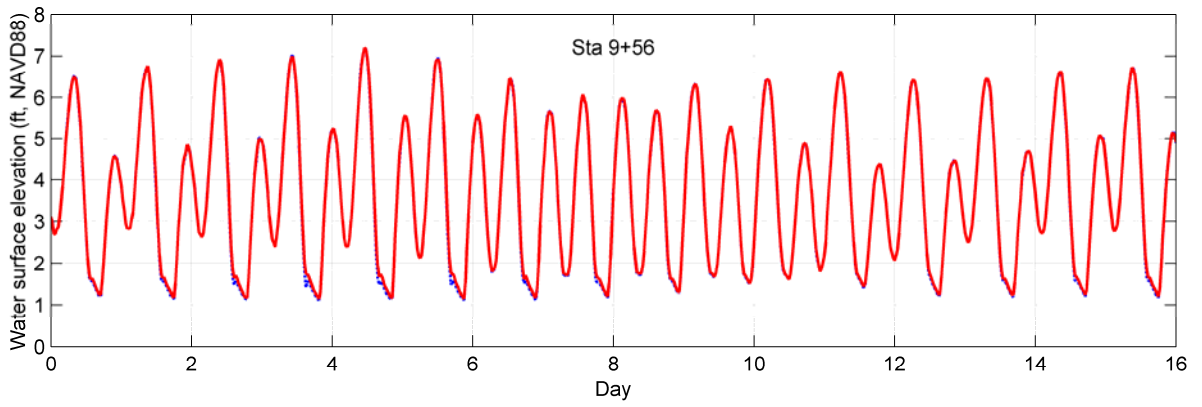
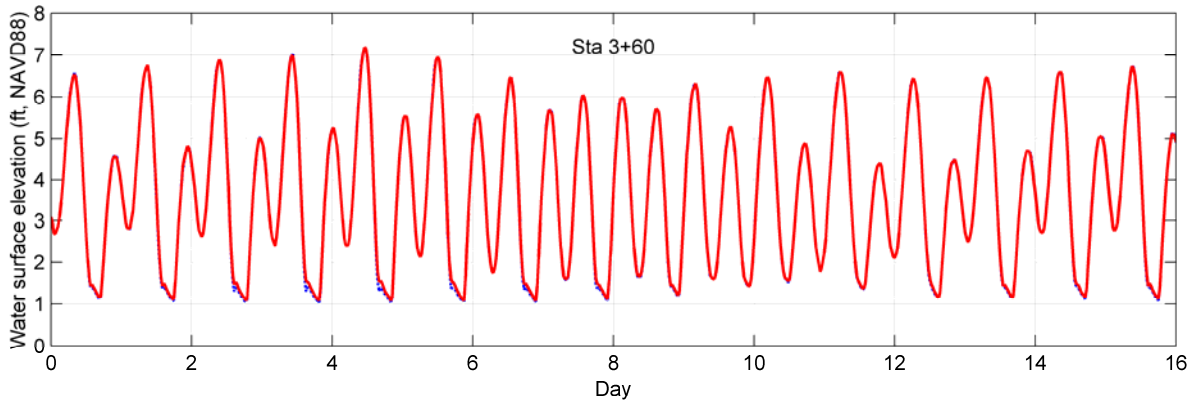
Figure 35. Water Levels in Northern Drainage Channel for WRA's Alternative 2B (Apr 1 – Aug 15)
