Re: **Applicability of NCI (2016) Hydrology Report to
Corte Madera 4-Acre Tidal Marsh Restoration Project**

Hydrology Report

WETLAND RESTORATION DESIGN AND PERMITTING SUPPORT SERVICES AT CORTE MADERA ECOLOGICAL RESERVE

CORTE MADERA, MARIN COUNTY, CALIFORNIA

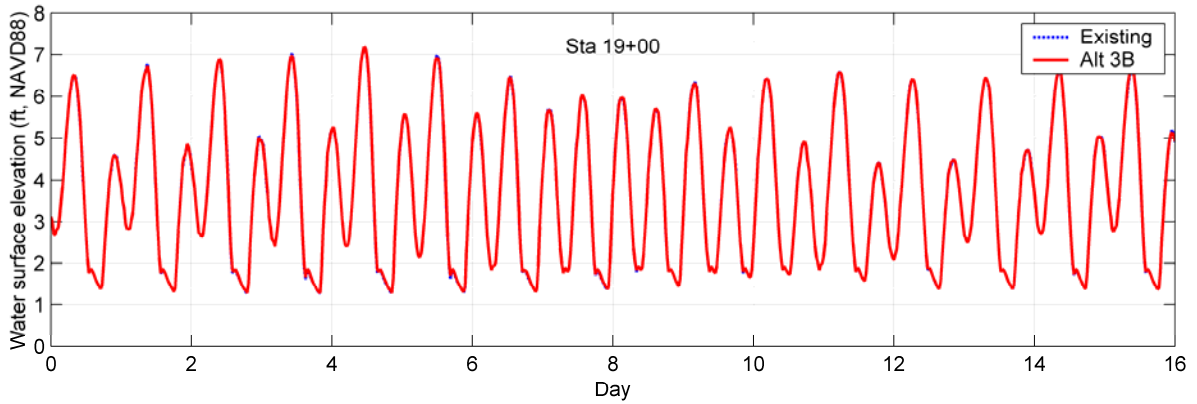
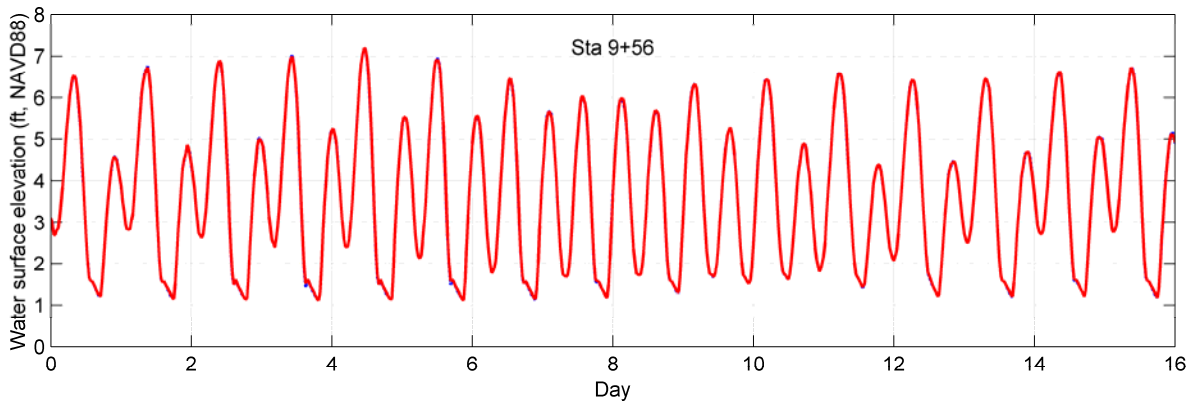
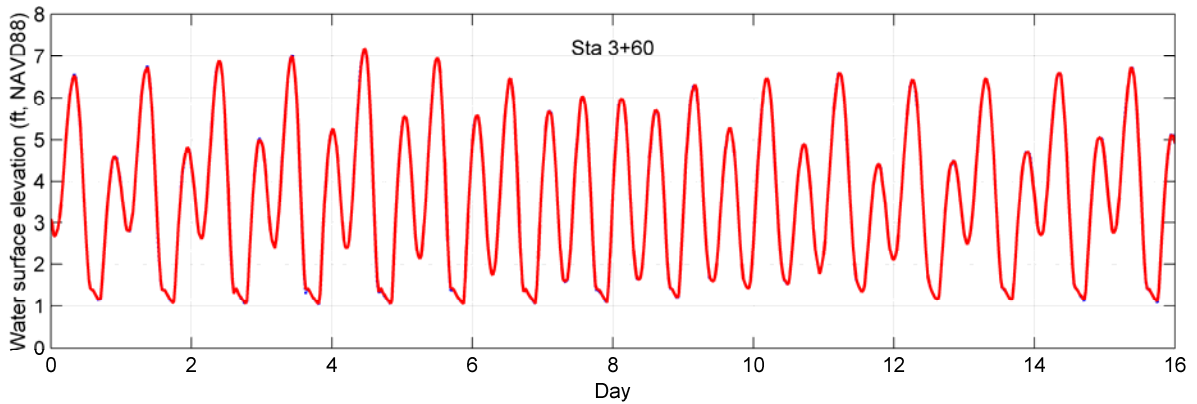
Figure 36. Water Levels in Northern Drainage Channel for WRA's Alternative 3B (Apr 1 – Aug 15)

The water levels computed for WRA's three preliminary alternatives and Alternative 2B with the optimized channel size are shown in Figure 34 through Figure 45 for the three representative locations in the northern drainage channel for various seasons, respectively. The water levels for the existing condition are also included in each of these figures for comparison. The annual variation ranges of the water levels, compared to the existing condition, are summarized in Table 5. As shown in these figures and in Table 5, the water levels along the drainage channel

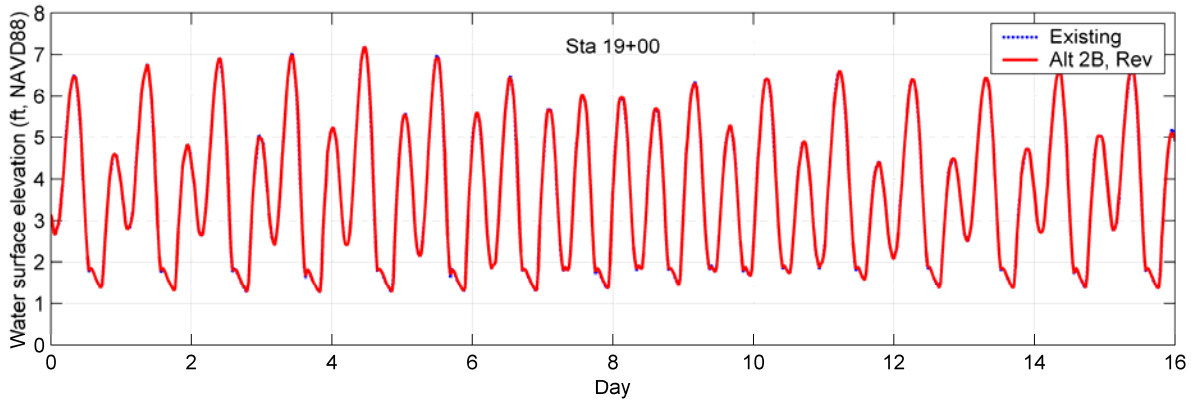
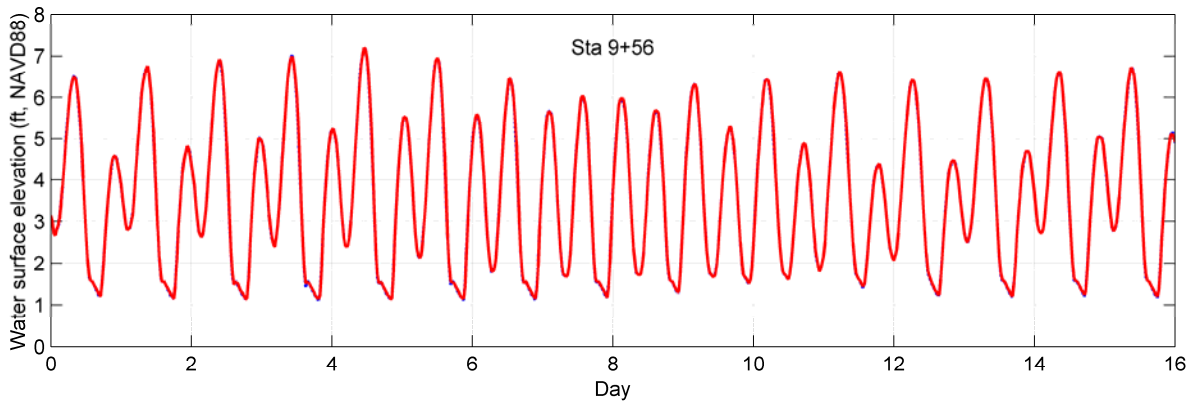
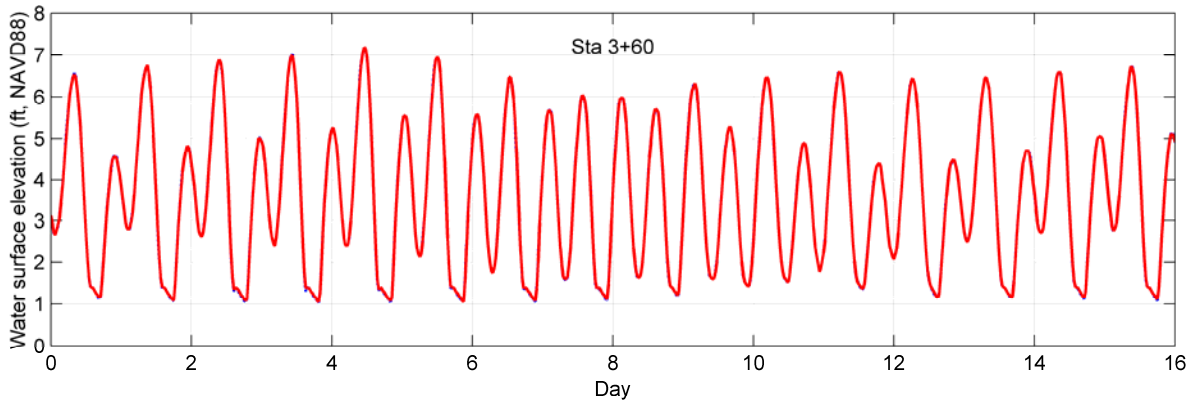
Figure 37. Water Levels in Northern Drainage Channel for WRA’s Alternative 2B with Optimized Channel Size for Breach and Internal Tidal Channels (Apr 1 – Aug 15)

- Based on the channel size optimization analysis, the size of the breach channel and the internal tidal channel for Alternative 2B need to be increased in order to maintain a relatively equilibrium condition in these channel. As shown in Figure 12, the optimized breach channel has a bottom width of 6' at the elevation of 0' NAVD88, a side slope of 5(H):1(V) below the elevation of +3' NAVD88, 6 feet wide benches at this elevation on both sides, and then a side slope of 8(H):1(V) for the elevation above +3' NAVD 88. The internal tidal channel near the breach will have the same configuration as the breach section. The cross section of the internal channels should become smaller as the distance from the breach location increases in order to be consistent with the reduction of tidal prism and the resulting water exchange volume. This can be done by reducing the channel width or elevating the channel bottom.

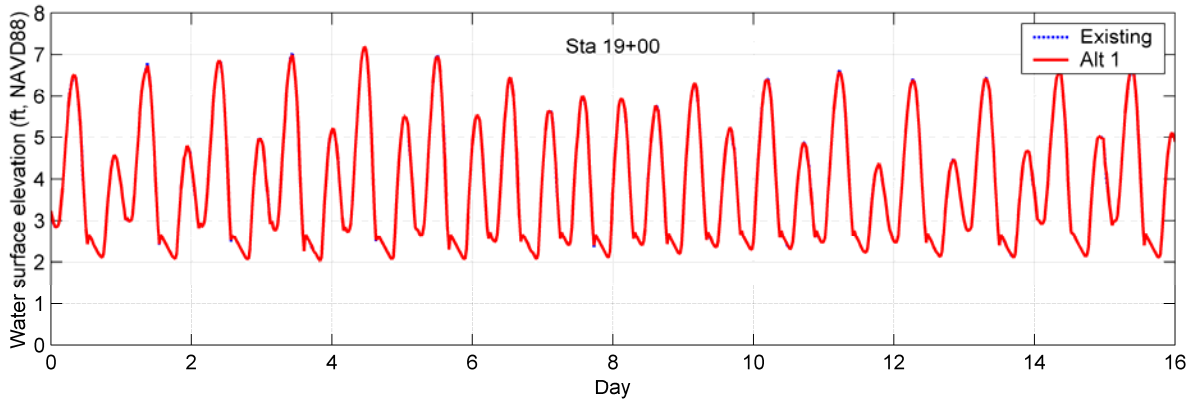
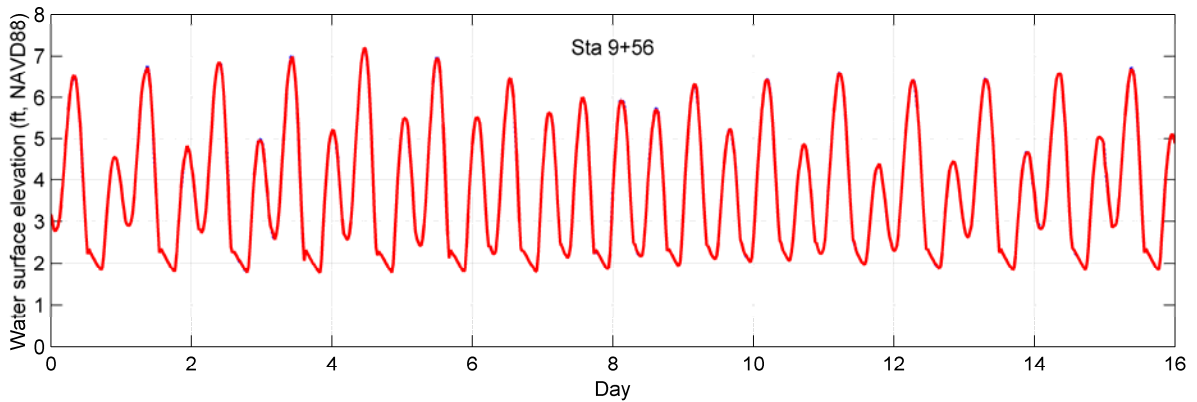
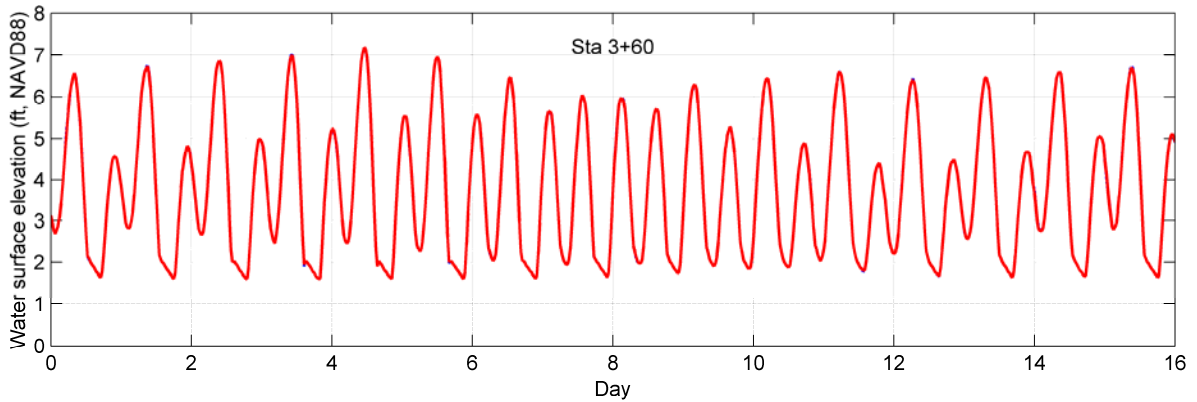
Figure 38. Water Levels in Northern Drainage Channel for WRA's Alternative 1 (Aug 15 – Beginning of Shorebird Marsh Fall Maintenance)

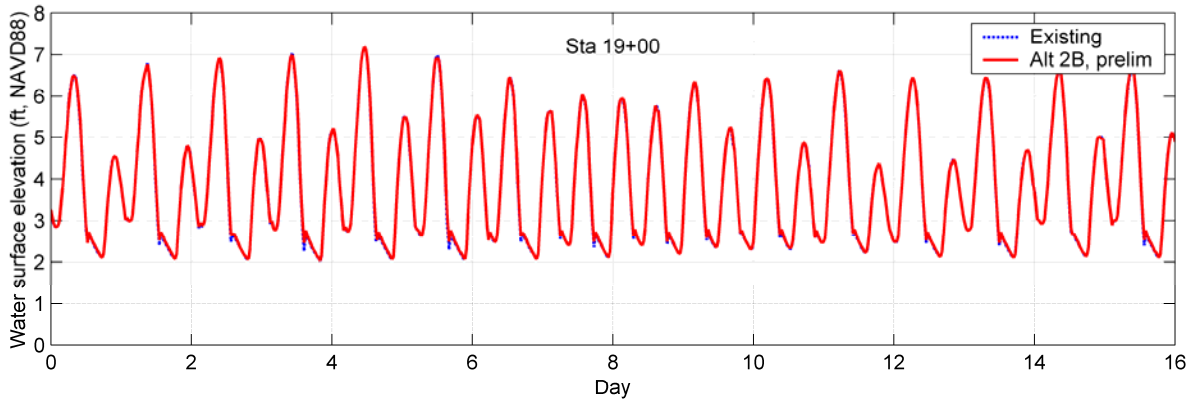
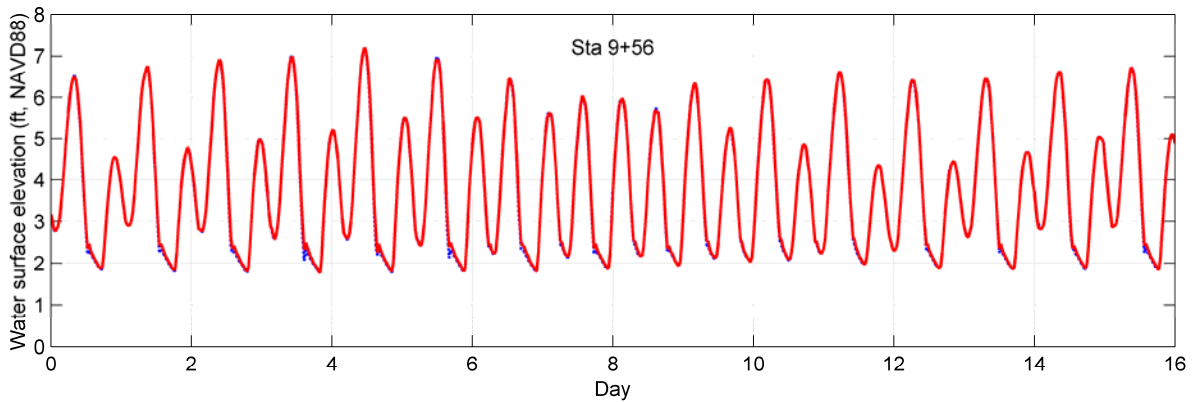
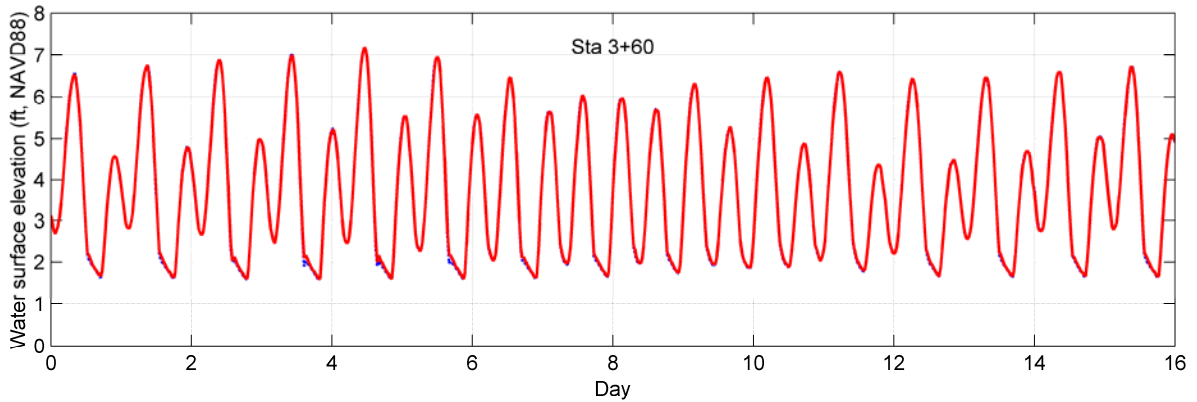
Figure 39. Water Levels in Northern Drainage Channel for WRA's Alternative 2B (Aug 15 – Beginning of Shorebird Marsh Fall Maintenance)

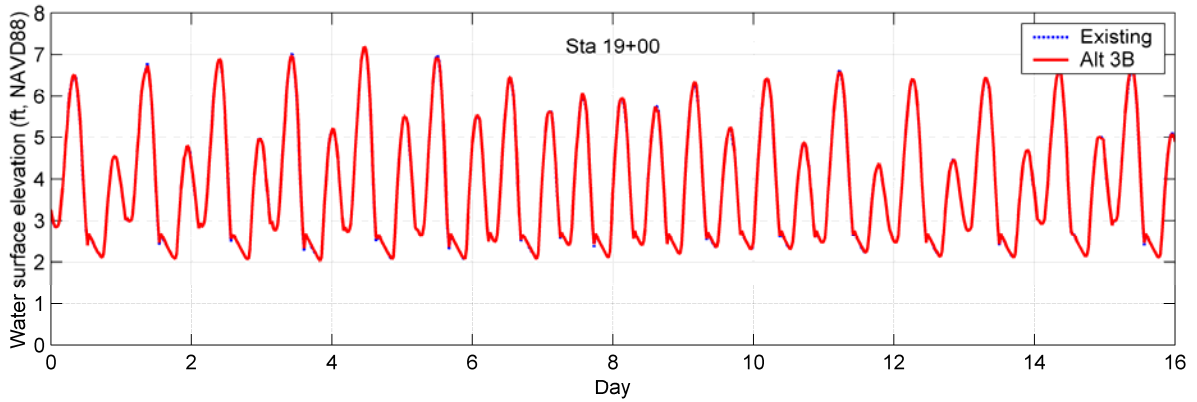
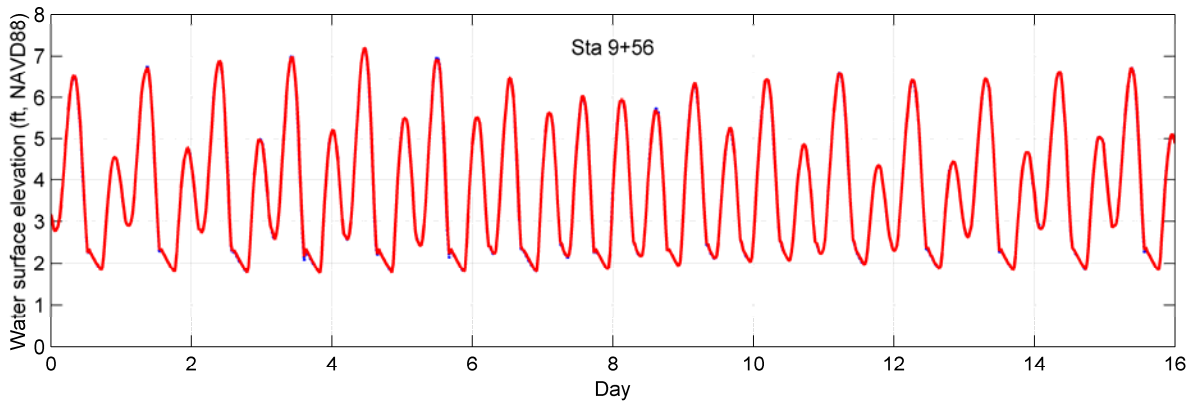
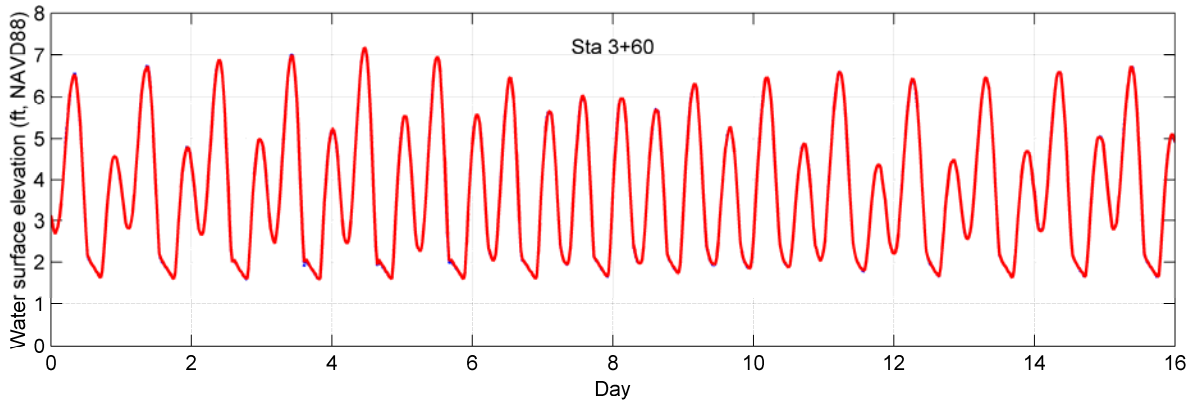
Figure 40. Water Levels in Northern Drainage Channel for WRA's Alternative 3B (Aug 15 – Beginning of Shorebird Marsh Fall Maintenance)

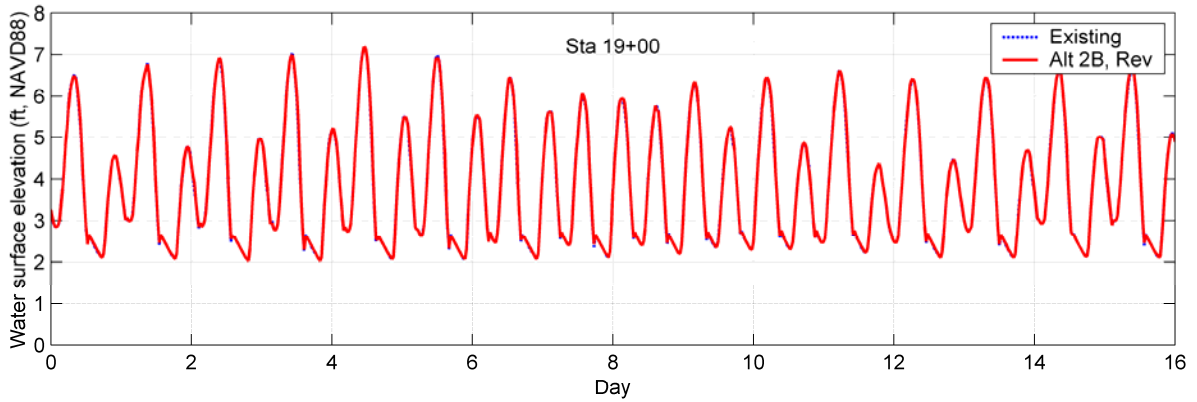
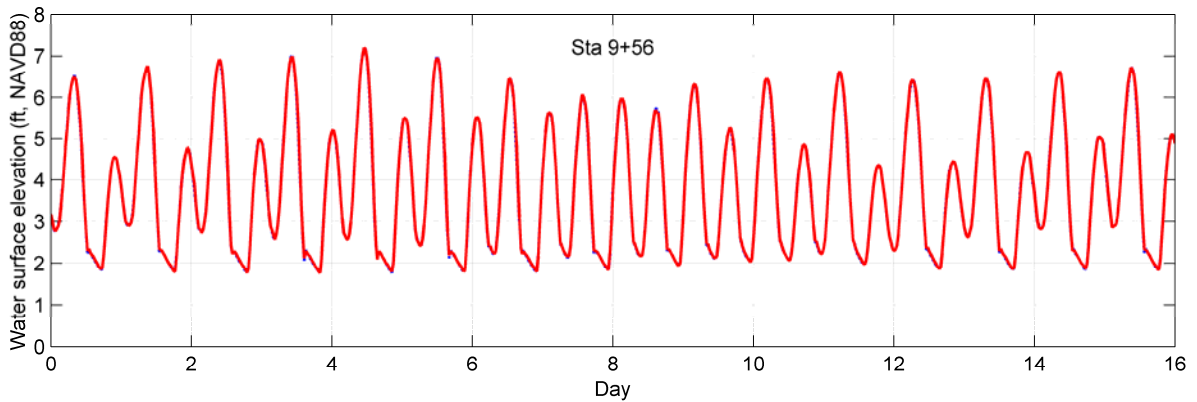
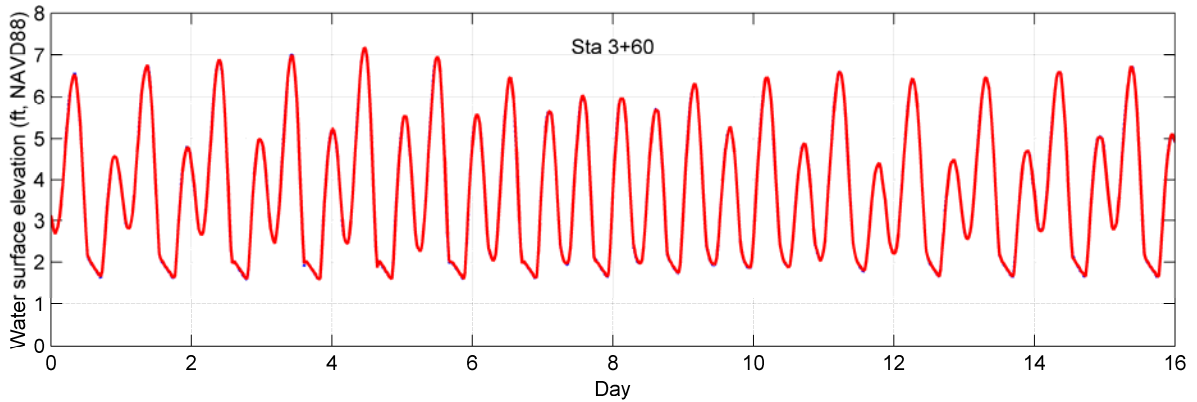
Figure 41. Water Levels in Northern Drainage Channel for WRA’s Alternative 2B with Optimized Channel Size for Breach and Internal Tidal Channels (Aug 15 – Beginning of Shorebird Marsh Fall Maintenance)

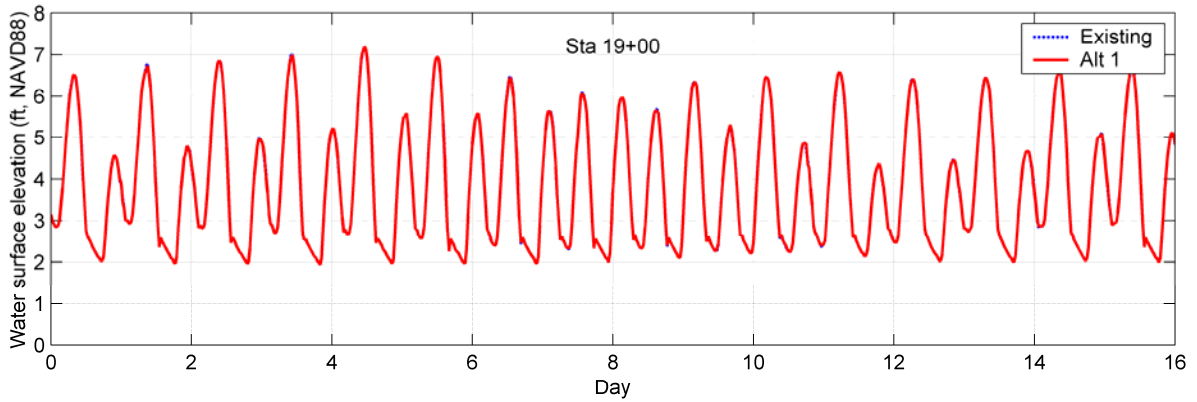
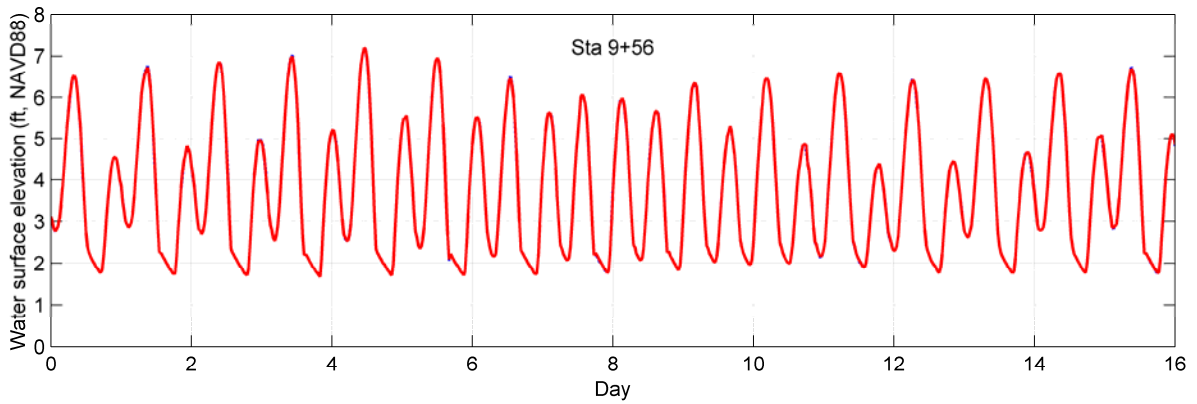
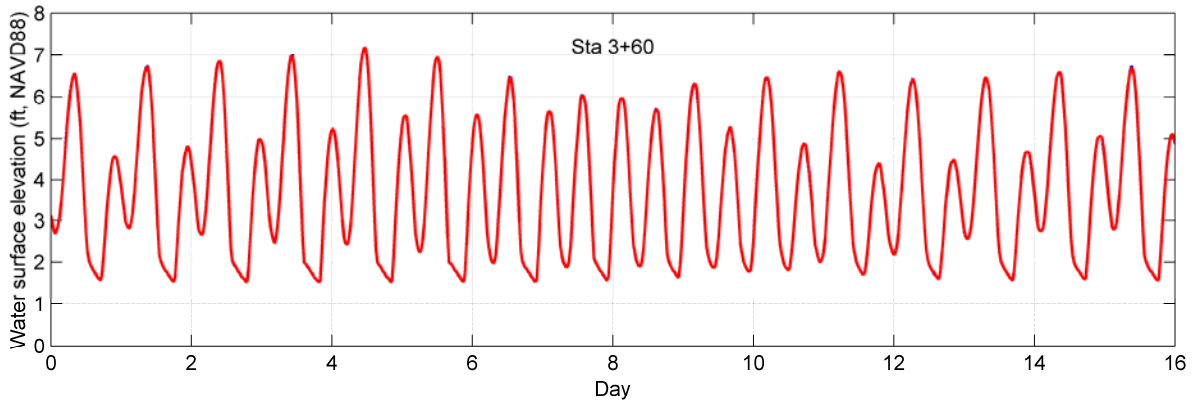
Figure 42. Water Levels in Northern Drainage Channel for WRA's Alternative 1 (Winter with No Precipitation Forecasted)

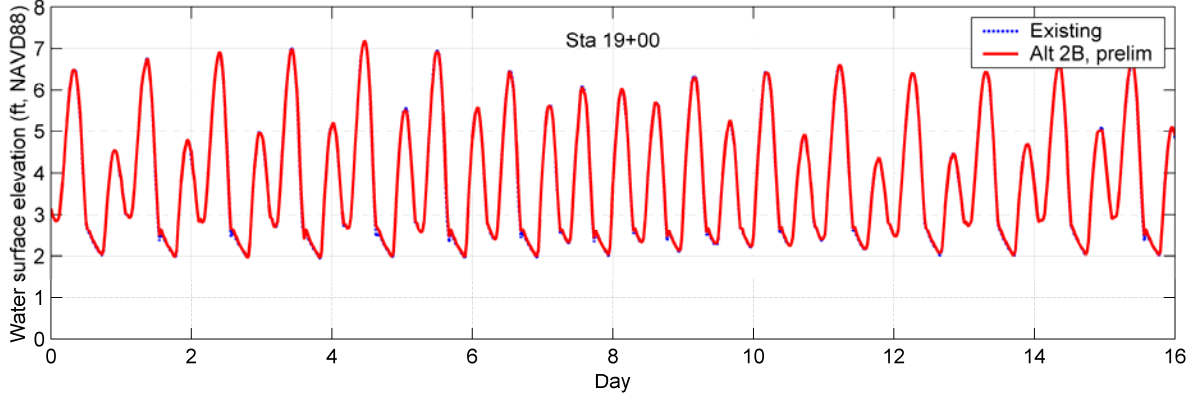
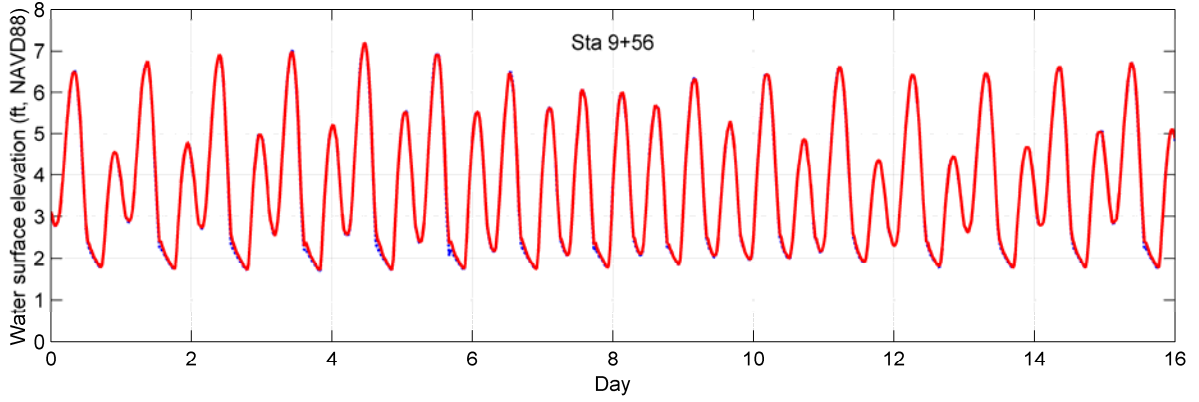
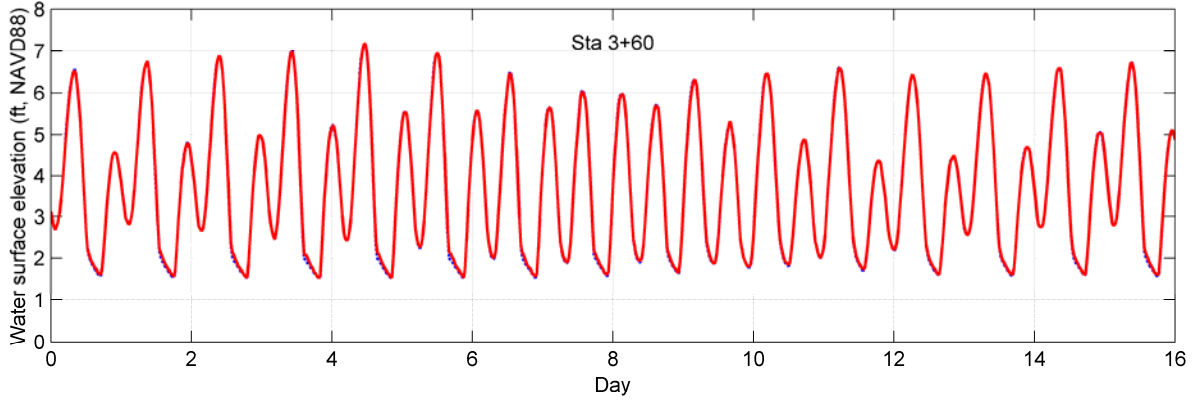
Figure 43. Water Levels in Northern Drainage Channel for WRA's Alternative 2B (Winter with No Precipitation Forecasted)

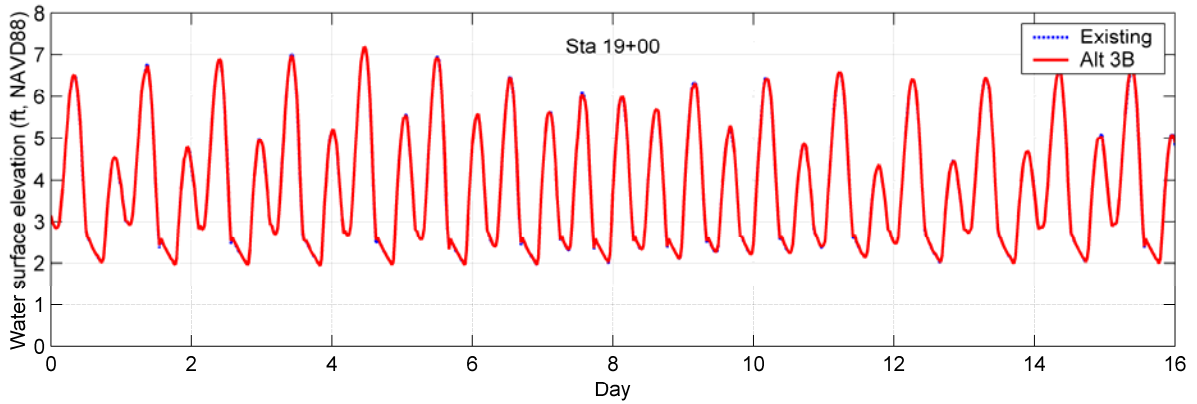
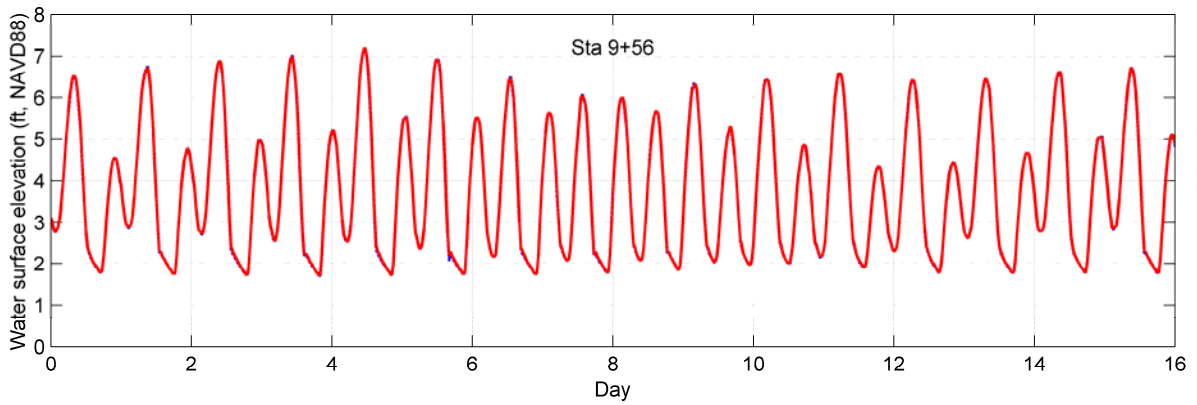
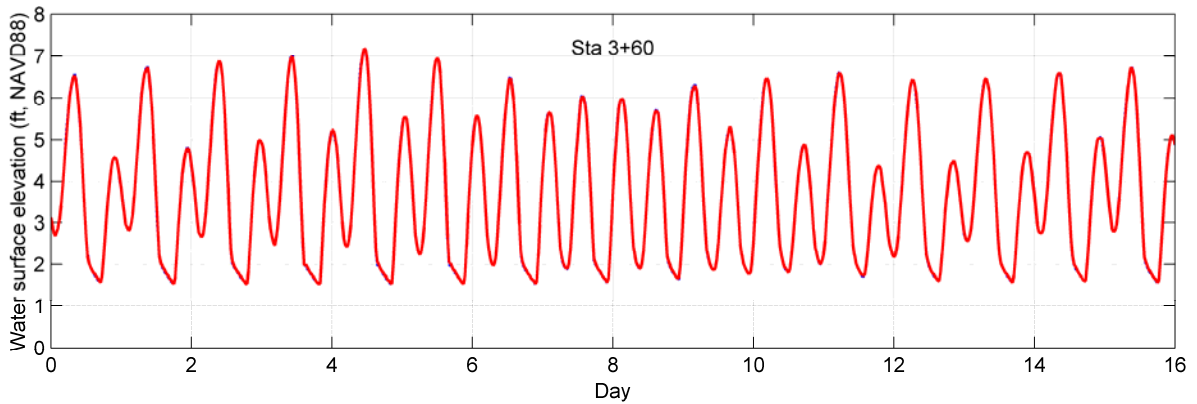
Figure 44. Water Levels in Northern Drainage Channel for WRA's Alternative 3B (Winter with No Precipitation Forecasted)

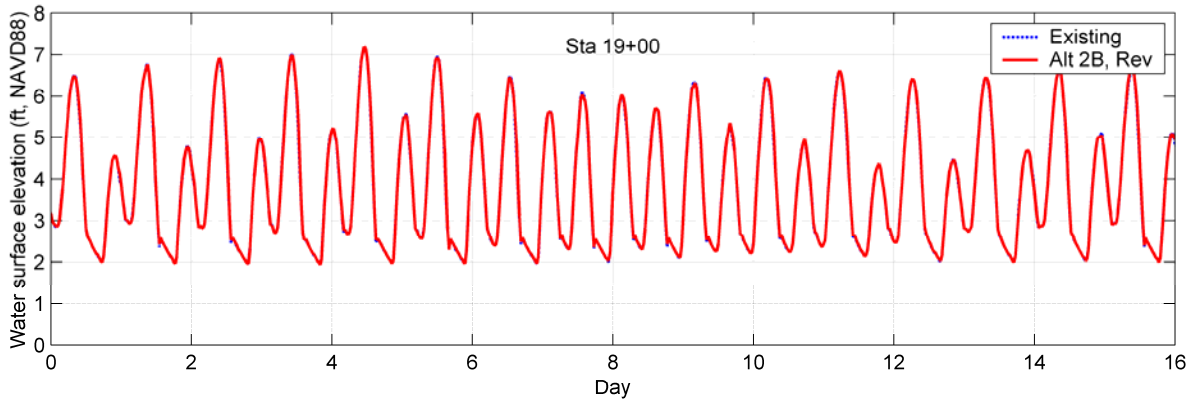
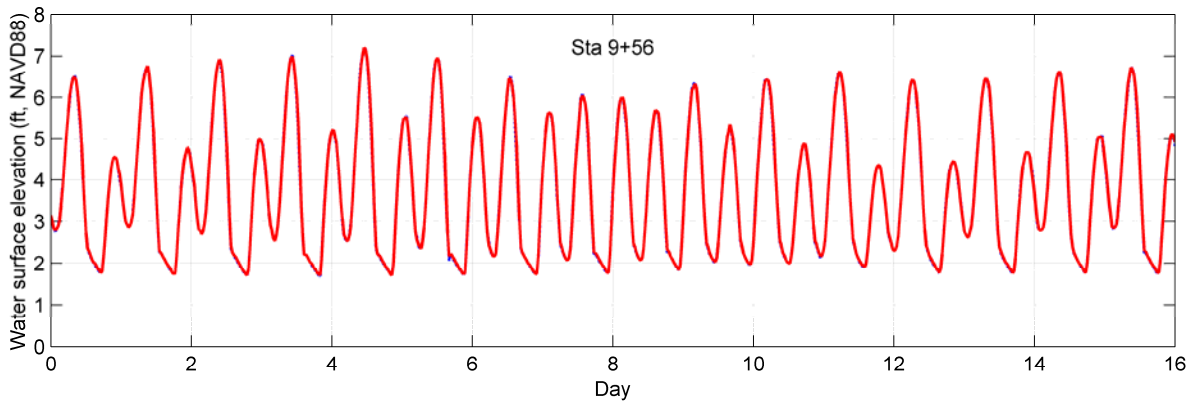
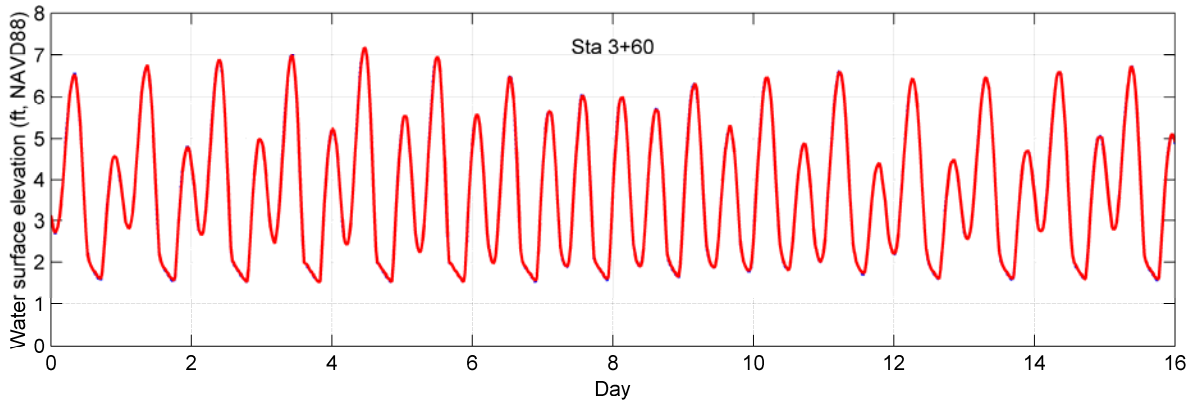
Figure 45. Water Levels in Northern Drainage Channel for WRA’s Alternative 2B with Optimized Channel Size for Breach and Internal Tidal Channels (Winter with No Precipitation Forecasted)

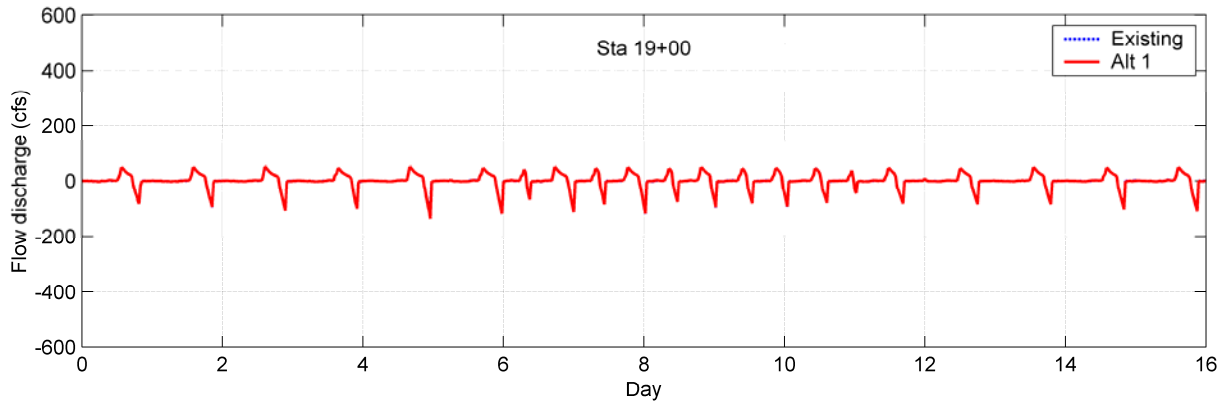
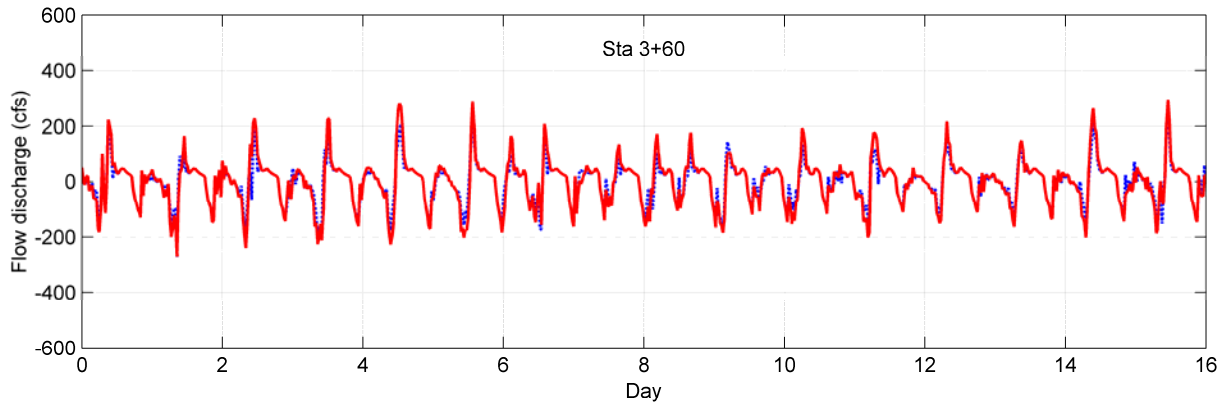
Figure 46. Flow Discharges in Northern Drainage Channel for WRA's Alternative 1 (Apr 1 – Aug 15)

The flow discharges computed for WRA's three preliminary alternatives and Alternative 2B with the optimized channel size, compared to the existing condition, are shown in Figure 46 through Figure 57 for various seasons, respectively. The annual variation ranges of the flow discharges, compared to the existing condition, are summarized in Table 6. As shown in these figures and in Table 6, the flow discharges in the lower reach of the drainage channel that is downstream of the proposed breach location will be increased due to the added water exchange between Corte Madera Marsh and the channel. On the other hand, these project alternatives will have limited impact to the flow discharges in the middle and upper reaches of the northern drainage channel that is upstream of the breach location.

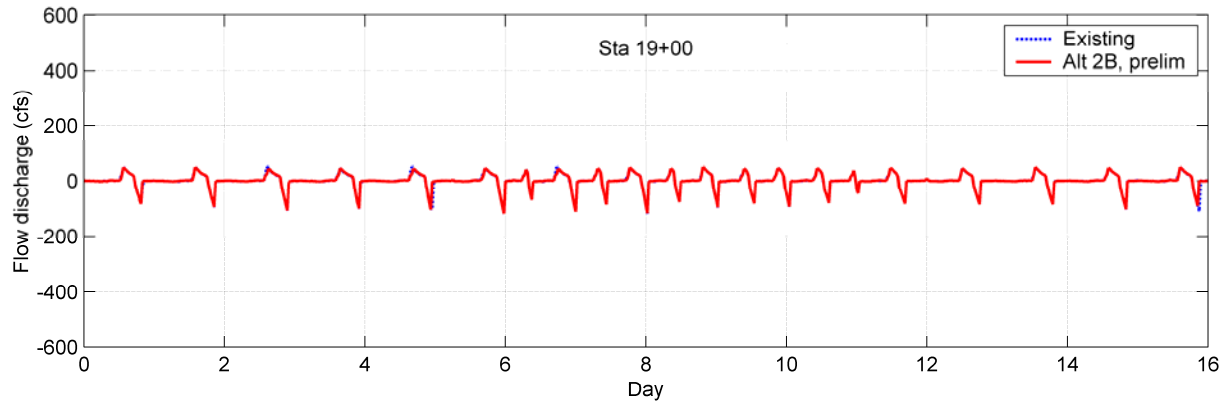
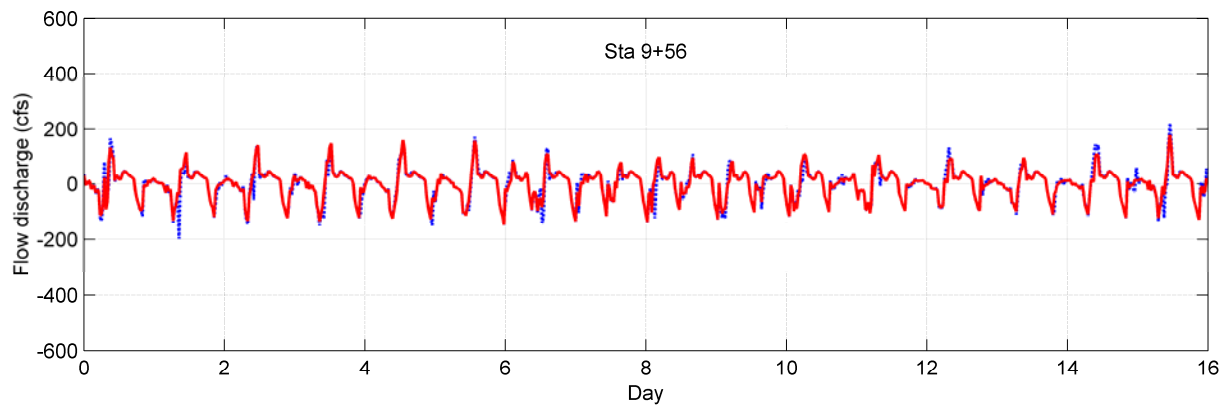
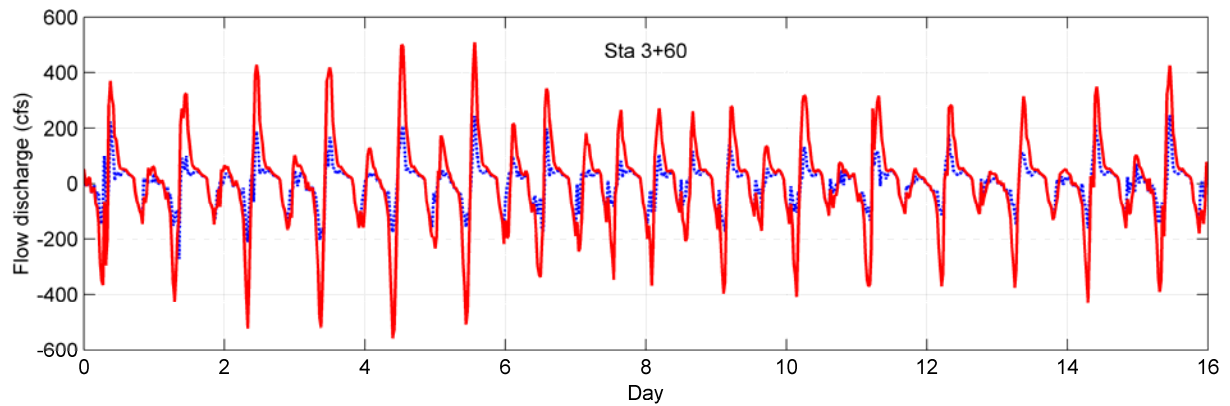
Figure 47. Flow Discharges in Northern Drainage Channel for WRA's Alternative 2B (Apr 1 – Aug 15)

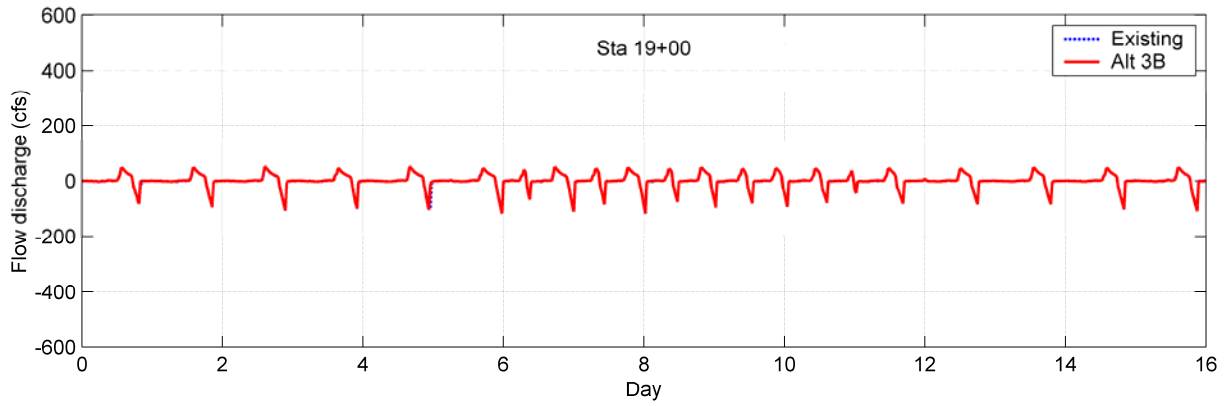
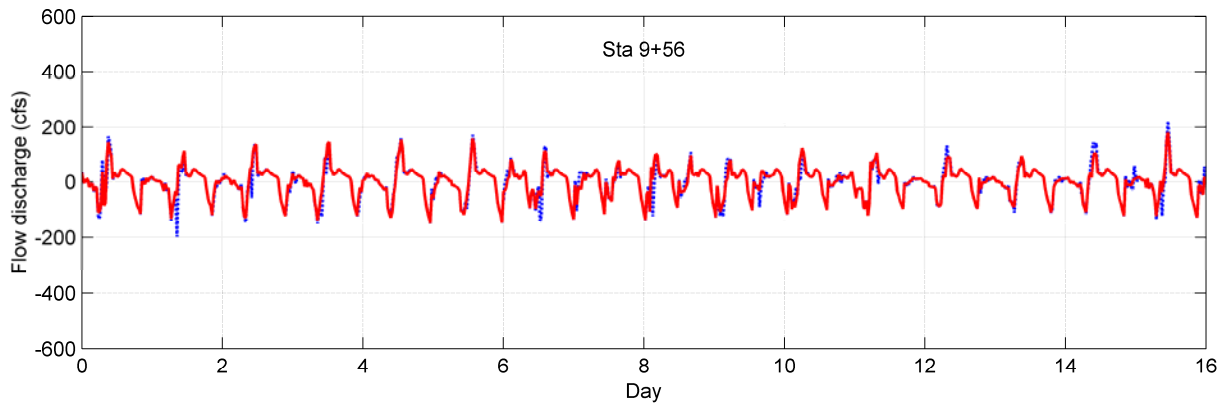
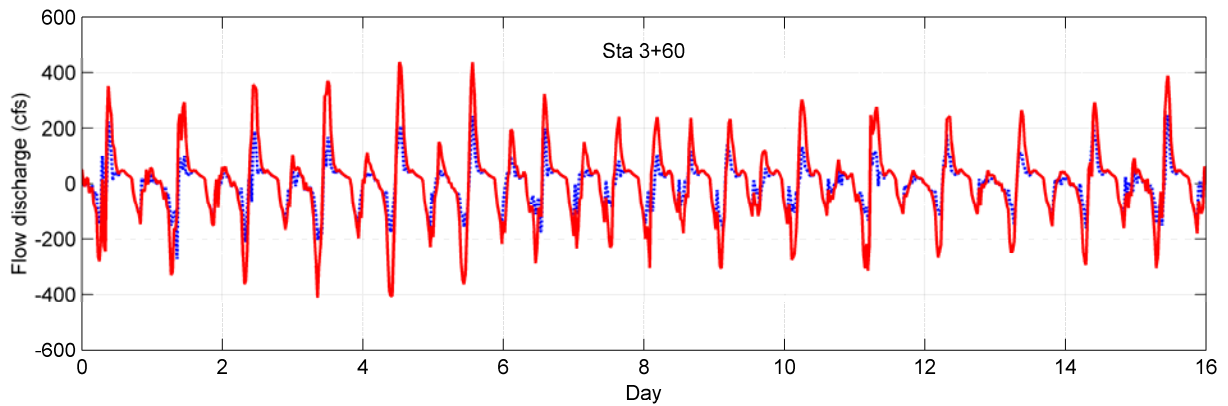
Figure 48. Flow Discharges in Northern Drainage Channel for WRA’s Alternative 3B (Apr 1 – Aug 15)

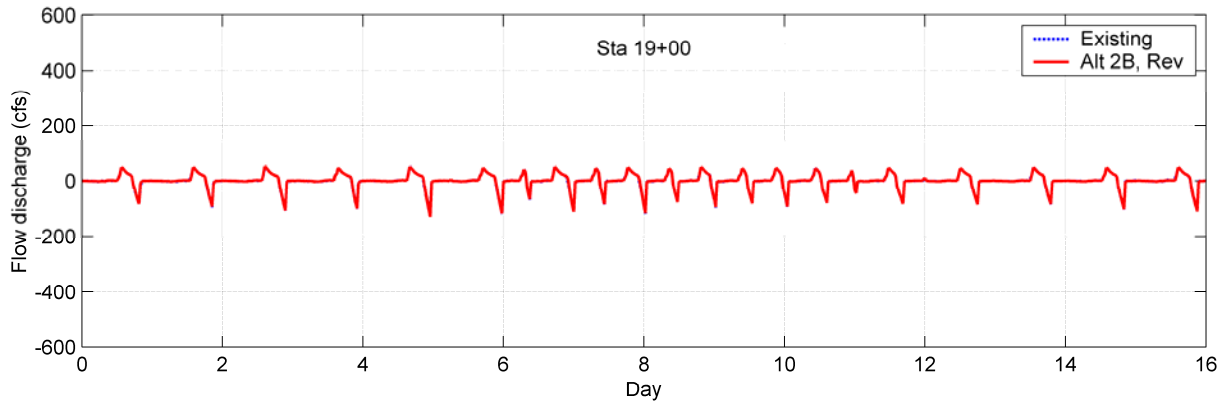
Figure 49. Flow Discharges in Northern Drainage Channel for WRA’s Alternative 2B with Optimized Channel Size for Breach and Internal Tidal Channels (Apr 1 – Aug 15)

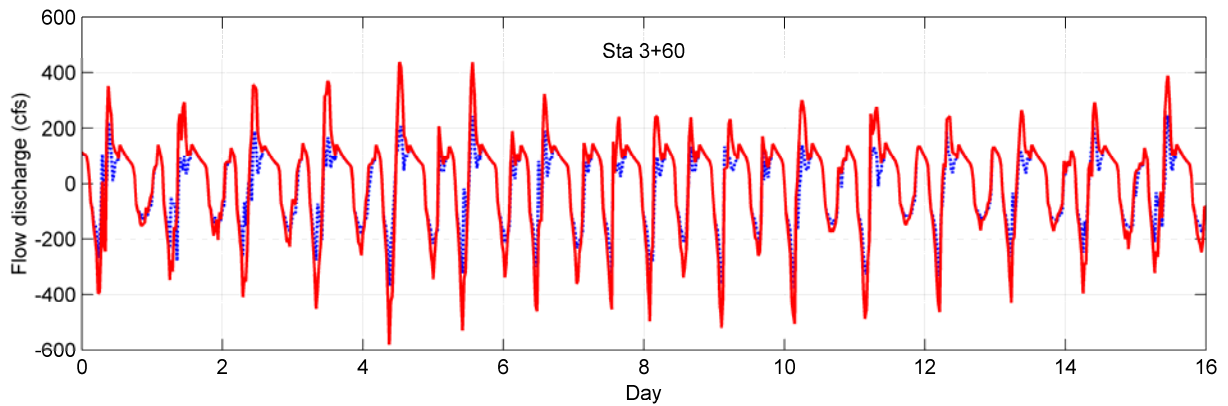
Figure 52. Flow Discharges in Northern Drainage Channel for WRA’s Alternative 3B (Aug 15 – Beginning of Shorebird Marsh Fall Maintenance)

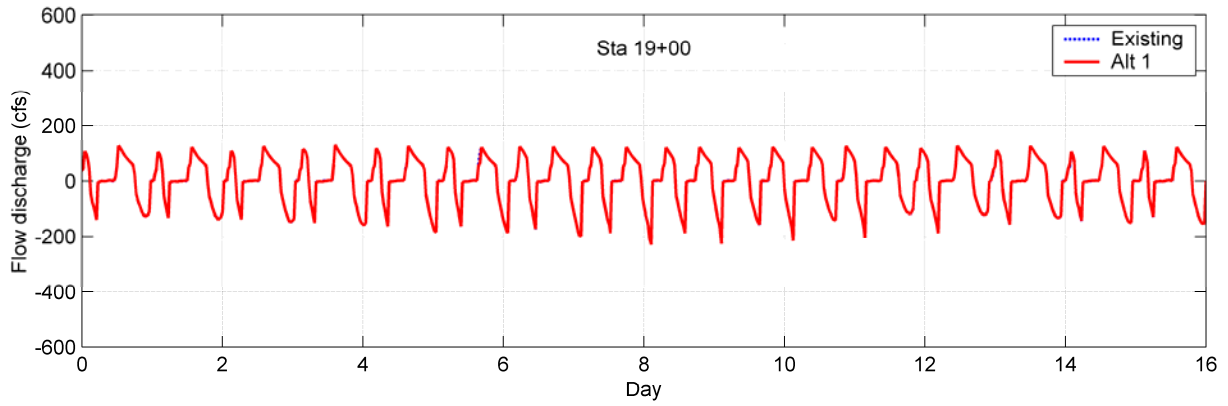
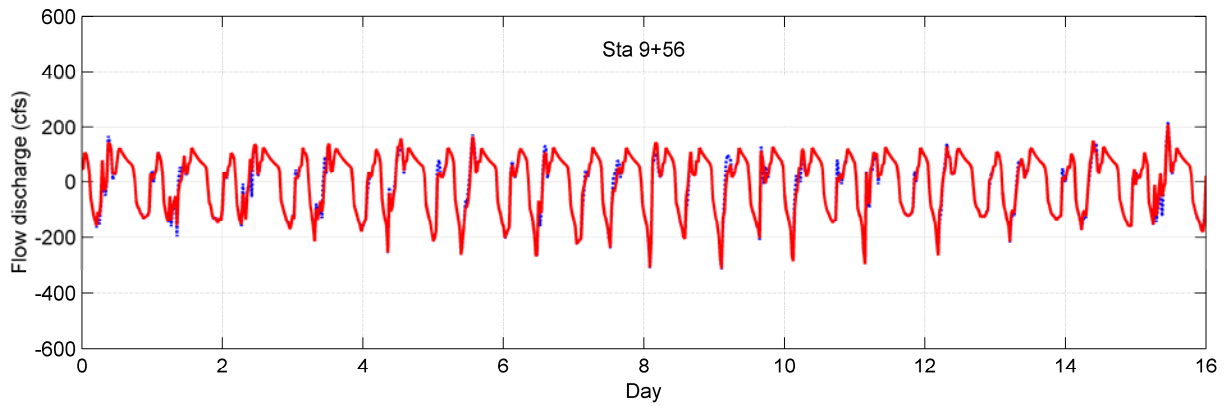
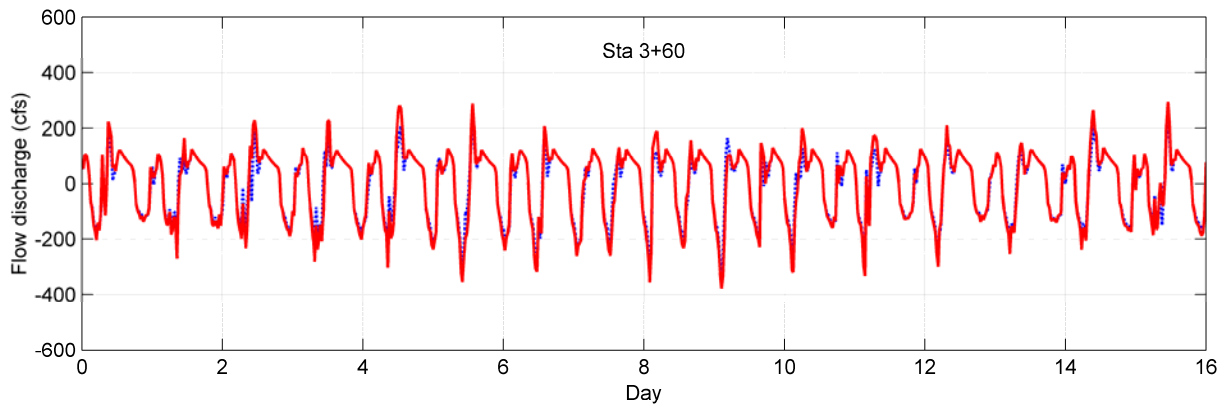
Figure 54. Flow Discharges in Northern Drainage Channel for WRA's Alternative 1 (Winter with No Precipitation Forecasted)
