Re: **Applicability of NCI (2016) Hydrology Report to
Corte Madera 4-Acre Tidal Marsh Restoration Project**

Hydrology Report

WETLAND RESTORATION DESIGN AND PERMITTING SUPPORT SERVICES AT CORTE MADERA ECOLOGICAL RESERVE

CORTE MADERA, MARIN COUNTY, CALIFORNIA

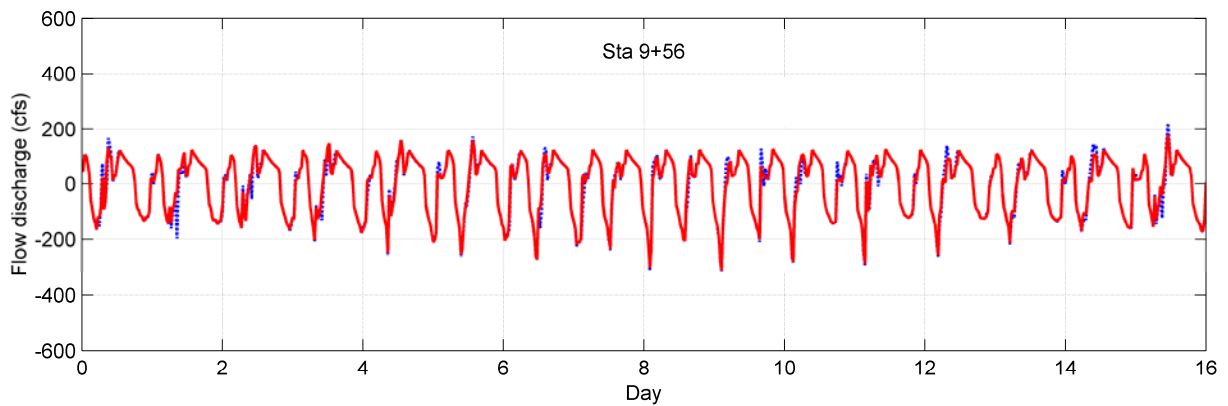
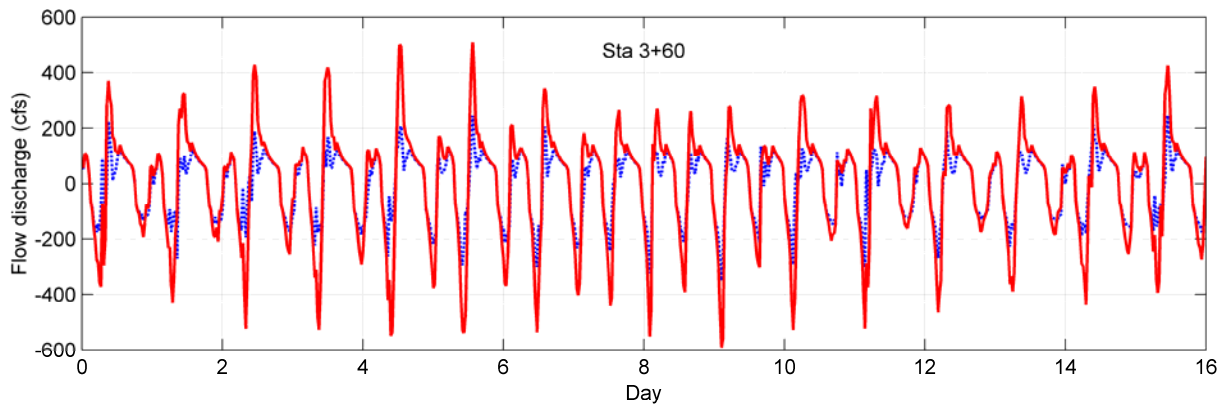
Figure 55. Flow Discharges in Northern Drainage Channel for WRA's Alternative 2B (Winter with No Precipitation Forecasted)

The flow discharges computed for WRA's three preliminary alternatives and Alternative 2B with the optimized channel size, compared to the existing condition, are shown in Figure 46 through Figure 57 for various seasons, respectively. The annual variation ranges of the flow discharges, compared to the existing condition, are summarized in Table 6. As shown in these figures and in Table 6, the flow discharges in the lower reach of the drainage channel that is downstream of the proposed breach location will be increased due to the added water exchange between Corte Madera Marsh and the channel. On the other hand, these project alternatives will have limited impact to the flow discharges in the middle and upper reaches of the northern drainage channel that is upstream of the breach location.

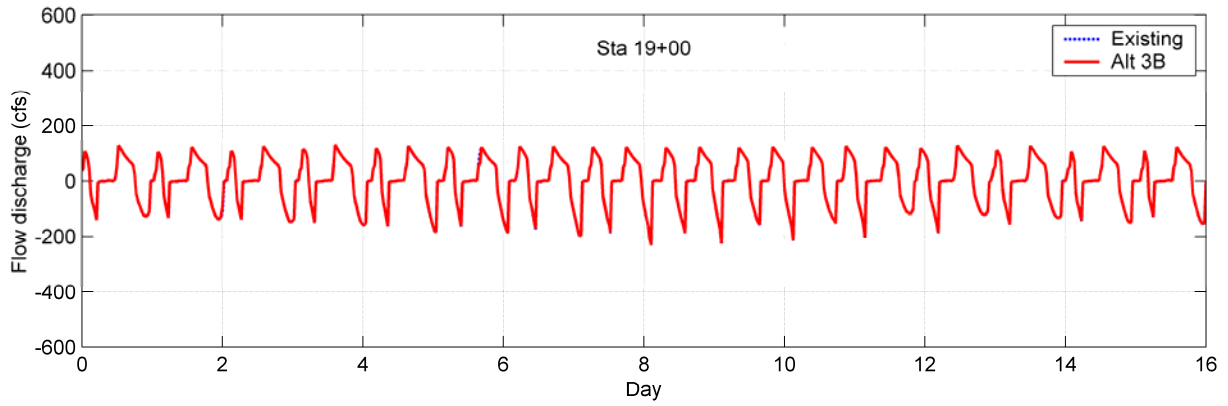
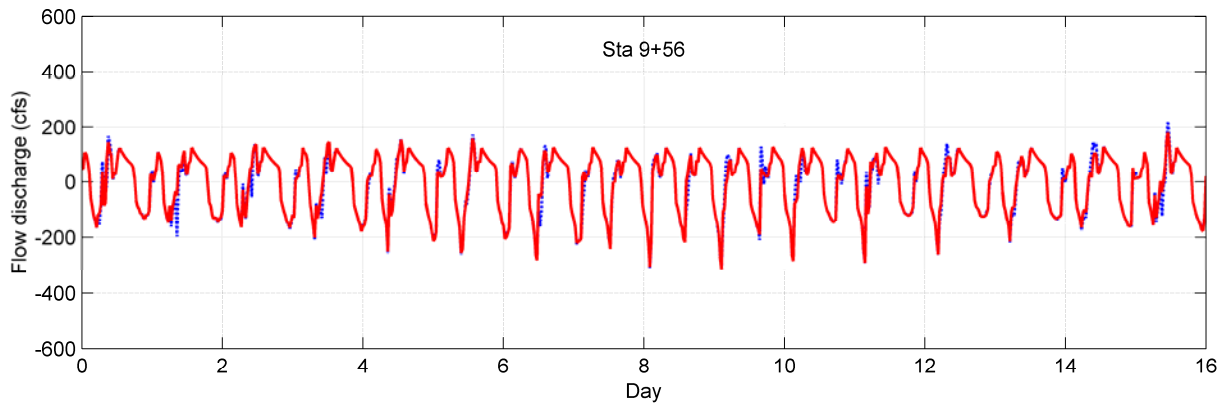
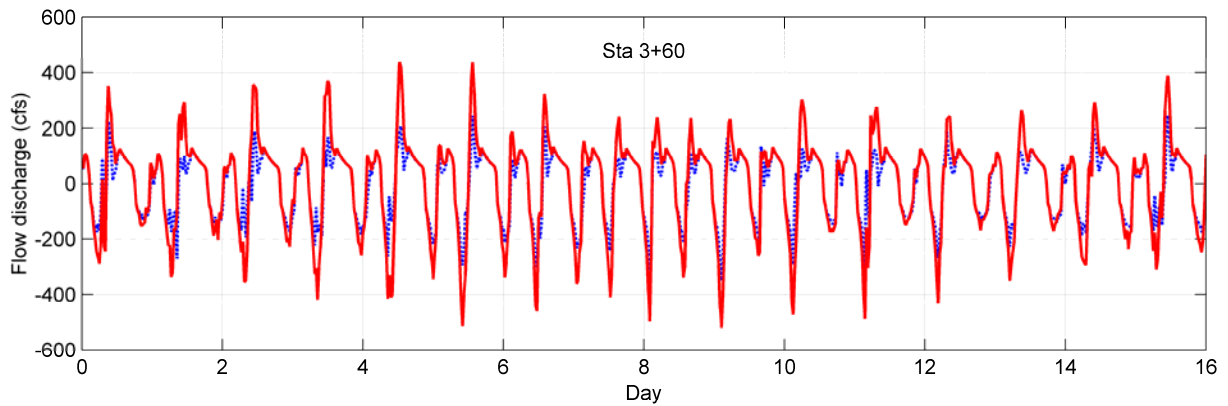
Figure 56. Flow Discharges in Northern Drainage Channel for WRA's Alternative 3B (Winter with No Precipitation Forecasted)

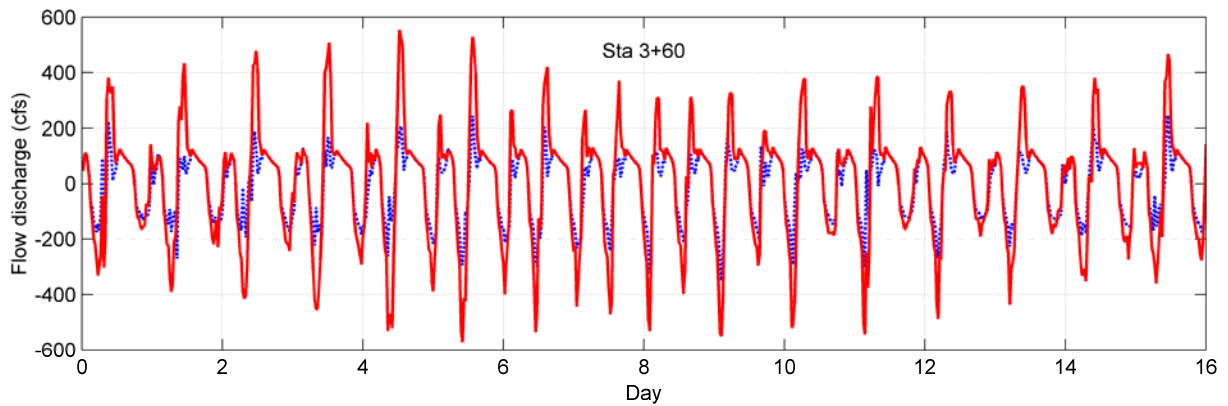
Figure 57. Flow Discharges in Northern Drainage Channel for WRA's Alternative 2B with Optimized Channel Size for Breach and Internal Tidal Channels (Winter with No Precipitation Forecasted)

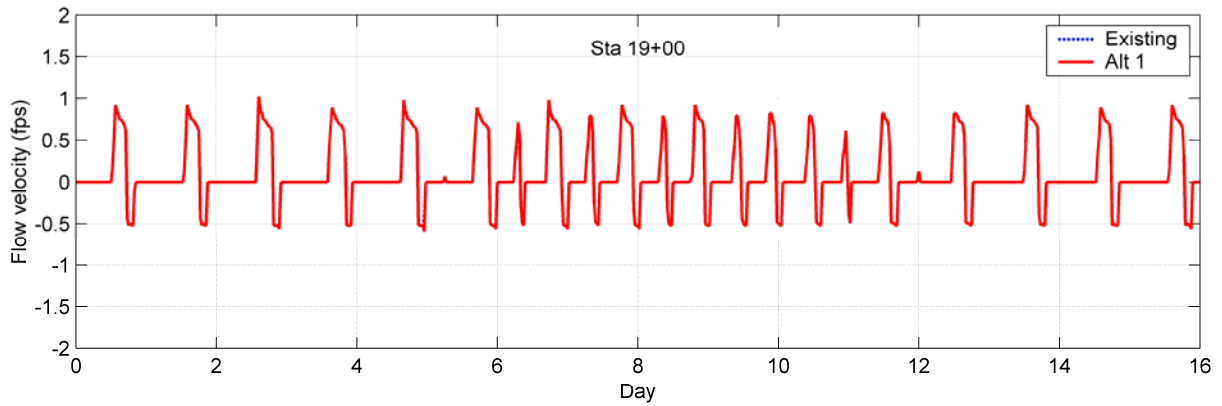
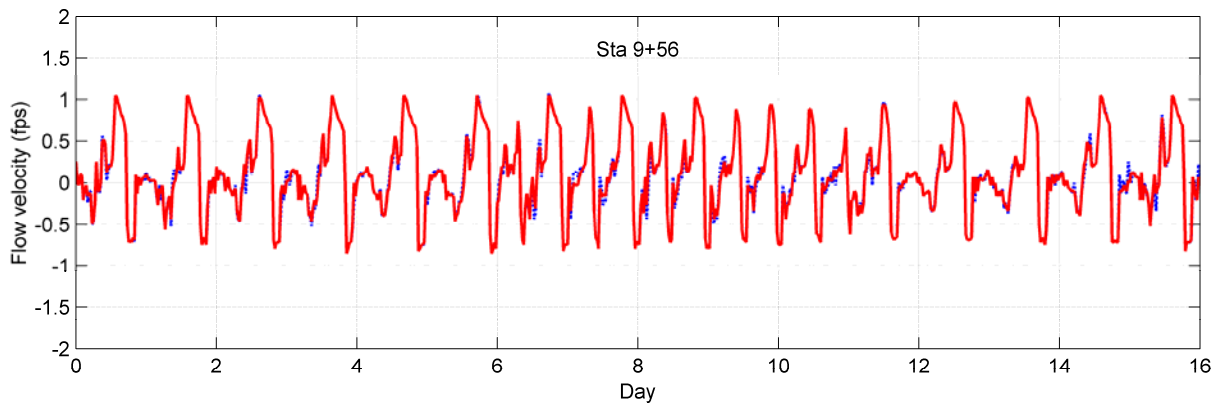
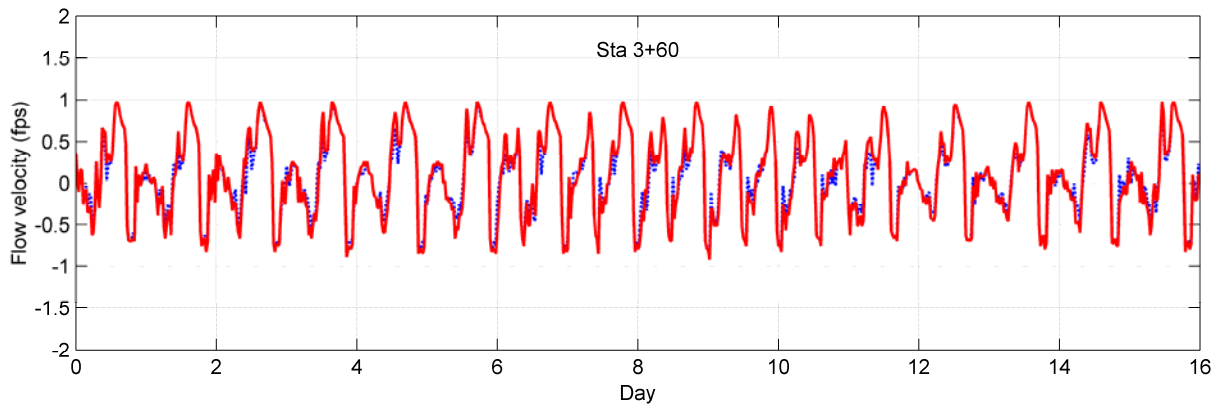
Figure 58. Flow Velocities in Northern Drainage Channel for WRA’s Alternative 1 (Apr 1 – Aug 15)

The flow velocities computed for WRA's three preliminary alternatives and Alternative 2B with the optimized channel size, compared to the existing condition, are shown in Figure 58 through Figure 69 for various seasons, respectively. The variation ranges of the flow velocities, compared to the existing condition, are summarized in Table 7. As shown in these figures and in Table 7, the flow velocities in the lower reach of the drainage channel that is downstream of the proposed breach will be increased due to the added water exchange between Corte Madera Marsh and the channel. The change is more significant for flood currents that flow from the Bay

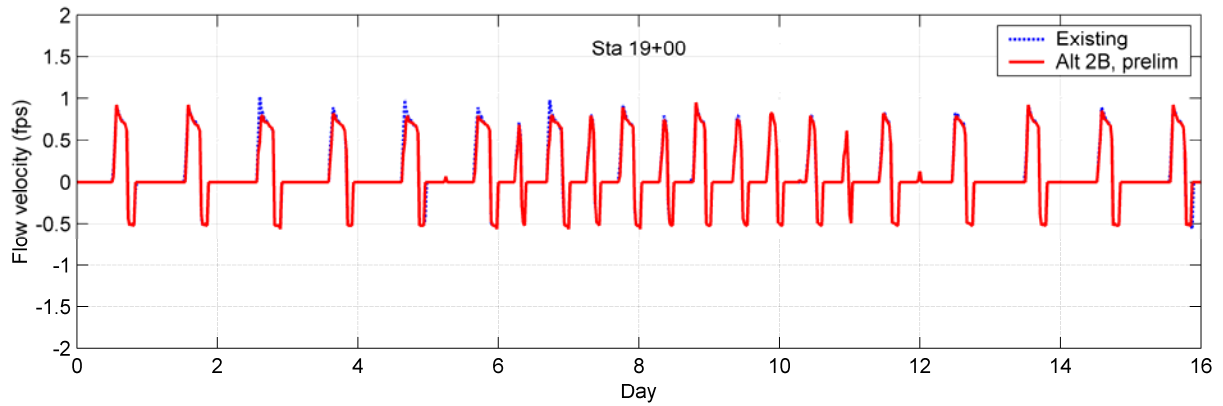
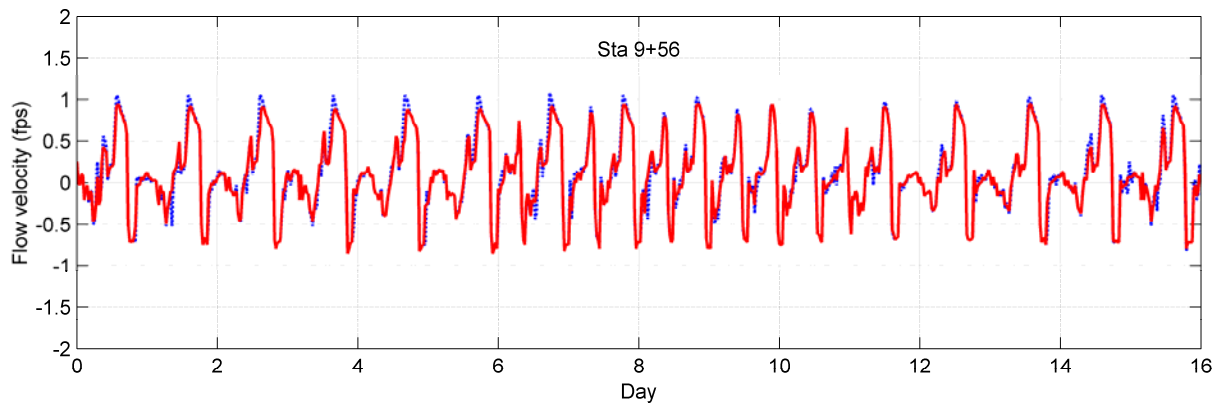
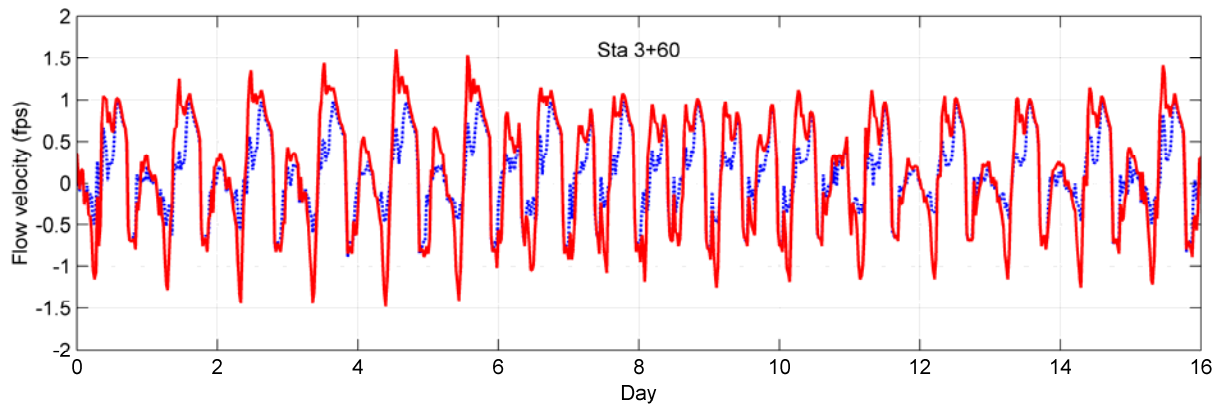
Figure 59. Flow Velocities in Northern Drainage Channel for WRA's Alternative 2B (Apr 1 – Aug 15)

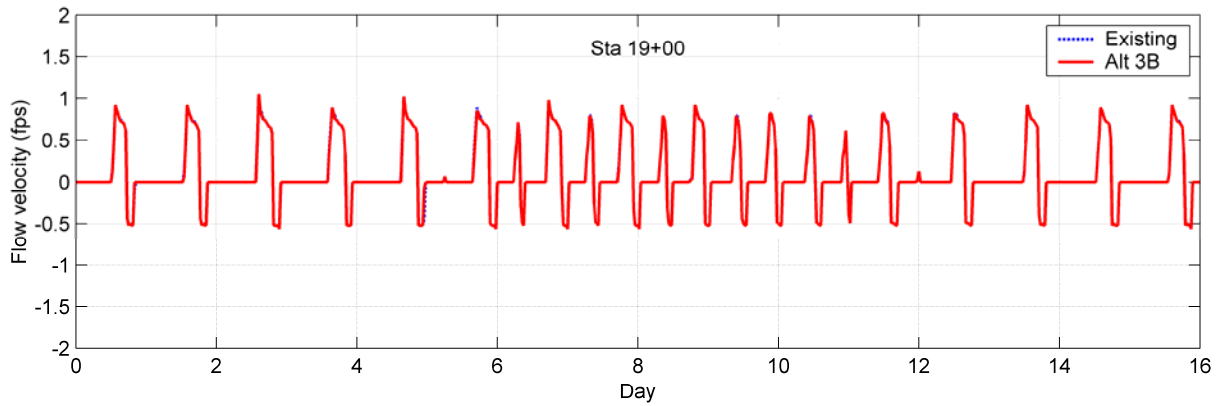
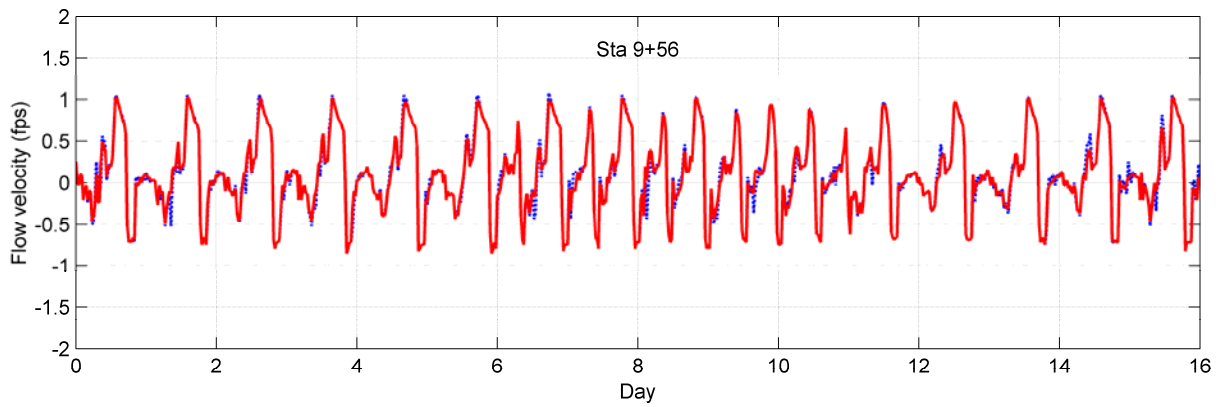
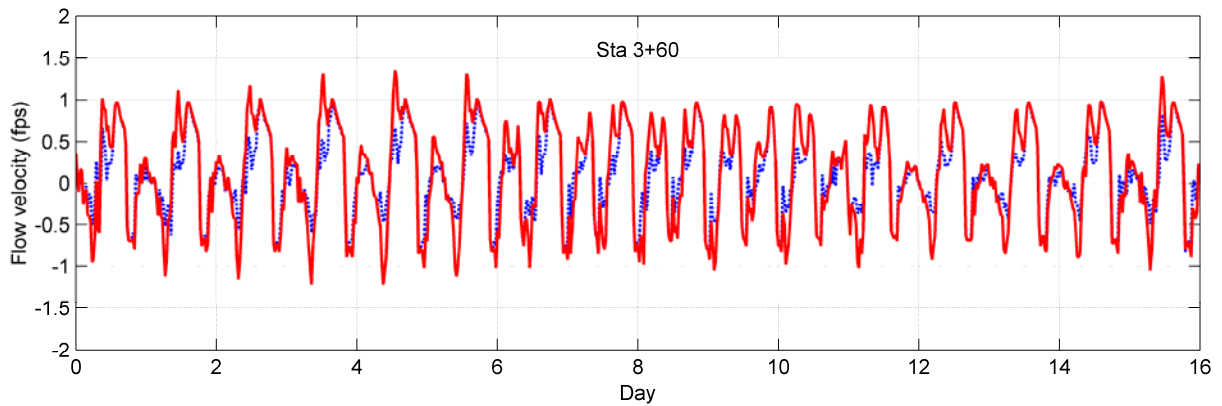
Figure 60. Flow Velocities in Northern Drainage Channel for WRA’s Alternative 3B (Apr 1 – Aug 15)

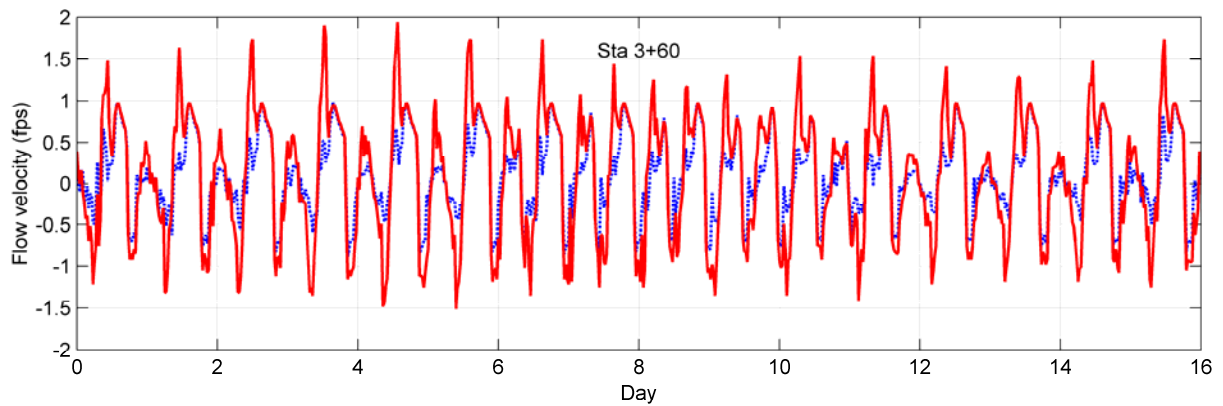
Figure 61. Flow Velocities in Northern Drainage Channel for WRA’s Alternative 2B with Optimized Channel Size for Breach and Internal Tidal Channels (Apr 1 – Aug 15)

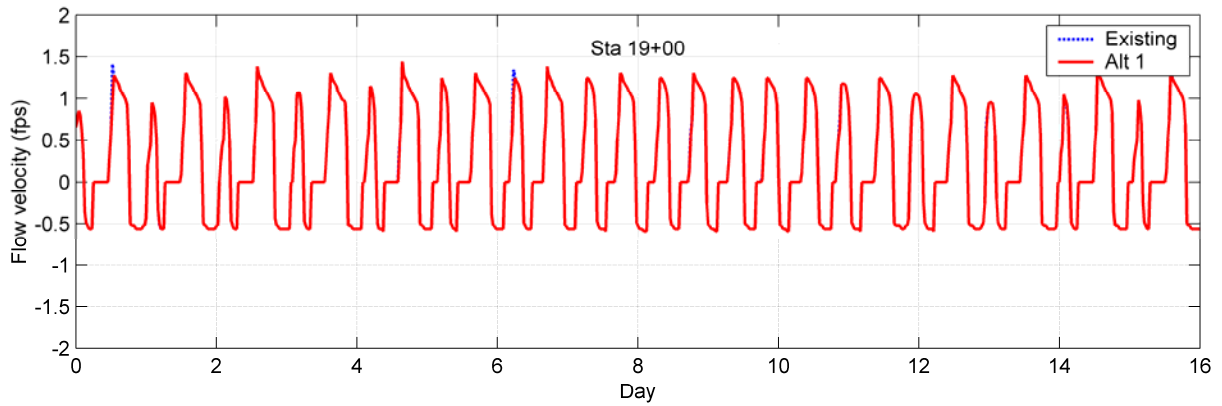
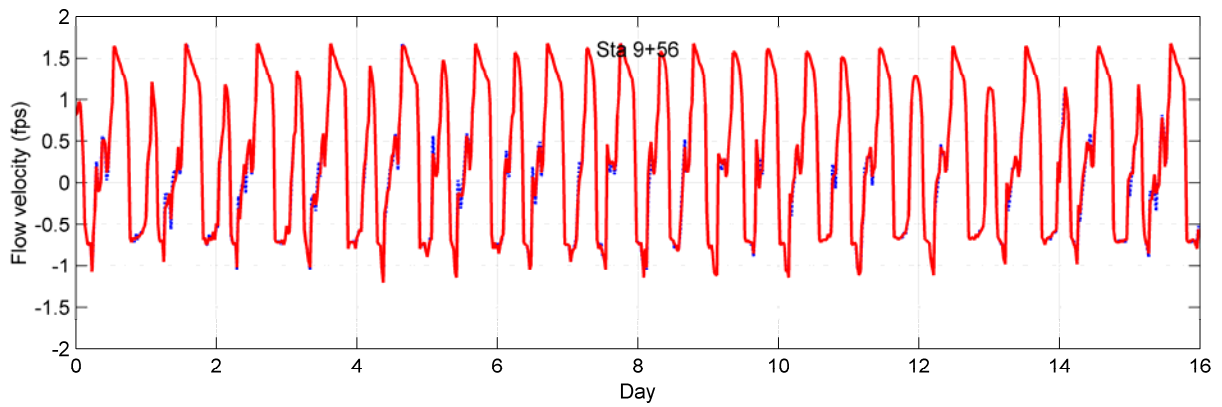
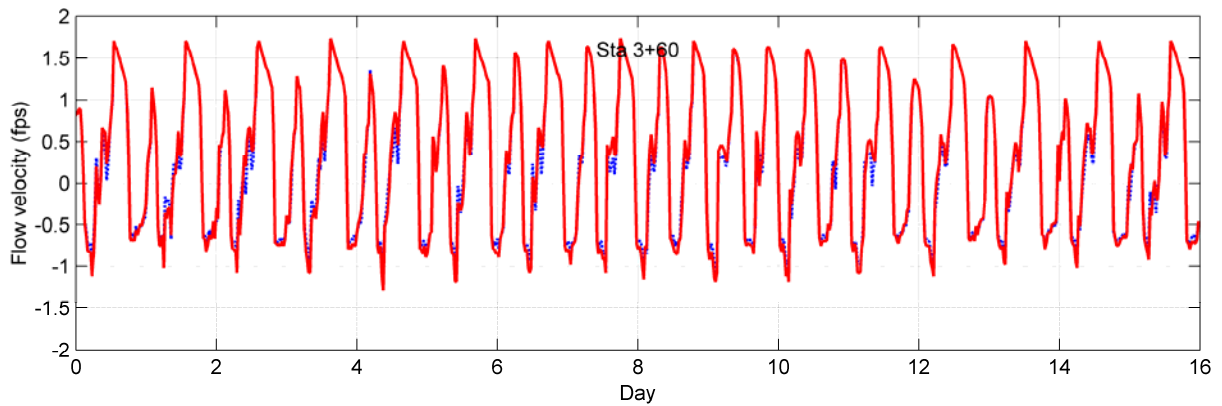
Figure 62. Flow Velocities in Northern Drainage Channel for WRA’s Alternative 1 (Aug 15 – Beginning of Shorebird Marsh Fall Maintenance)

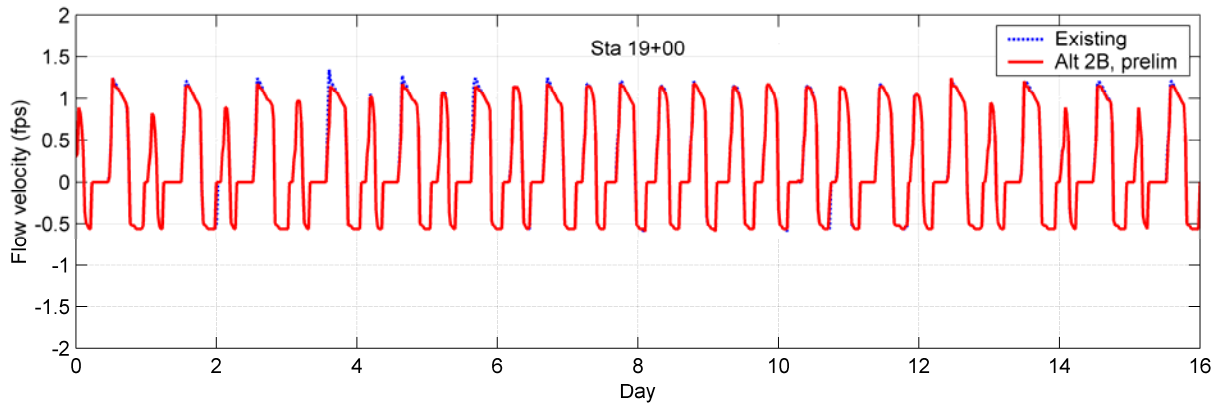
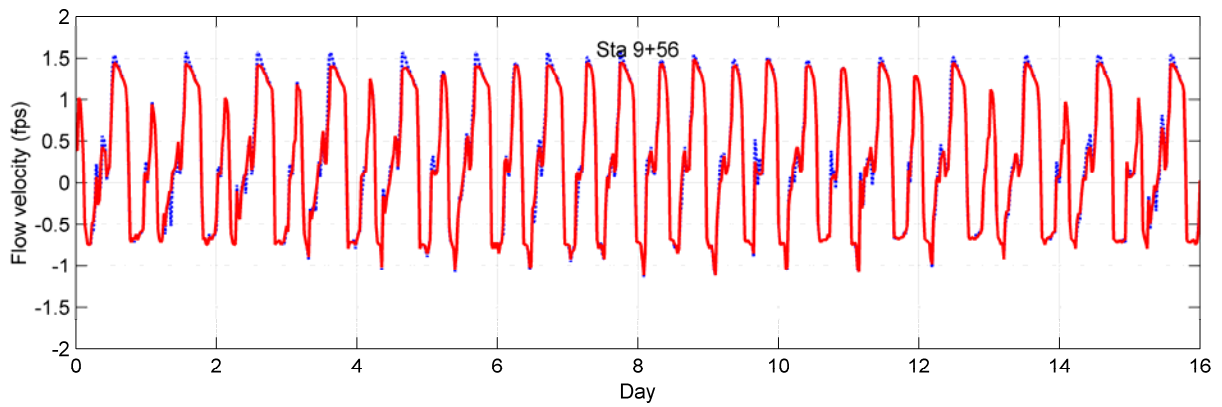
Figure 67. Flow Velocities in Northern Drainage Channel for WRA’s Alternative 2B (Winter with No Precipitation Forecasted)

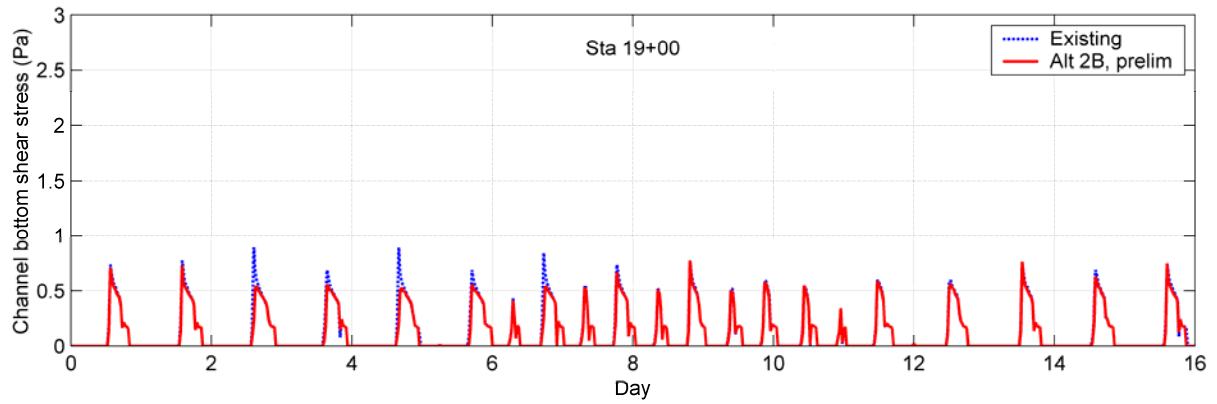
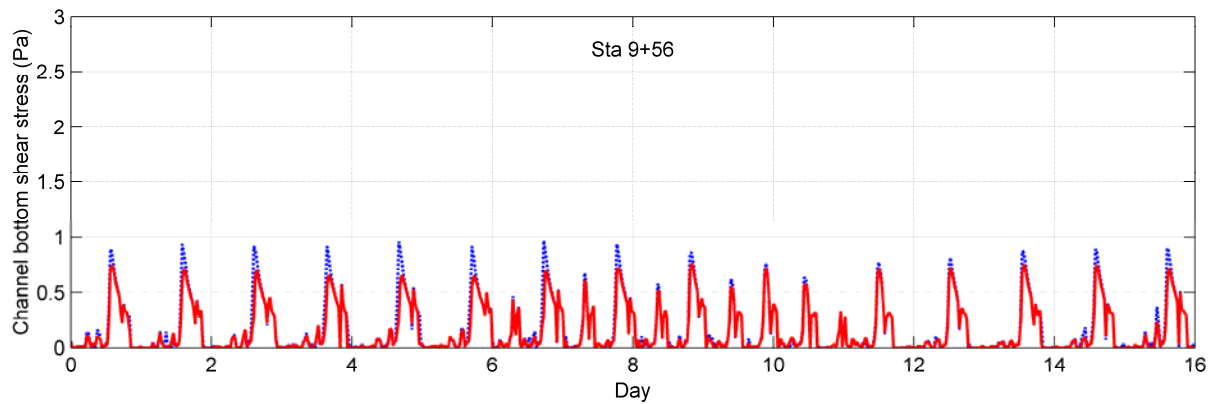
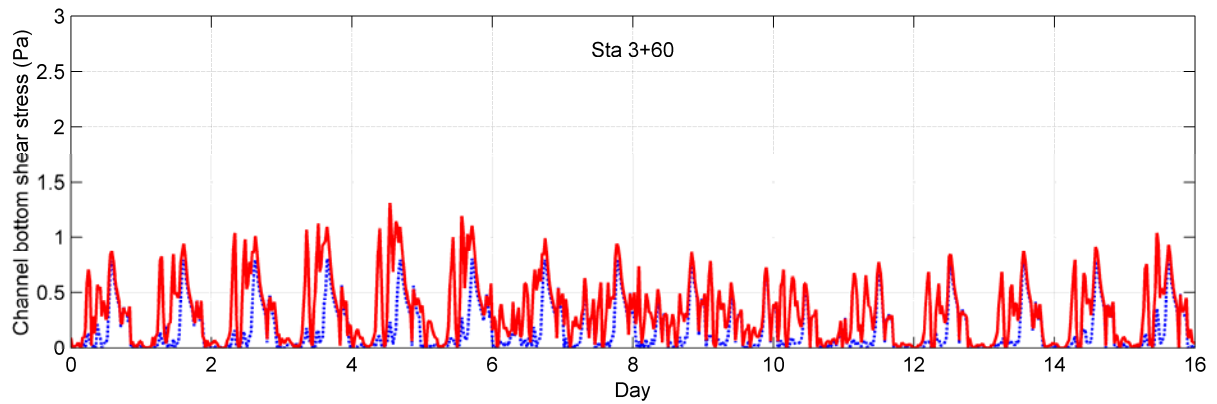
Figure 70. Bottom Shear Stresses in Northern Drainage Channel for WRA's Alternative 1 (Apr 1 – Aug 15)

The channel bottom shear stresses computed for WRA's three preliminary alternatives and Alternative 2B with the optimized channel size, compared to the existing condition, are shown in Figure 70 through Figure 81 for various seasons, respectively. The maximum shear stresses, compared to the existing condition, are summarized in Table 8. As shown in these figures and in Table 8, the bottom shear stresses in the lower reach of the drainage channel that is downstream of the proposed breach location will be slightly increased due to the added water exchange between Corte Madera Marsh and the channel. For example, the maximum bottom shear stress at Station 3+60 is approximately 2.2 Pa for the existing condition and for Alternative 1, but it will increase to 2.8 Pa for Alternative 2B, 2.4 Pa for Alternatives 3B, and 2.3 Pa for Alternatives 2B with optimized channel size. The existing northern drainage channel seems to be in a dynamical equilibrium condition in long term. If using the existing bottom shear stress in the northern drainage channel as a baseline measure, Alternatives 2B and 3B may induce insignificant scour in the lower reach of the northern drainage channel that is downstream of the breach location. On the other hand, Alternative 1 and Alternative 2B with optimized size for the breach and internal tidal channels will not induce any noticeable morphologic change to the northern drainage channel.

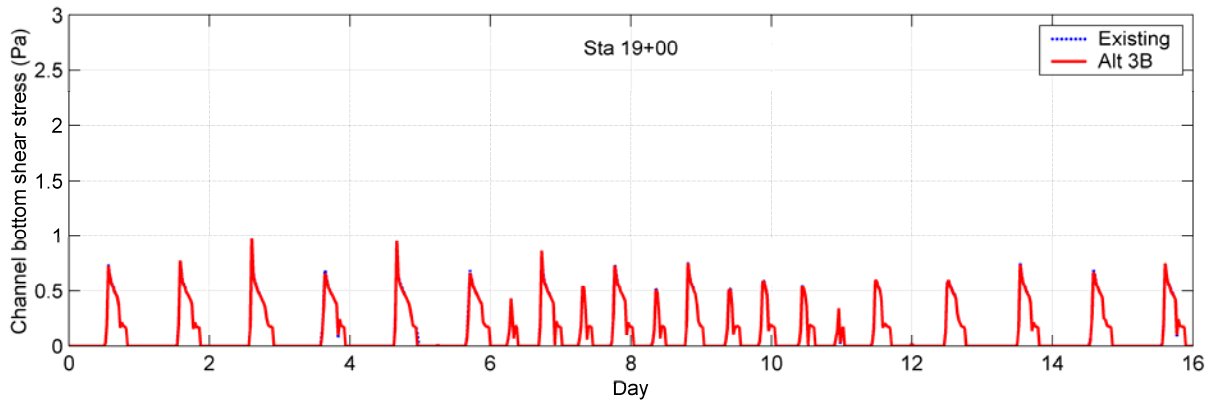
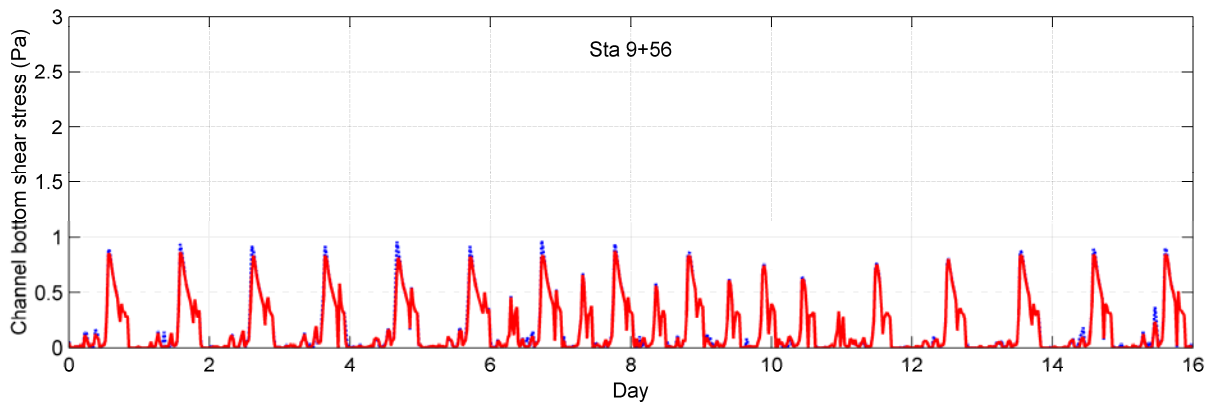
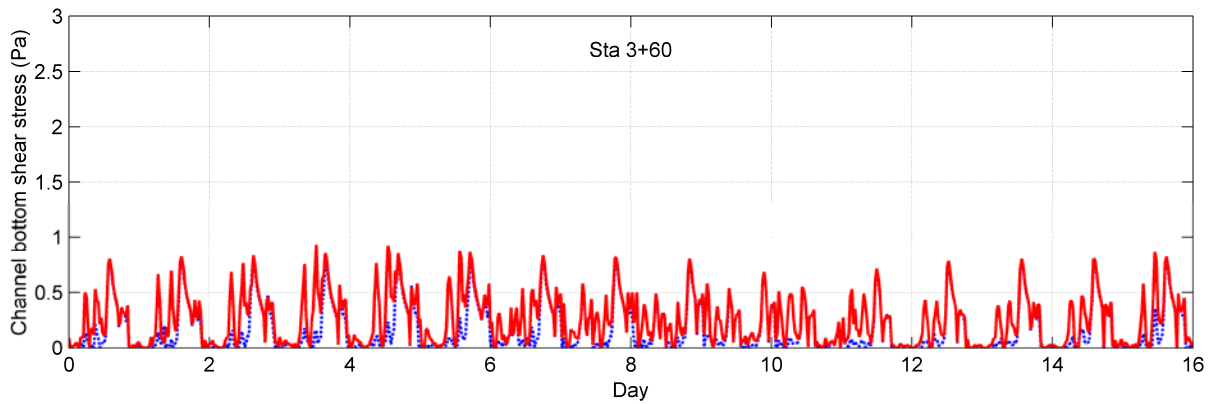
Figure 71. Bottom Shear Stresses in Northern Drainage Channel for WRA's Alternative 2B (Apr 1 – Aug 15)

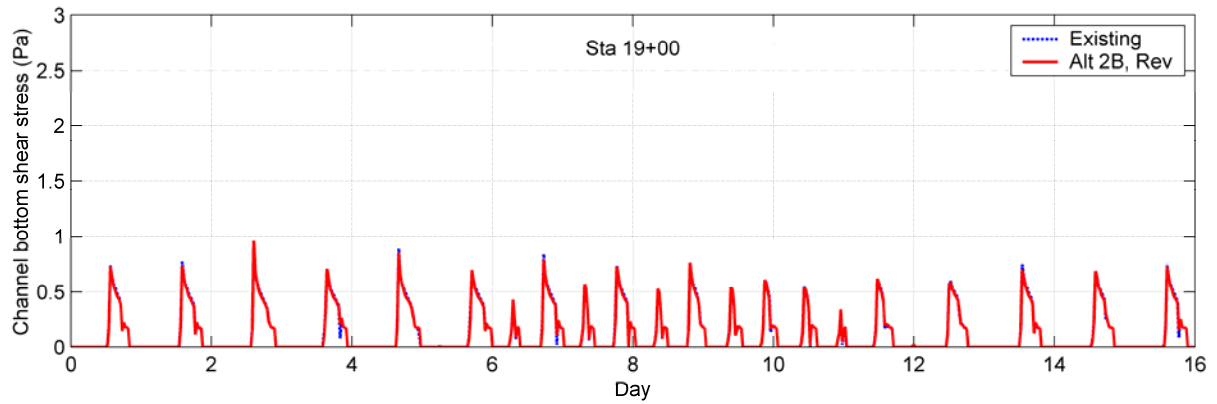
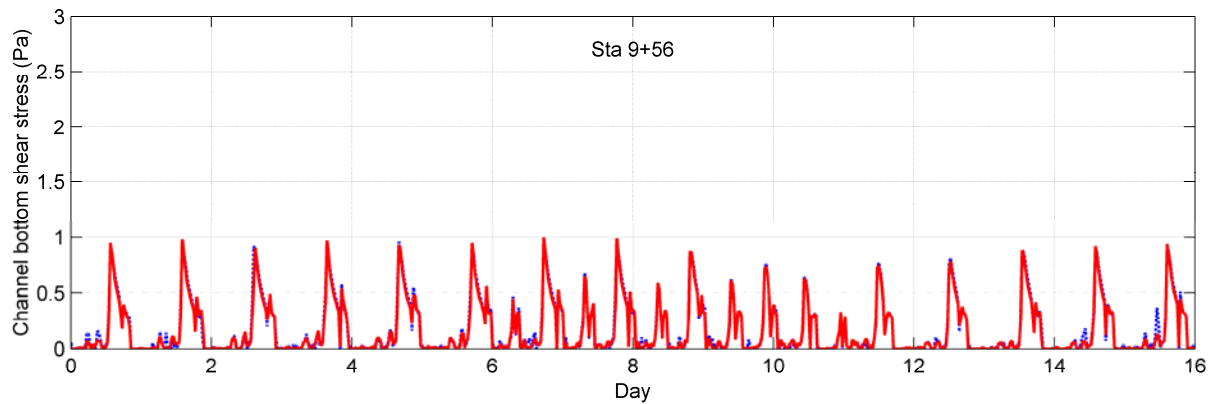
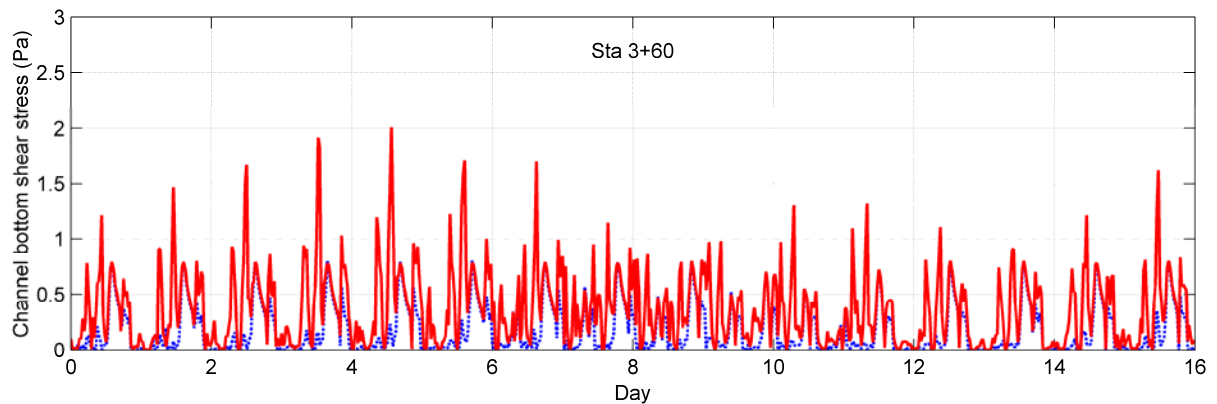
Figure 72. Bottom Shear Stresses in Northern Drainage Channel for WRA’s Alternative 3B (Apr 1 – Aug 15)

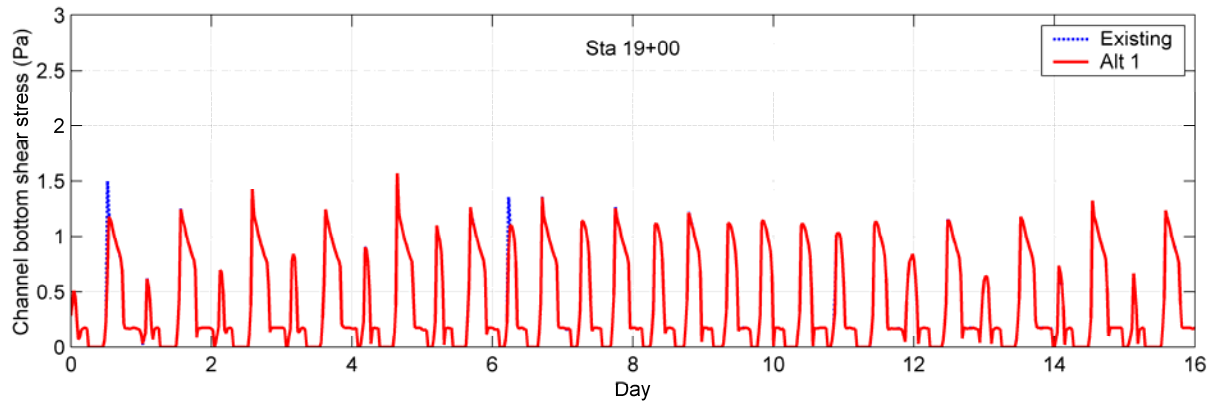
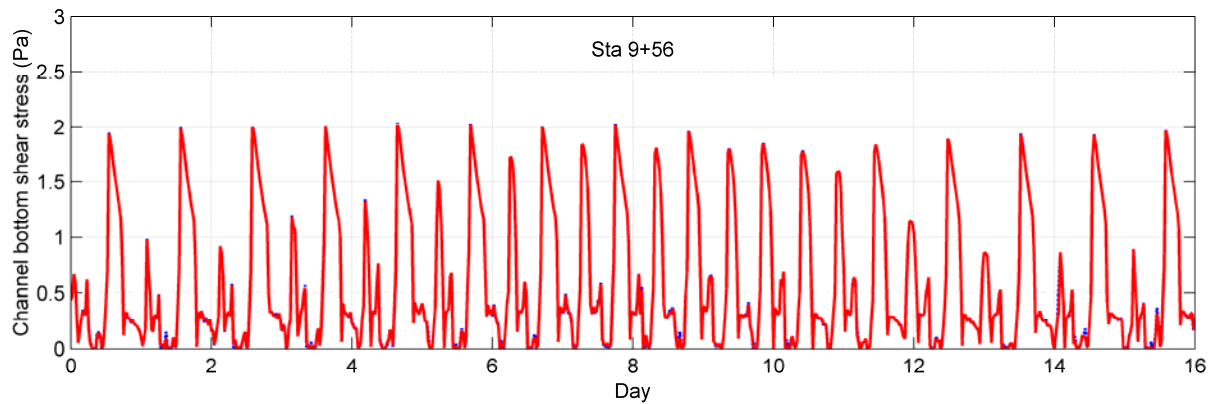
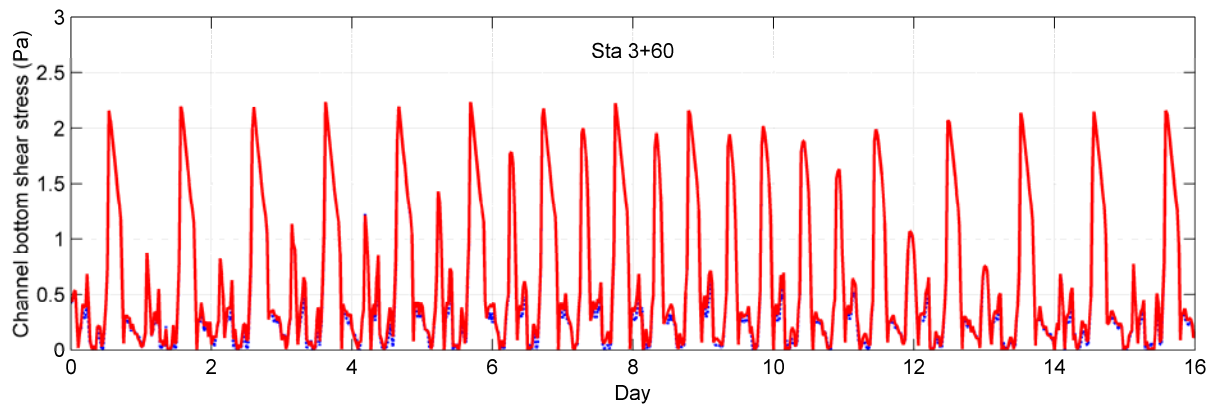
Figure 73. Bottom Shear Stresses in Northern Drainage Channel for WRA’s Alternative 2B with Optimized Channel Size for Breach and Internal Tidal Channels (Apr 1 – Aug 15)

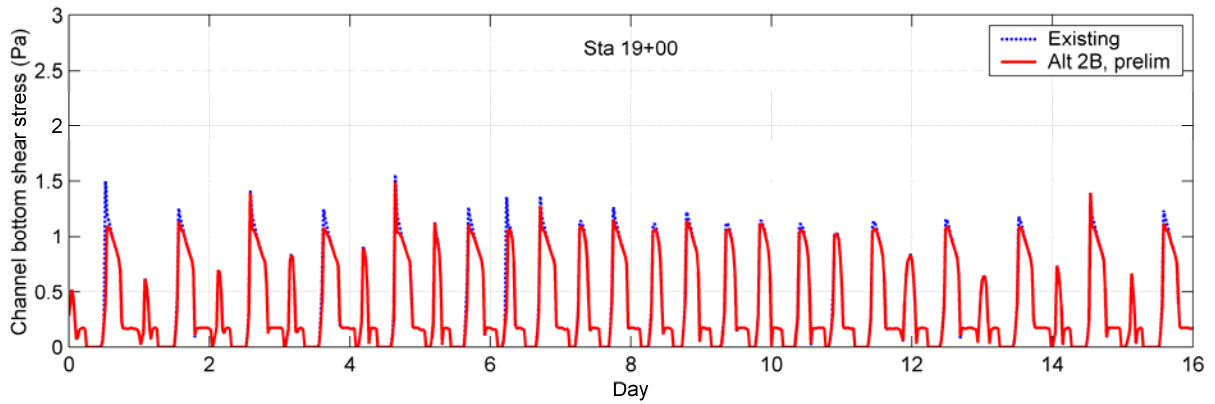
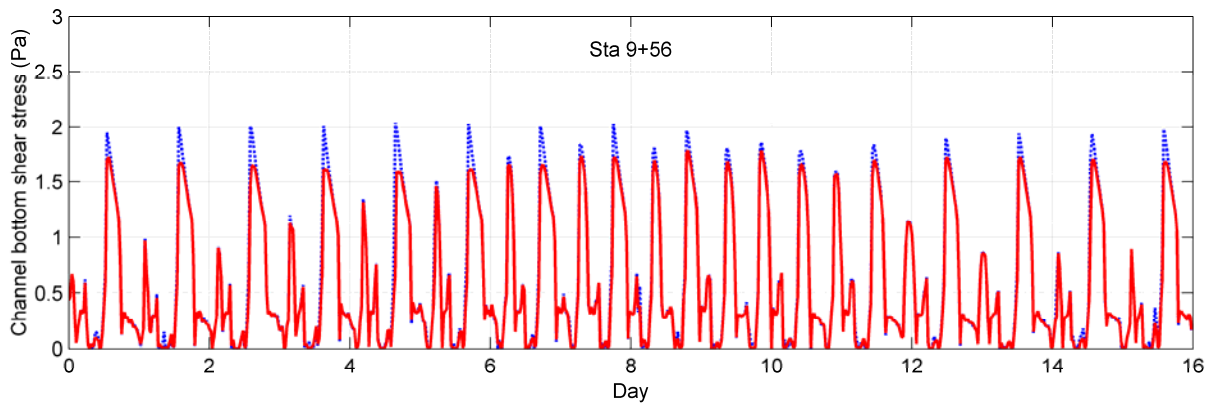
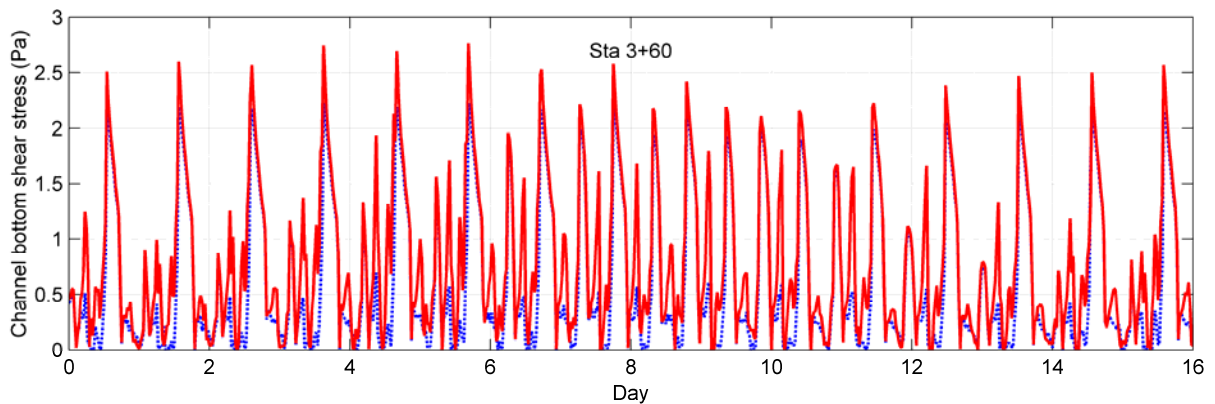
Figure 74. Bottom Shear Stresses in Northern Drainage Channel for WRA's Alternative 1 (Aug 15 – Beginning of Shorebird Marsh Fall Maintenance)

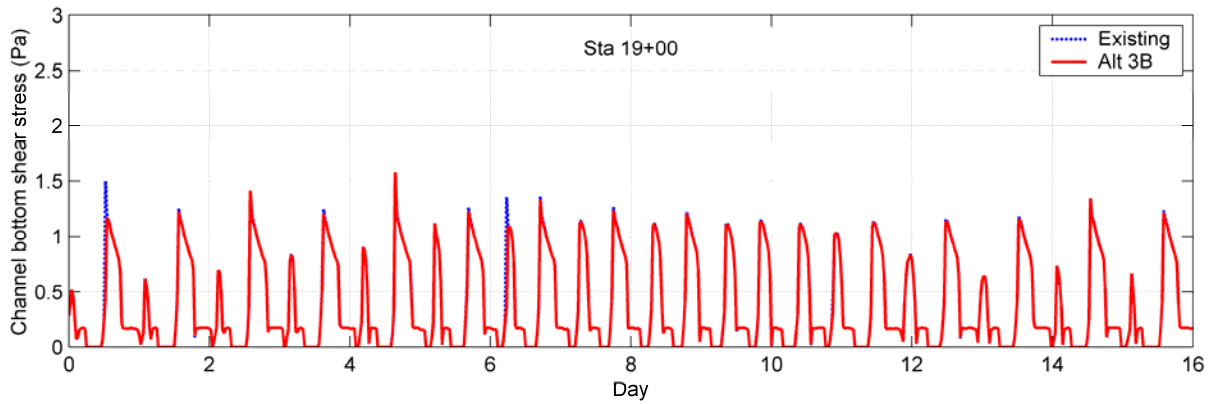
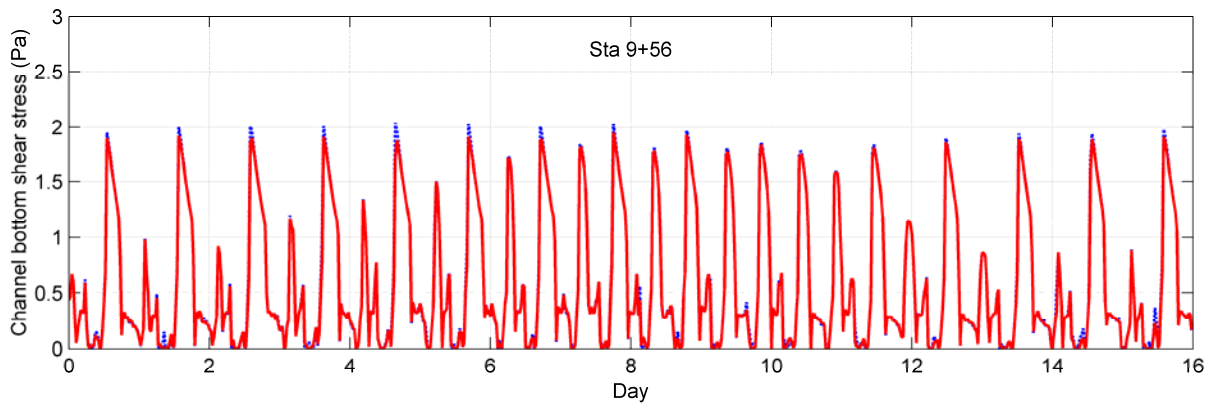
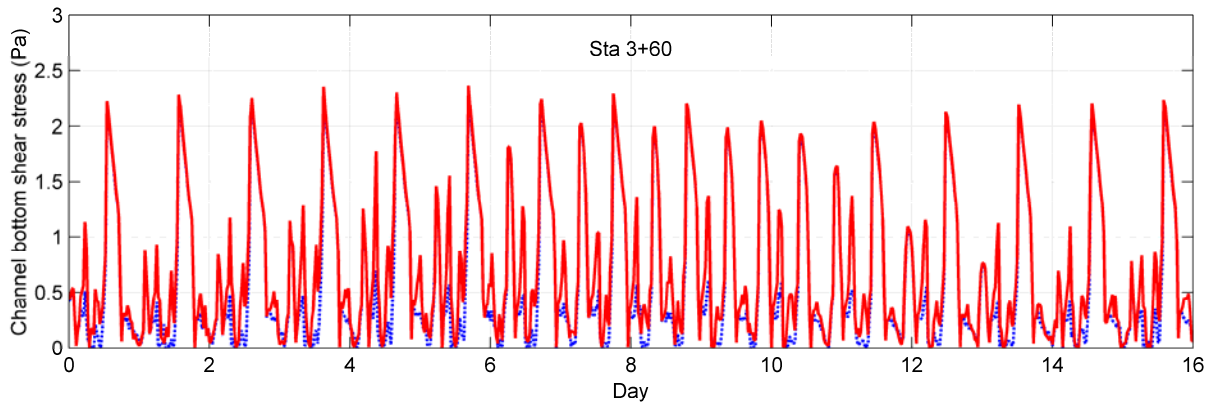
Figure 75. Bottom Shear Stresses in Northern Drainage Channel for WRA’s Alternative 2B (Aug 15 – Beginning of Shorebird Marsh Fall Maintenance)
